Re: Monthly Summary – November 2021
DEP File No. 200-0195
Eversource Montague-Fairmont Structure Replacement Project (MFRP)
Leverett, MA

CONSTRUCTION MONITORING REPORT

Eversource Transmission Lines: 1044/1113	Location: Leverett Environmental Permits: EPA CGP, Leverett OOC, ACO
USEPA NOI Tracking No: MAR1002TQ	GZA Project No: 15.0166637.24

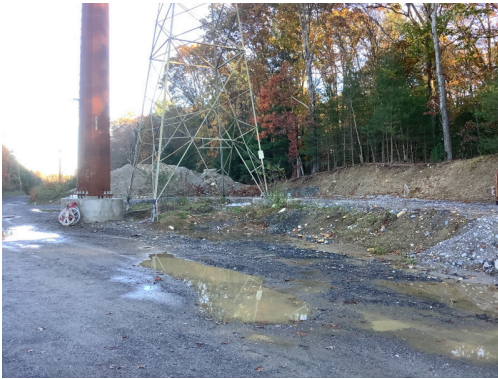
Photo No. 1

STR 10134 looking north.

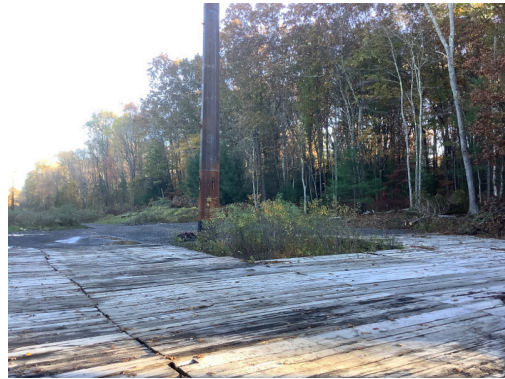
Photo No. 2

STR 10133 looking north.

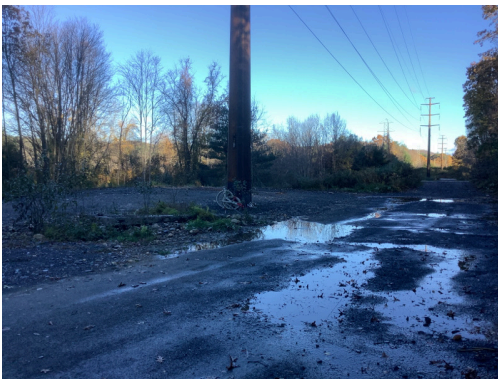
Photo No. 3

STR 10132 looking north.

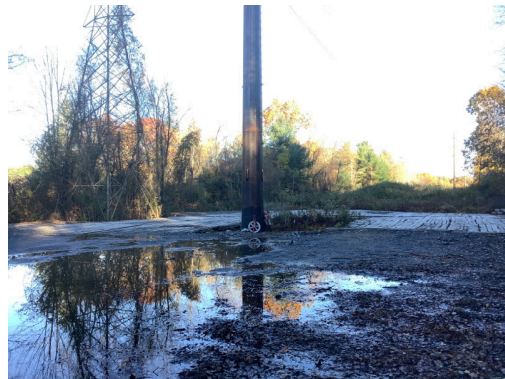
Photo No. 4

STR 10131 looking north.

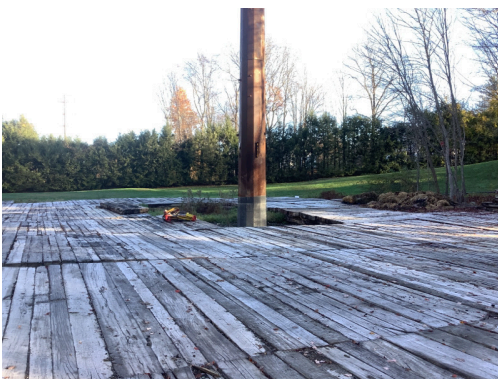
Photo No. 5

STR 10130 looking north.

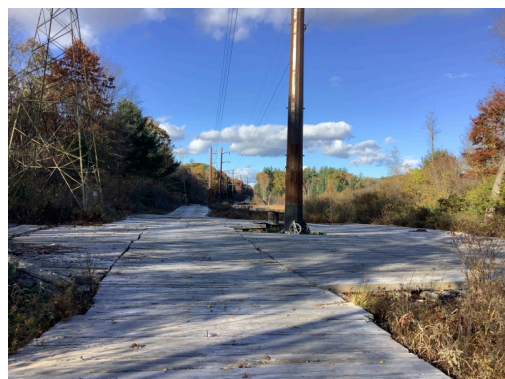
Photo No. 6

STR 10129 looking north.

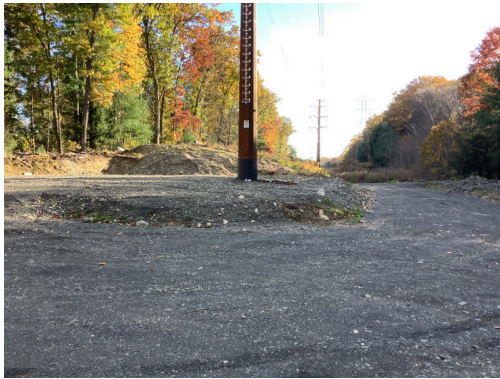
Photo No. 7

STR 10124 looking south.

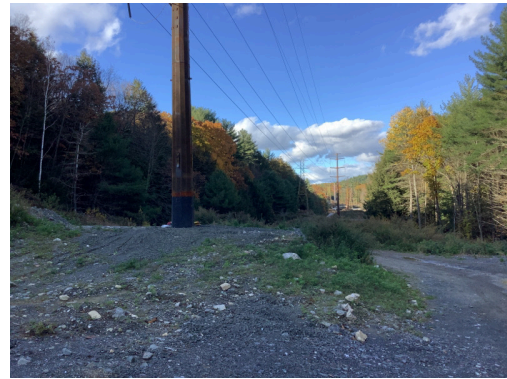
Photo No. 8

STR 10123 facing north.

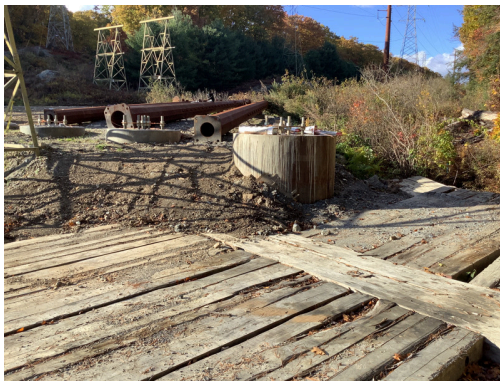
Photo No. 9

STR 10119 facing north west. Mats need sweeping prior to next phase of line work.

- STRs 10084 & 10087 - Repairs to cultural exclusion area fence are needed.
- STR 10119 - Sweep partially matted pad prior to next phase of line work.

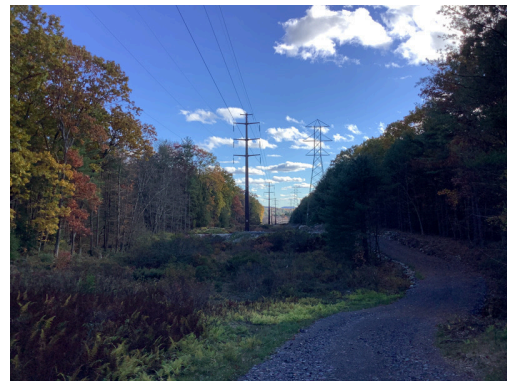
Photo No. 10

STR 10115 facing south.

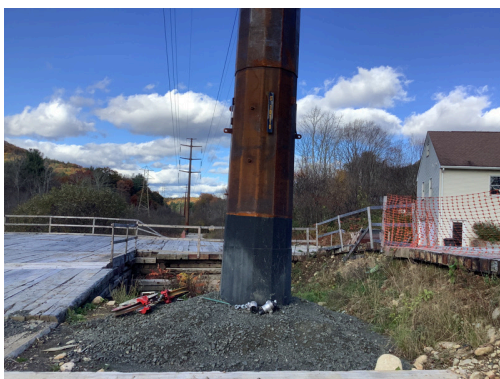
Photo No. 11

STR 10110 facing north.

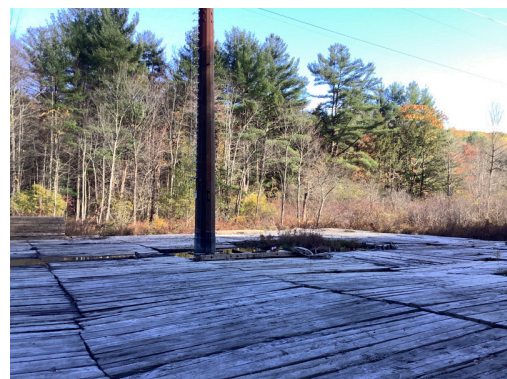
Photo No. 12

STR 10105 facing east.

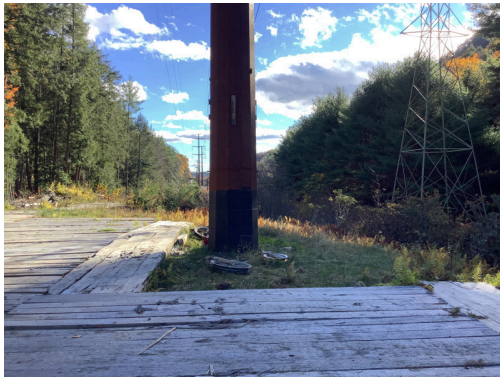
Photo No. 13

STR 10098 facing south.

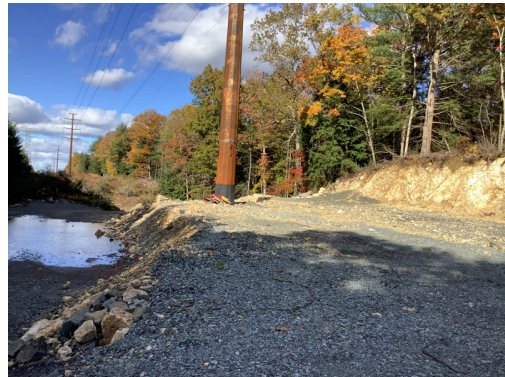
Photo No. 14

STR 10094 facing north.

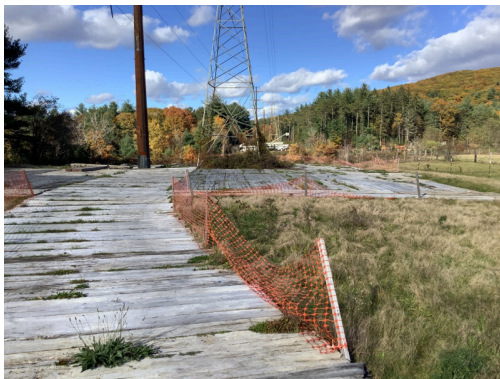
Photo No. 15

STR 10087 repairs to cultural fencing are needed, facing north.

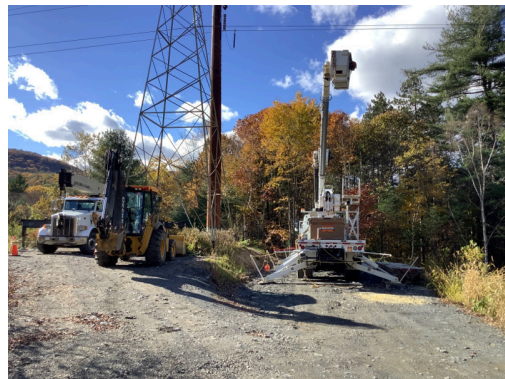
Photo No. 16

Line crew staged at STR 10086 looking west.

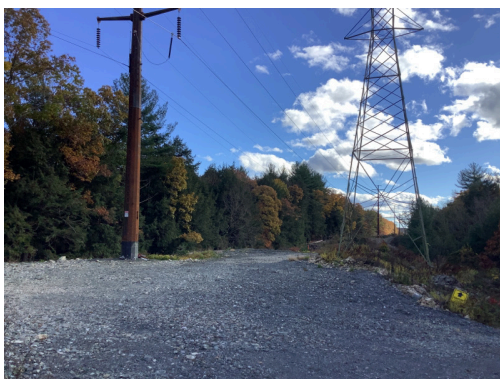
Photo No. 17

STR 10082 facing south.

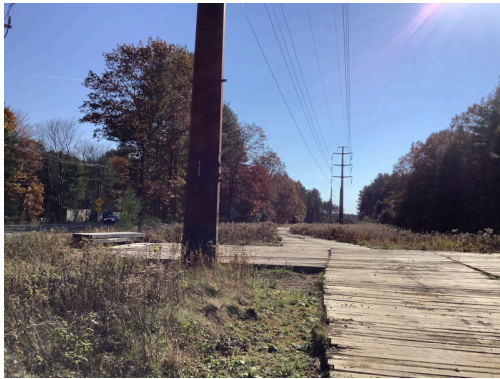
Photo No. 1 STR 10083 line pull complete, facing south.

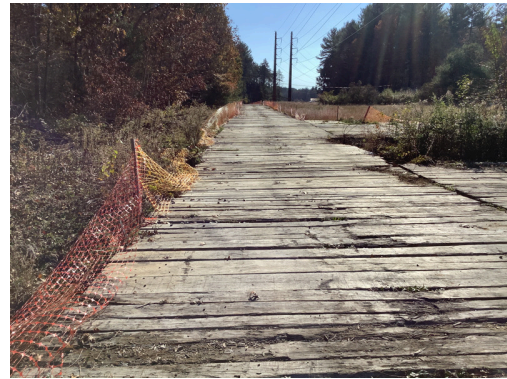
Photo No. 2 STR 10084 repairs to cultural fencing are needed, facing south.

- STRs 10084 & 10087 - Repairs to cultural exclusion area fence are needed.
- STR 10119 - Sweep partially matted pad prior to next phase forecasted rain event on November 12, 2021. .

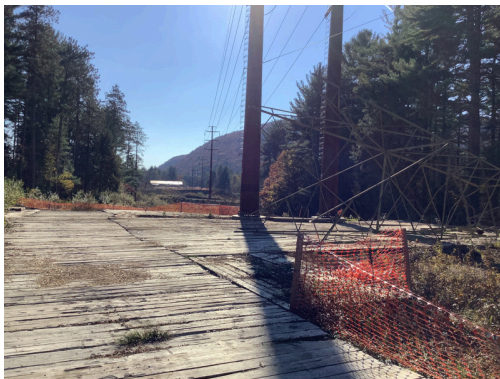
Photo No. 3 STR 10085 line work complete, facing south.

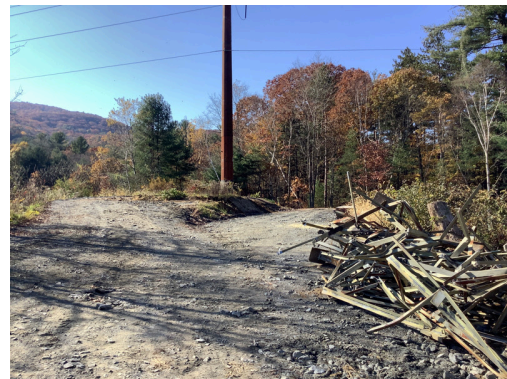
Photo No. 4 STR 10086 line work complete, facing west.

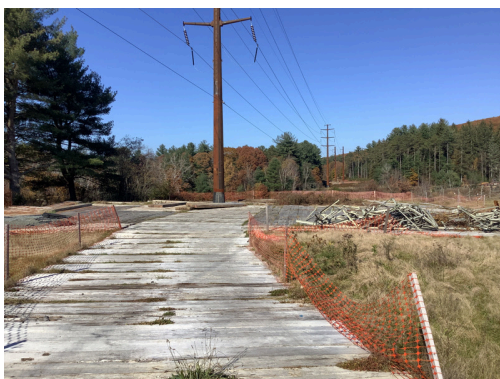
Photo No. 5 STR 10087 line work complete, facing north. Repairs to cultural fence are needed.

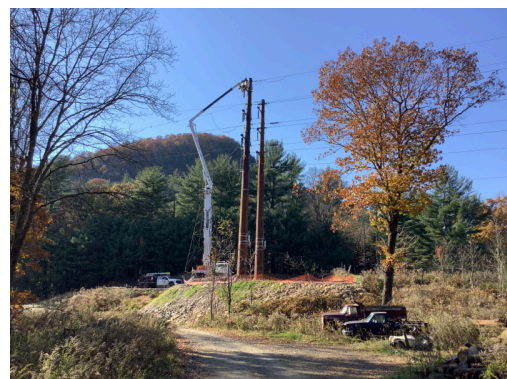
Photo No. 6 STR 10089 line work in progress, facing west.

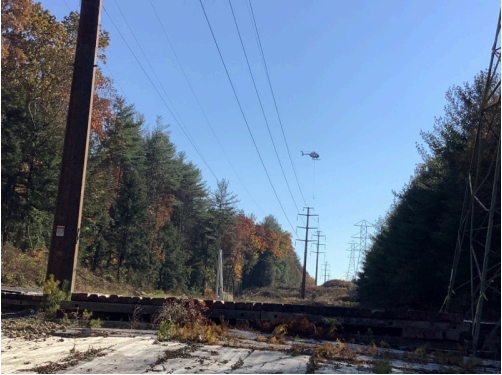
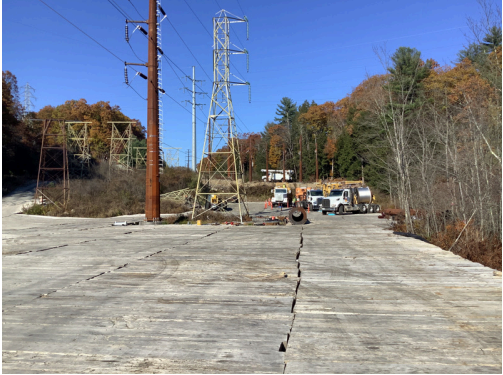
Photo No. 7	STR 10090 helicopter line pull work in progress, facing south.	Photo No. 8	STR 10120 facing north. Active line pull work at STR 10119 in background.

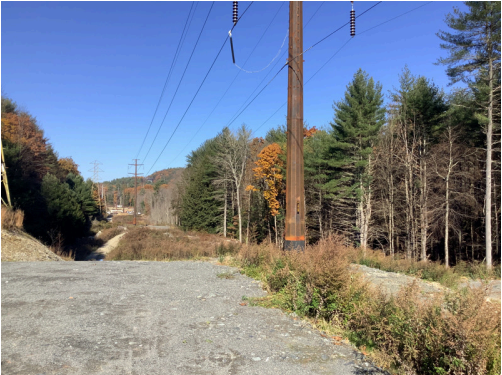
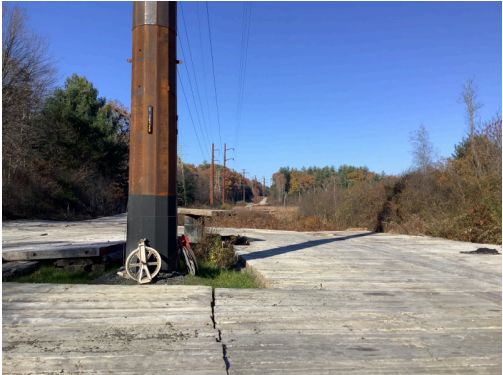
Photo No. 9	STR 10123 facing north.	Photo No. 10	STR 10129 facing north.

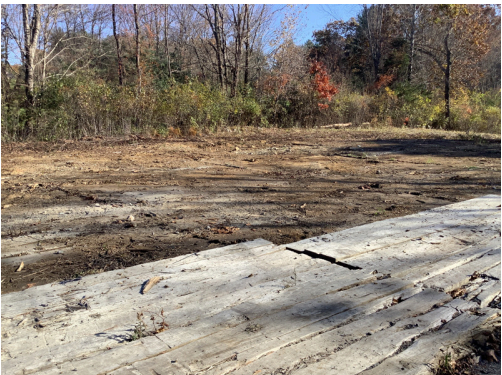
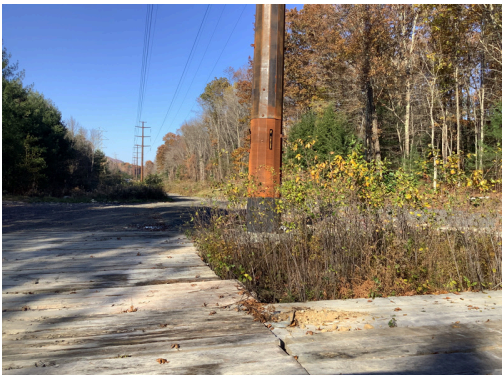
Photo No. 11	STR 10130.5 civil restoration in progress, facing east.	Photo No. 12	STR 10133 facing north.

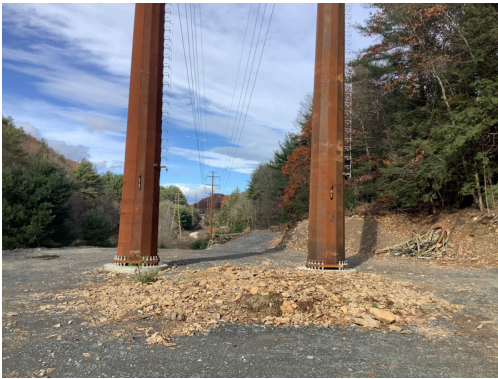
Photo No. 7 STR 10100 facing north, line work complete.

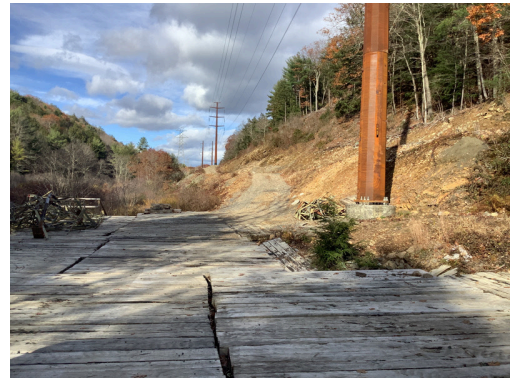
Photo No. 8 STR 10102 facing north. Line work complete.

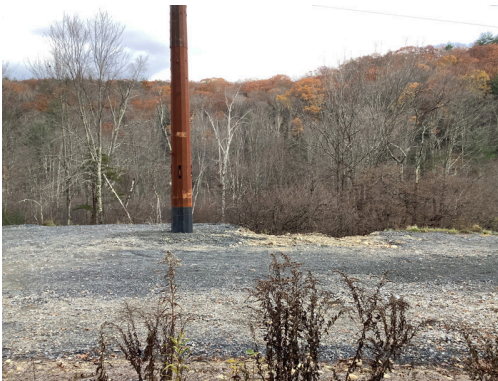
Photo No. 9 STR 10108 facing east.

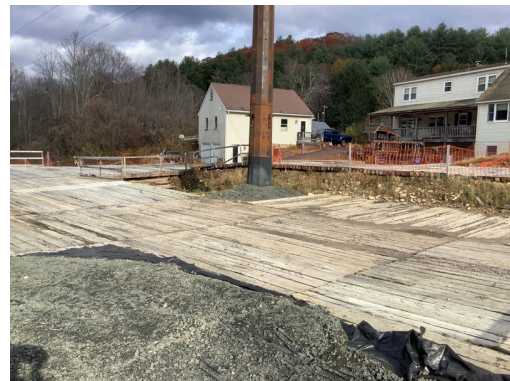
Photo No. 10 STR 10110 facing north east.

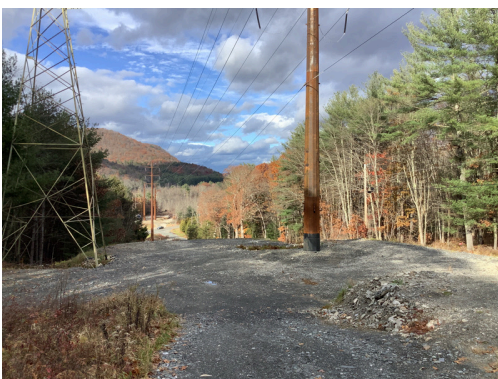
Photo No. 11 STR 10113 line work complete, facing north.

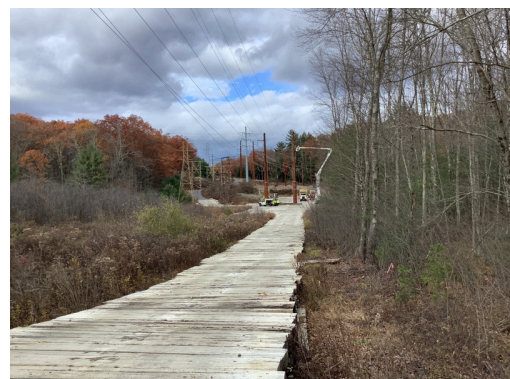
Photo No. 12 STR 10119 - 10137, line work in progress.

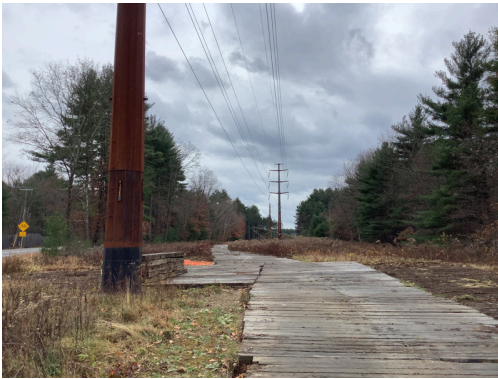
Photo No. 1

STR 10083 civil restoration in progress, facing south.

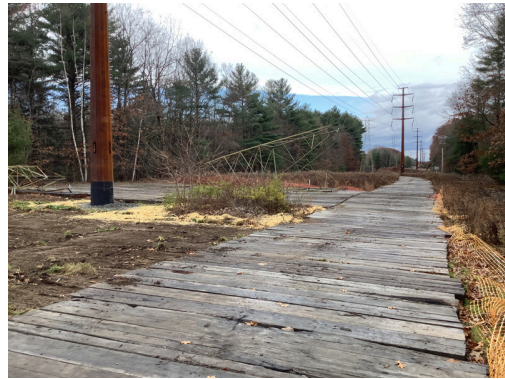
Photo No. 2

STR 10084 civil restoration in progress, facing north. Cultural fence repairs needed.

- STRs 10084 - Repairs to cultural exclusion area fence are needed.
- STR 10119 - Sweep mats and refresh erosion controls near stream.

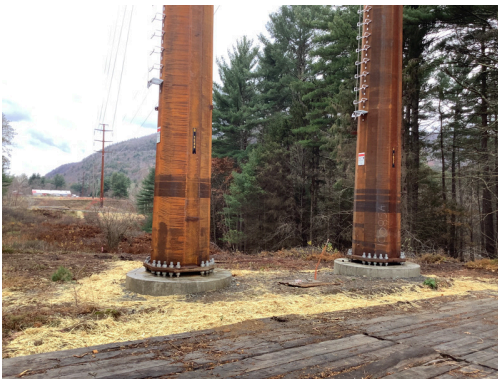
Photo No. 3

STR 10085 civil restoration in progress, facing south.

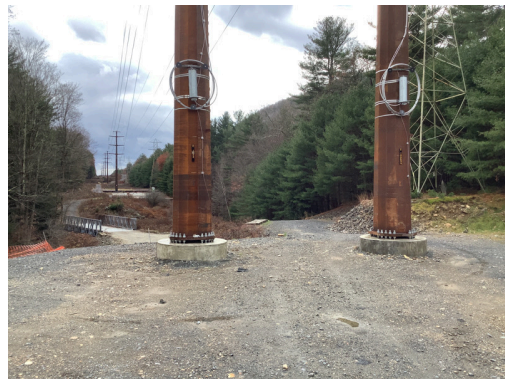
Photo No. 4

STR 10089 facing south.

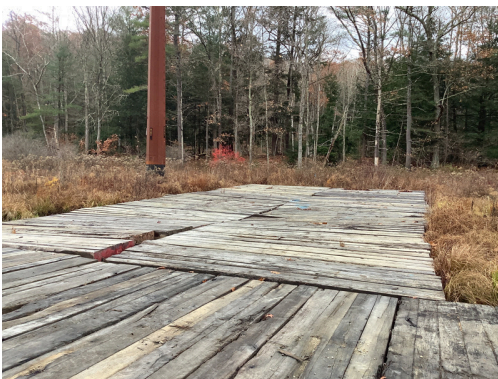
Photo No. 5

STR 10104 facing east.

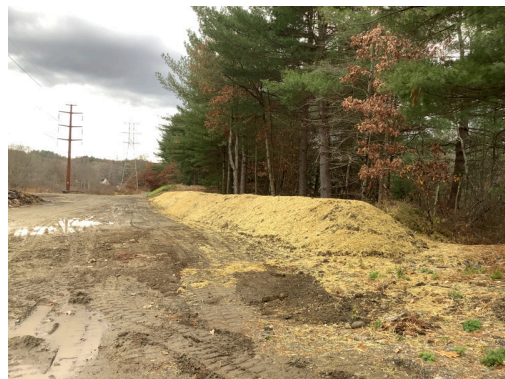
Photo No. 6

STR 10107 pull pad civil restoration in progress, facing south.

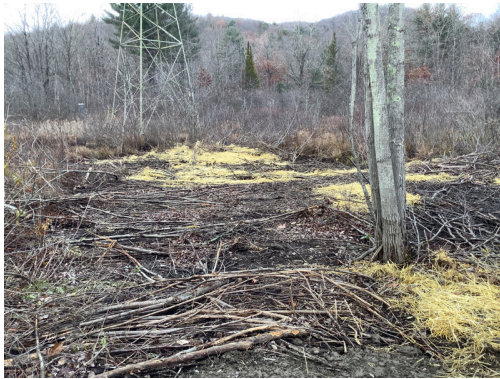
Photo No. 7 STR 10109 civil restoration in progress, facing west.

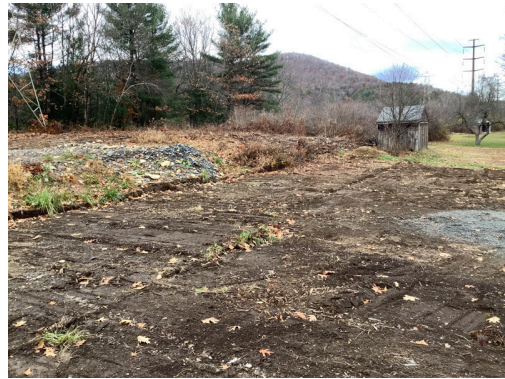
Photo No. 8 STR 10111 civil restoration in progress, facing north.

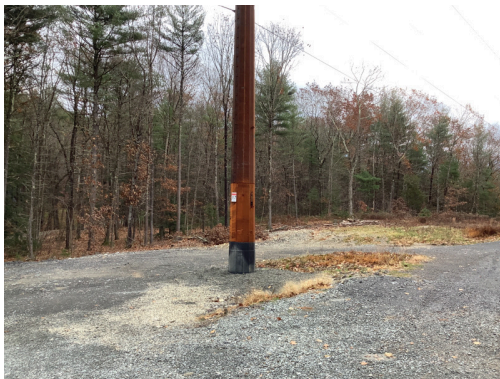
Photo No. 9 STR 10113 facing south east.

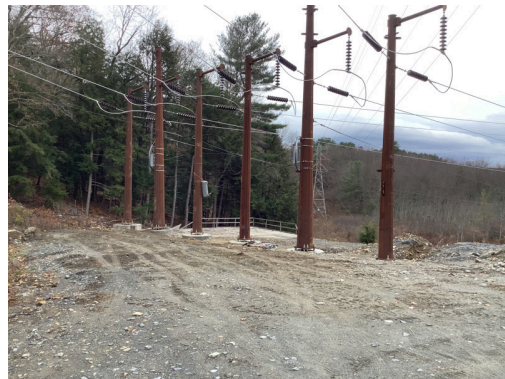
Photo No. 10 STR 10119 line work complete, facing east.

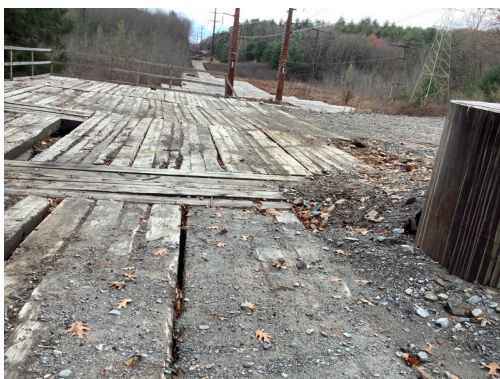
Photo No. 11 STR 10119 sweep mats and refresh erosion controls near stream.

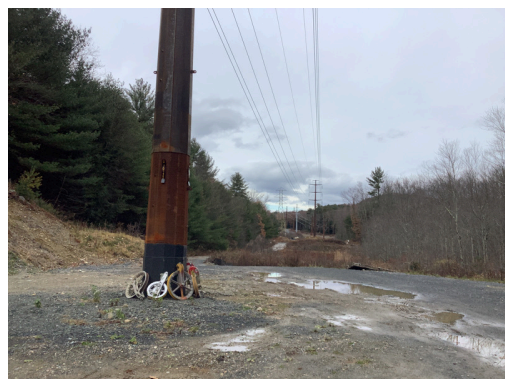
Photo No. 12 STR 10122 line work complete, facing north.

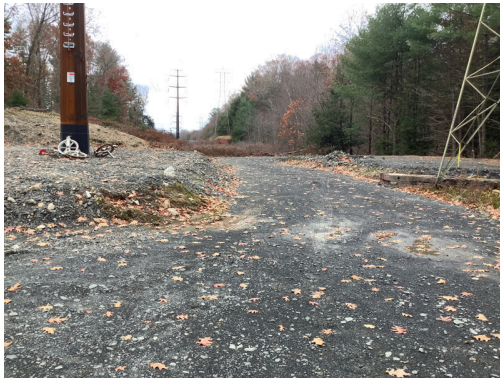
Photo No. 13 STR 10124 line work complete, facing south.

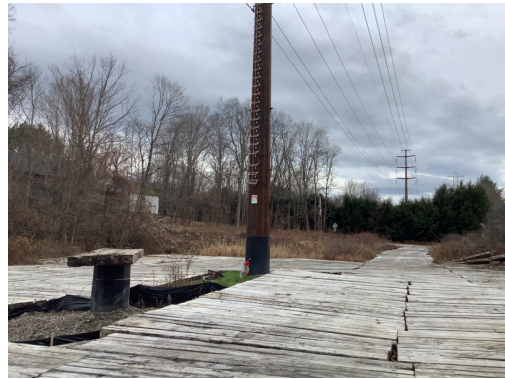
Photo No. 14 STR 10128 facing south.

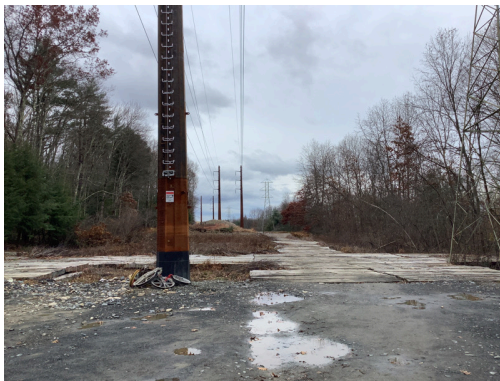
Photo No. 15 STR 10133 facing south.
