THE FIELD BUILDING LEVERETT, MASSACHUSETTS

BUILDING CONDITIONS ASSESSMENT MARCH 2026

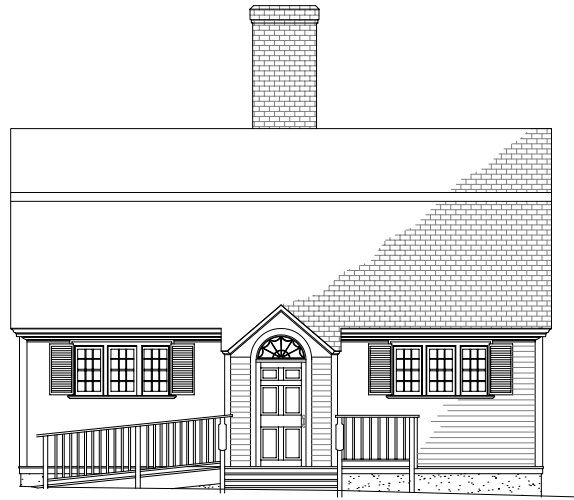
THE FIELD BUILDING
BUILDING CONDITIONS ASSESSMENT

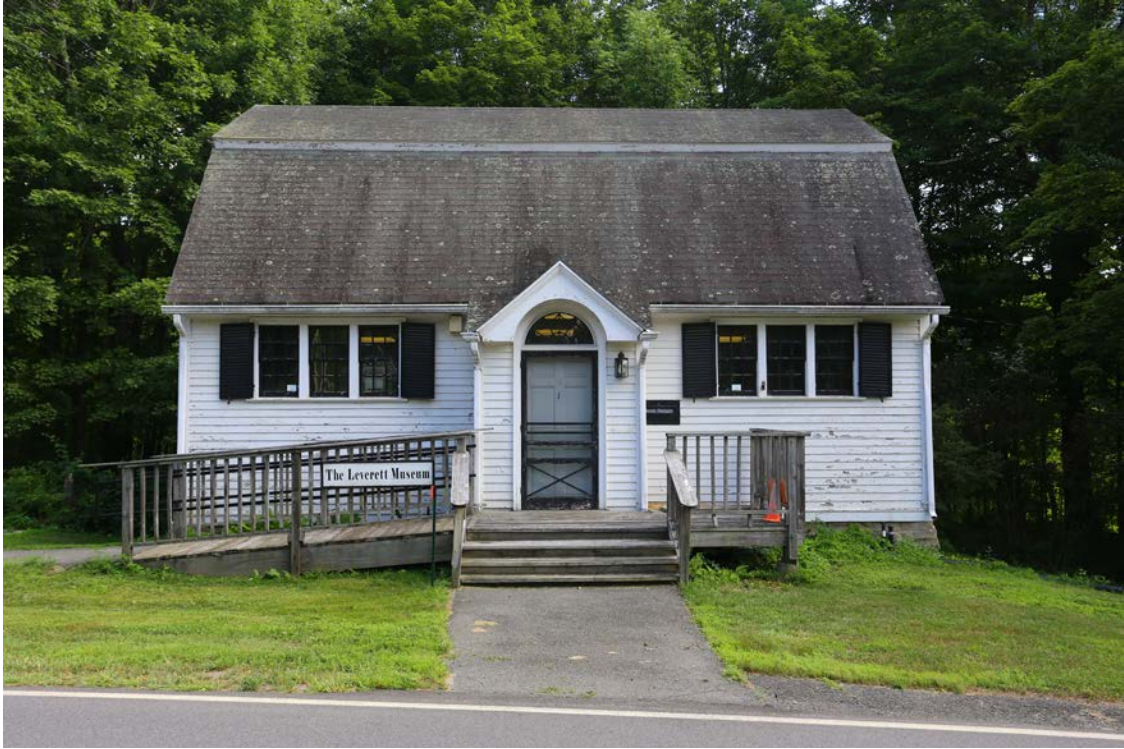
Fig. 1. North elevation. July 2025.

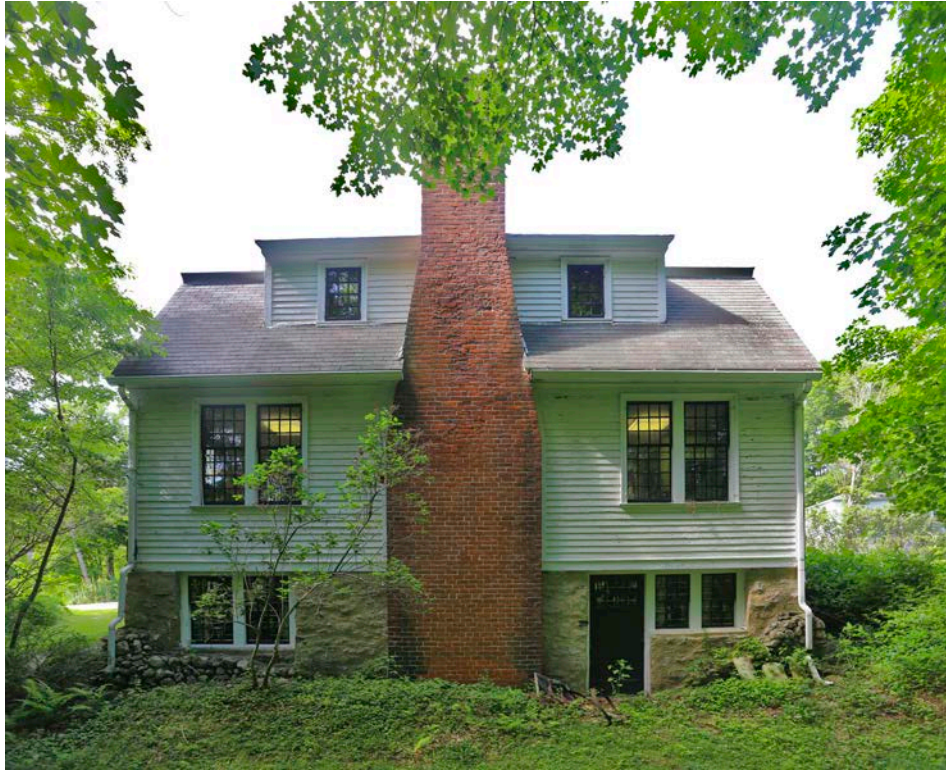
Fig. 3. South elevation. July 2025.

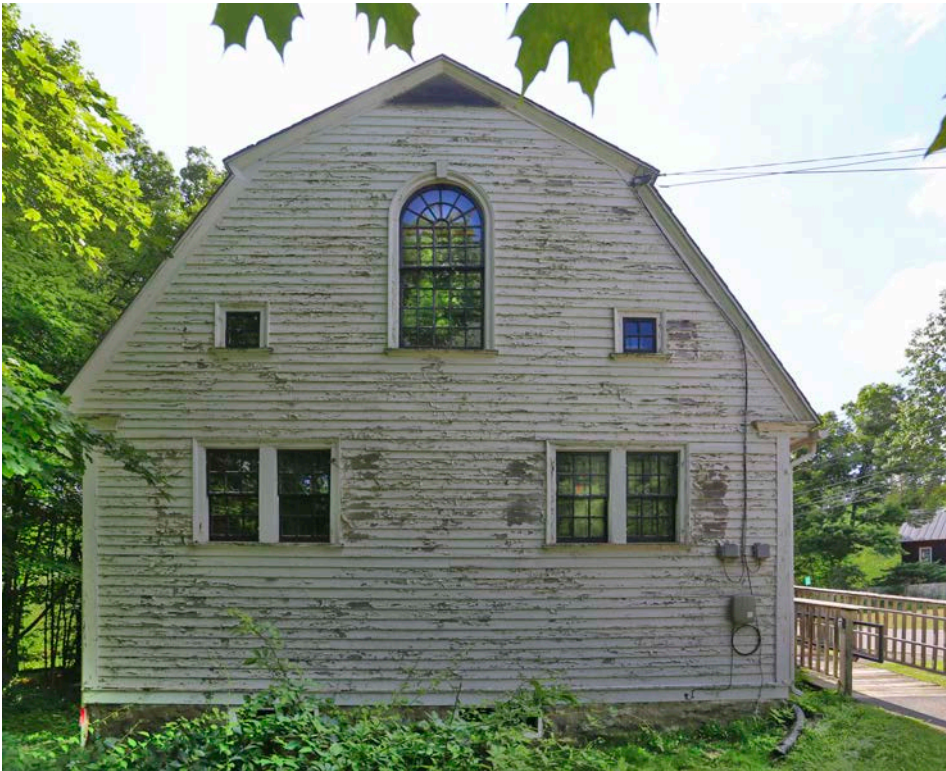
Fig. 4. East elevation. July 2025.

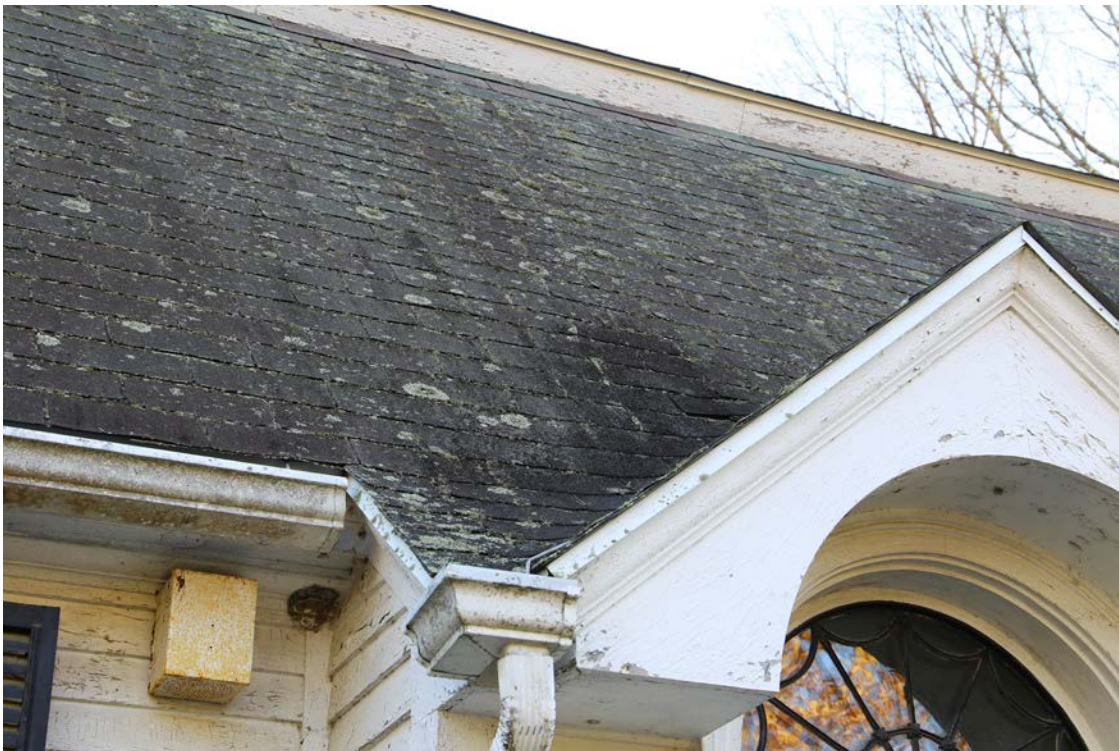
Fig. 5. Detail of the north roof, lower pitch showing lichen and staining on shingles. Note the condition of the gutters and woodwork.

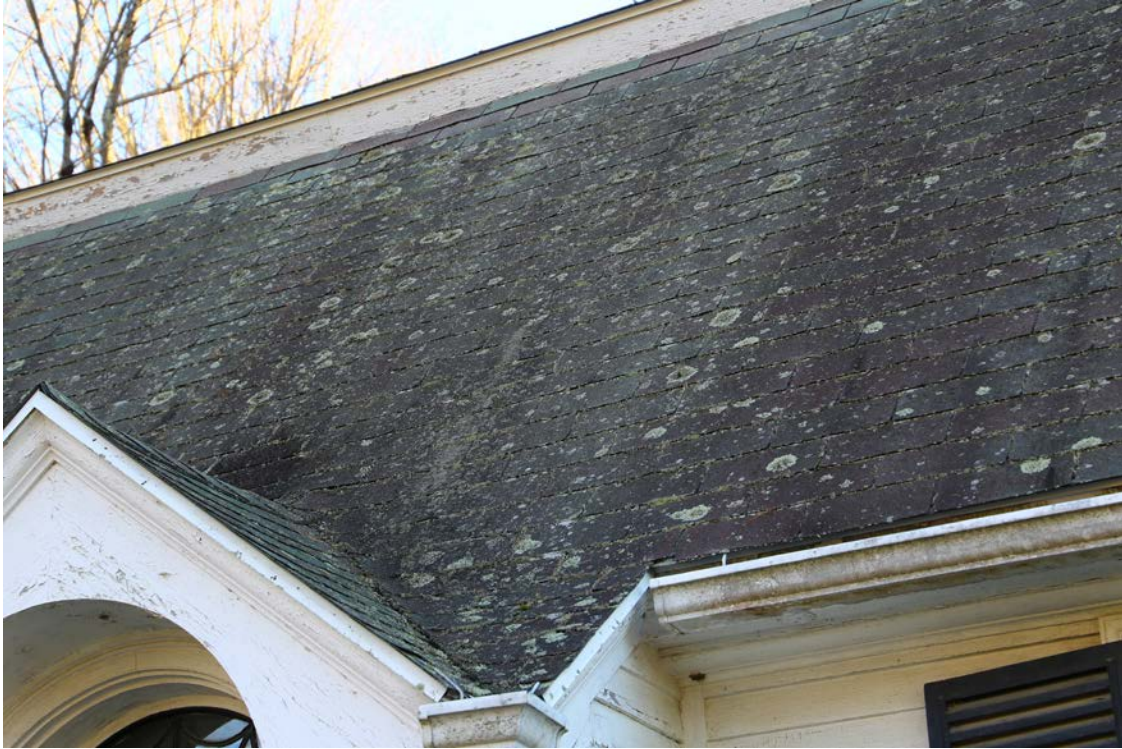
Fig. 6. Detail of the north roof, lower pitch showing general condition of the roof shingles, gutter and surrounding wood surfaces.

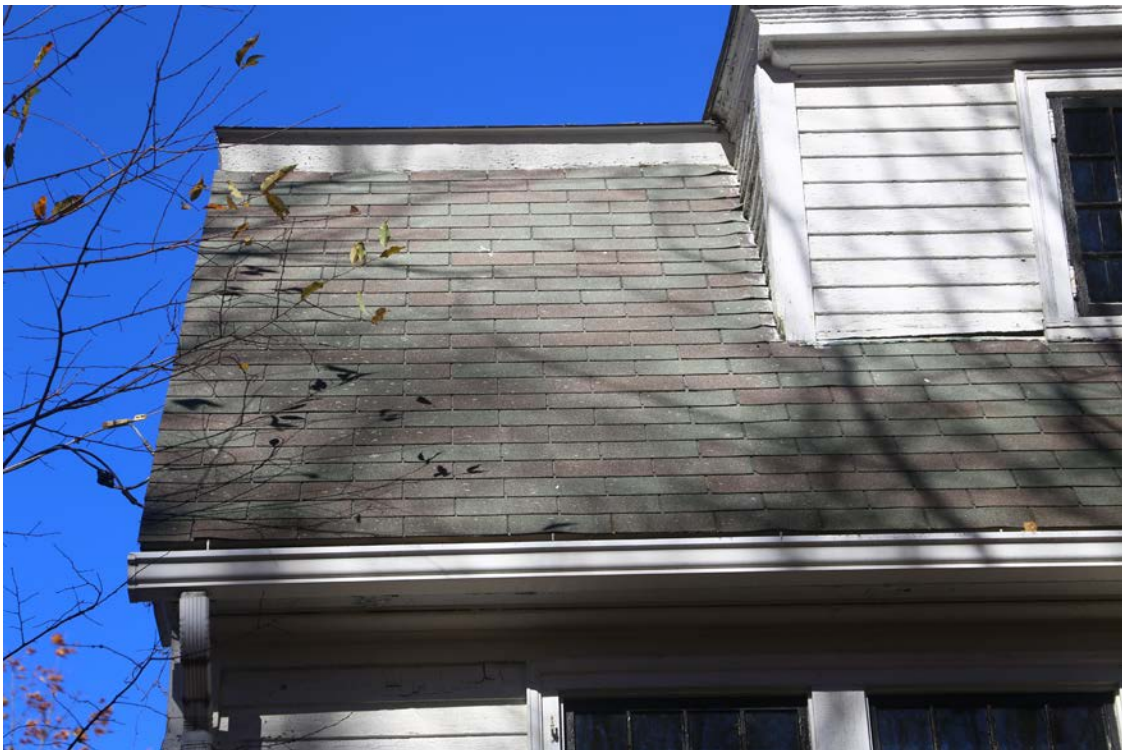
Fig. 7. South elevation, west end. Shingles on the south side of the building, which receive direct sunlight, do not have lichen growth or surface staining. Although the surface condition is better than on the north side, the shingles are nearing the end of their service life and should be replaced soon.

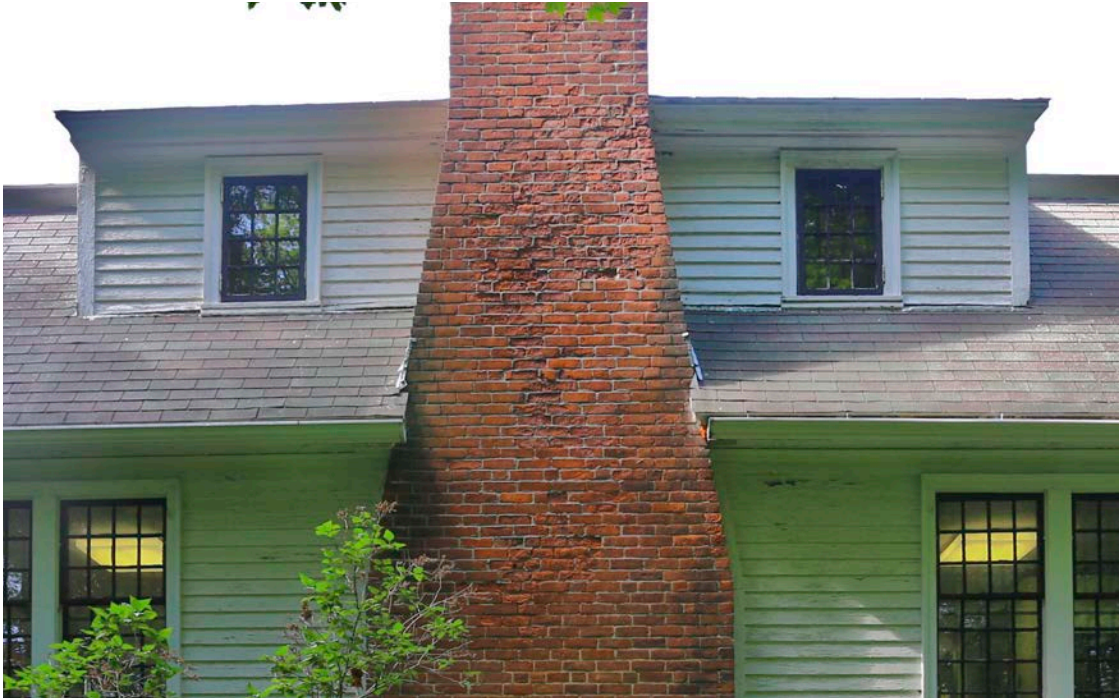
Fig. 8. South elevation. Detail of the chimney identifying an area of deteriorated brick. While unsightly, the brick appears to remain structurally sound. Closer inspection, including probing of the exposed brick surfaces, is recommended to confirm condition. As the fireplace is no longer active, the chimney currently serves only to vent the furnace. The flue should be inspected to determine its condition and suitability for continued use.

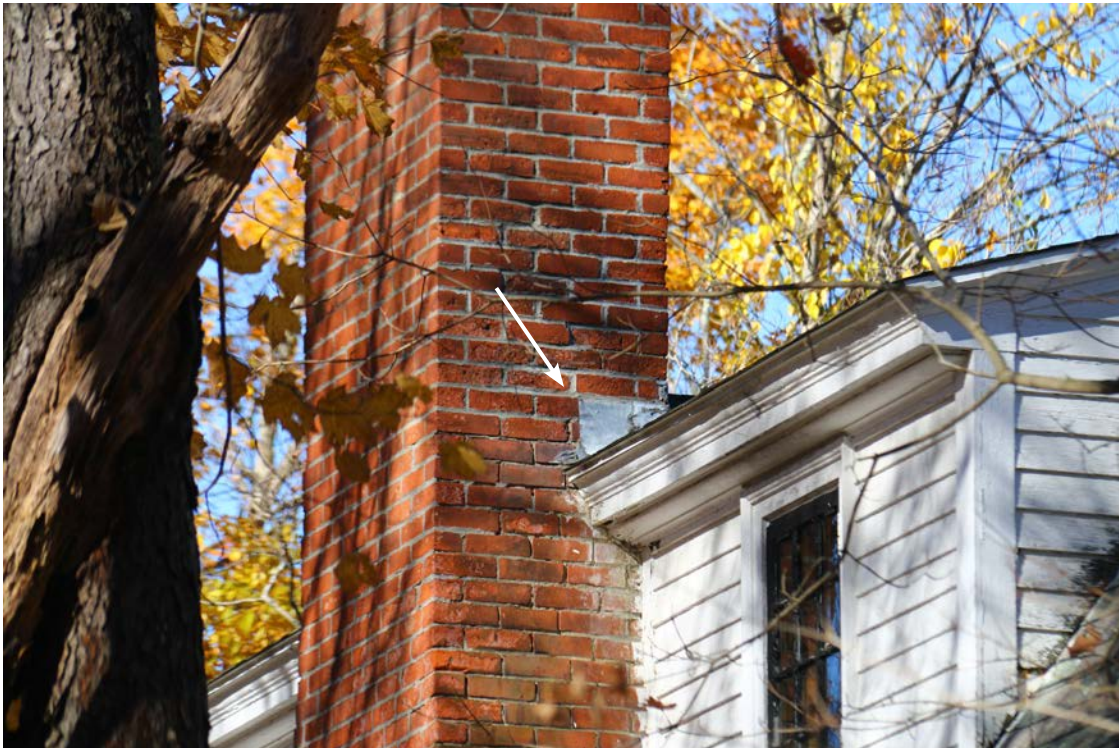
Fig. 9. South elevation, east side of chimney at dormer. New copper/lead coated copper flashings (arrow) should be installed when the roof is replaced.

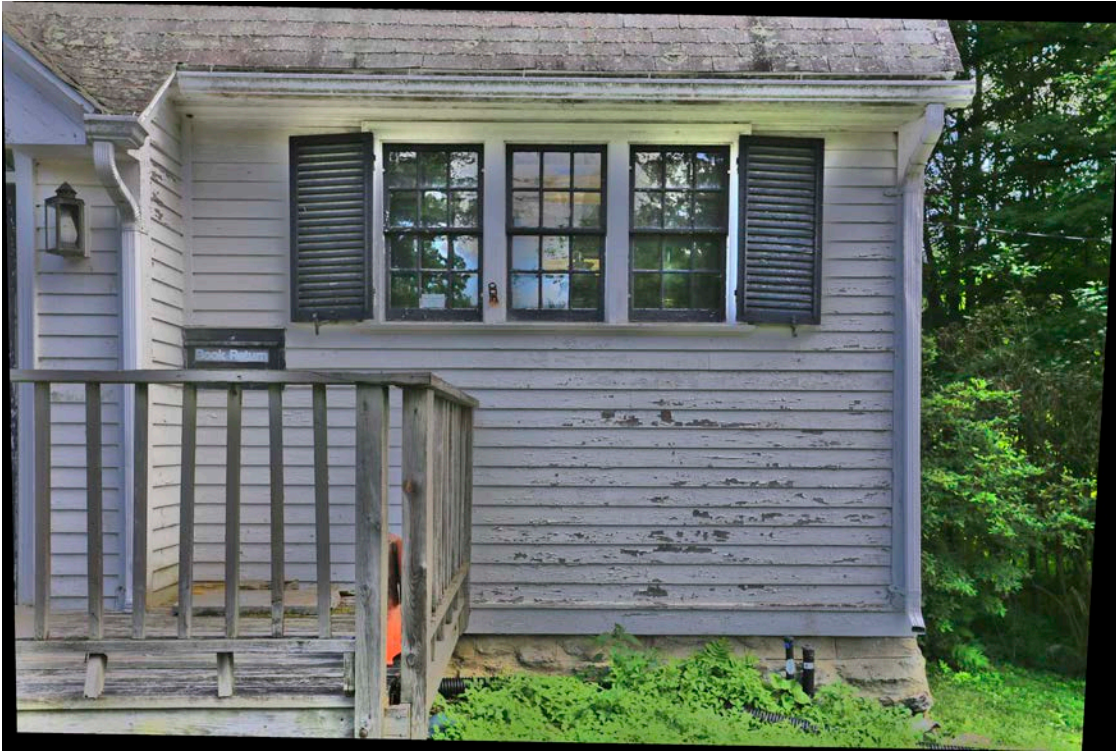
Fig. 10. North elevation, west end. View showing the typical siding and trim materials used on the building. Unfortunately the gutters hide a nicely molded cornice running along the edge of the roof.

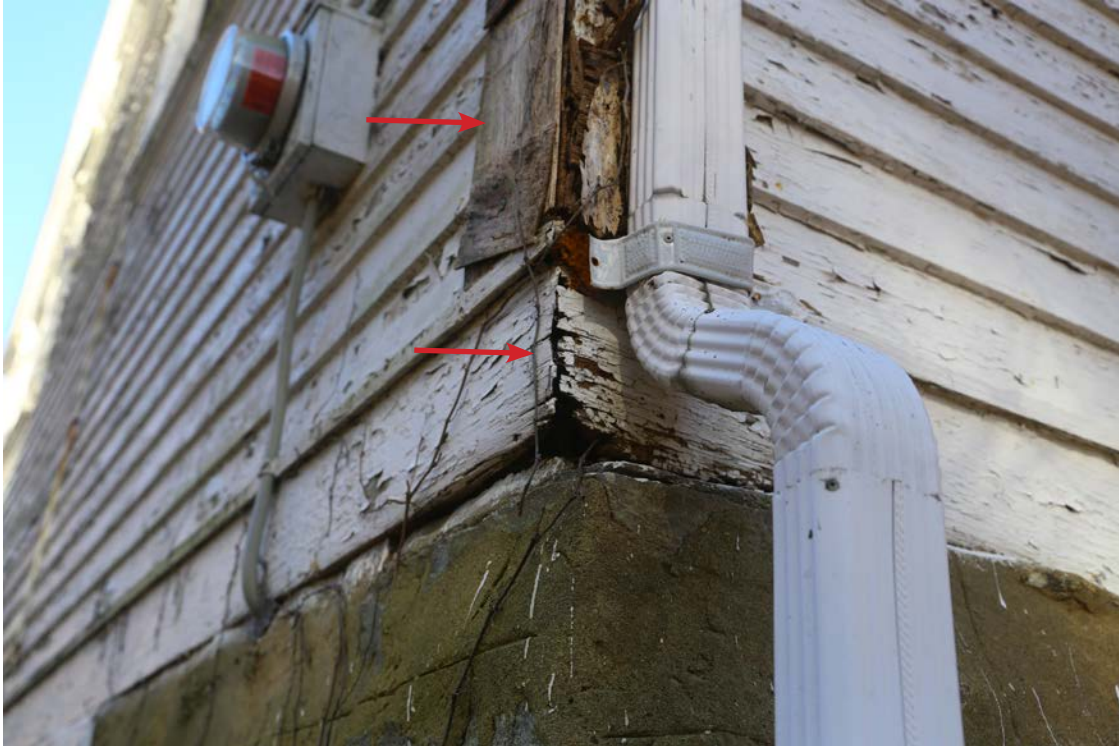
Fig. 11. Southwest corner. The lower portion of the corner of the building here is rotted. The siding and watertable needs to be removed to determined the full extent of repairs. The deterioration appears to be localized to the lower 3'-4' of the corner.

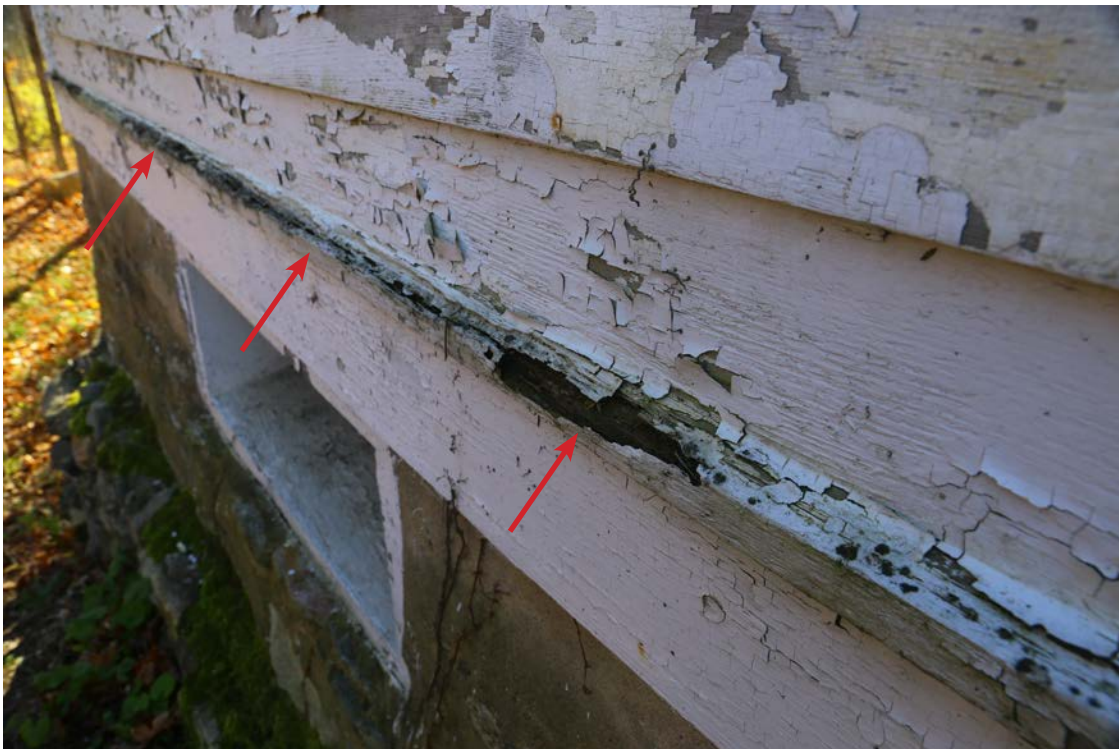
Fig. 12. East elevation showing rotted area of drip mold. The drip mold should be removed and replaced with new material.

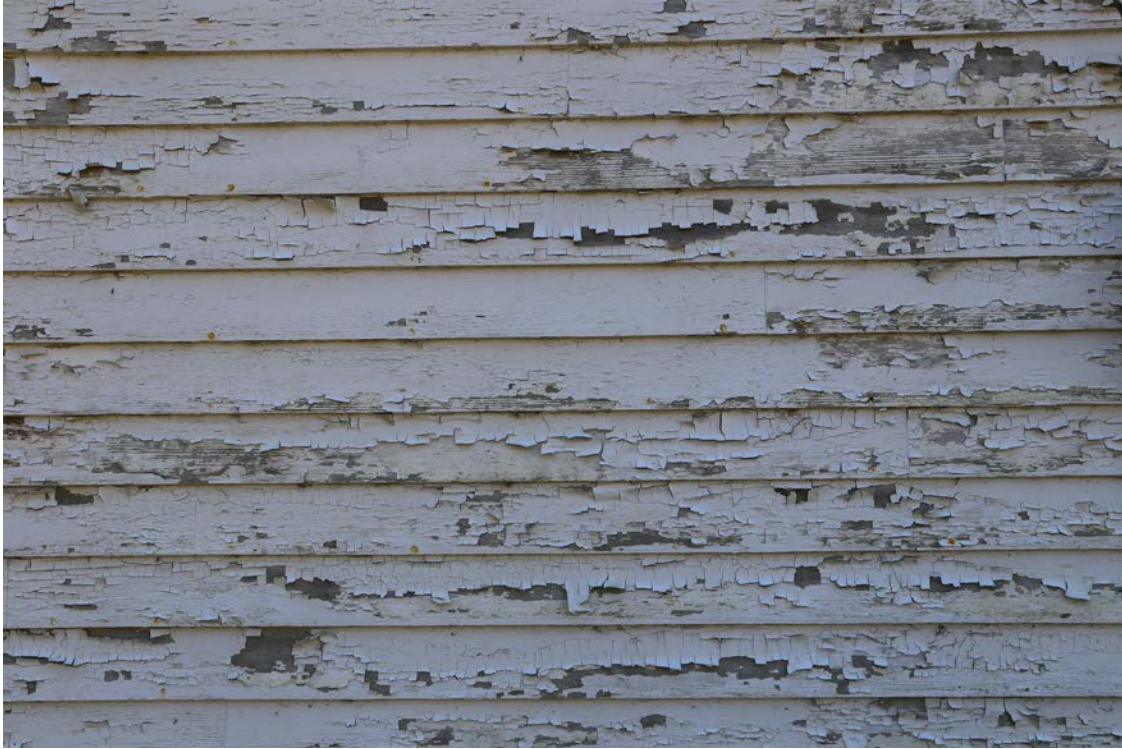
Fig. 13. Representative example showing the typical condition of the exterior paint finish. The majority of the clapboards and wood trim remains in good condition, with only the paint finish failing.

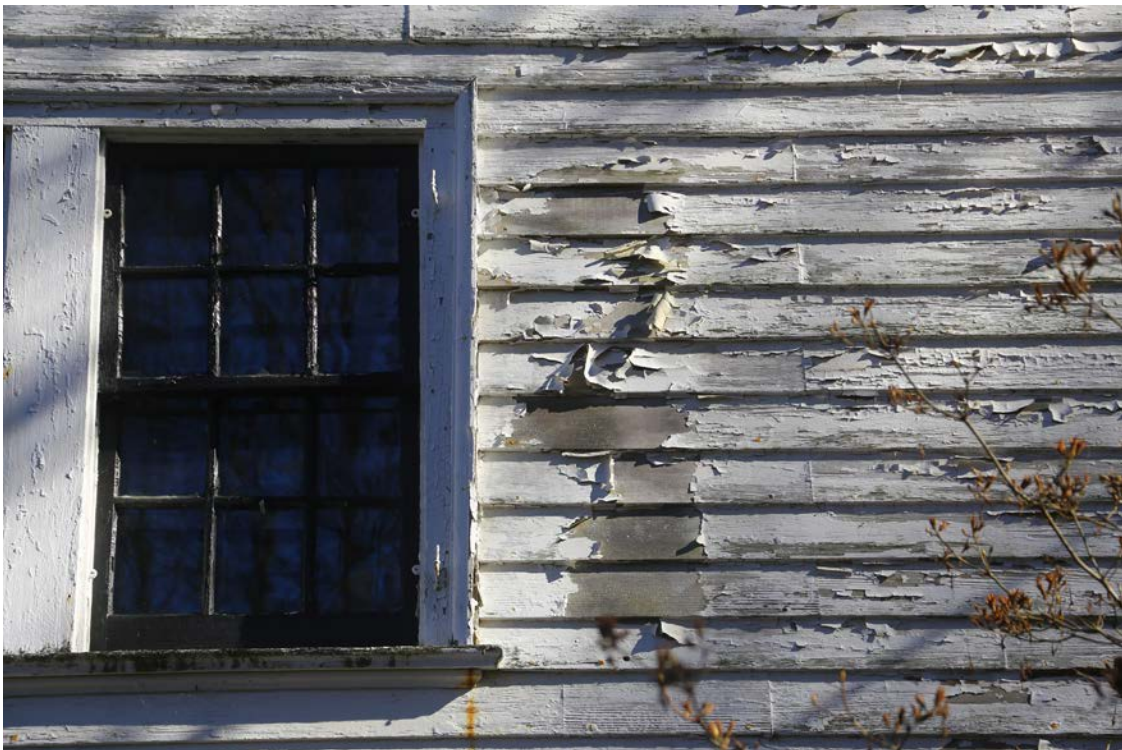
Fig. 14. Another example showing paint failing to bare wood. A thorough scraping of the building, followed by the application of a high-quality primer, will prepare the siding for repainting.

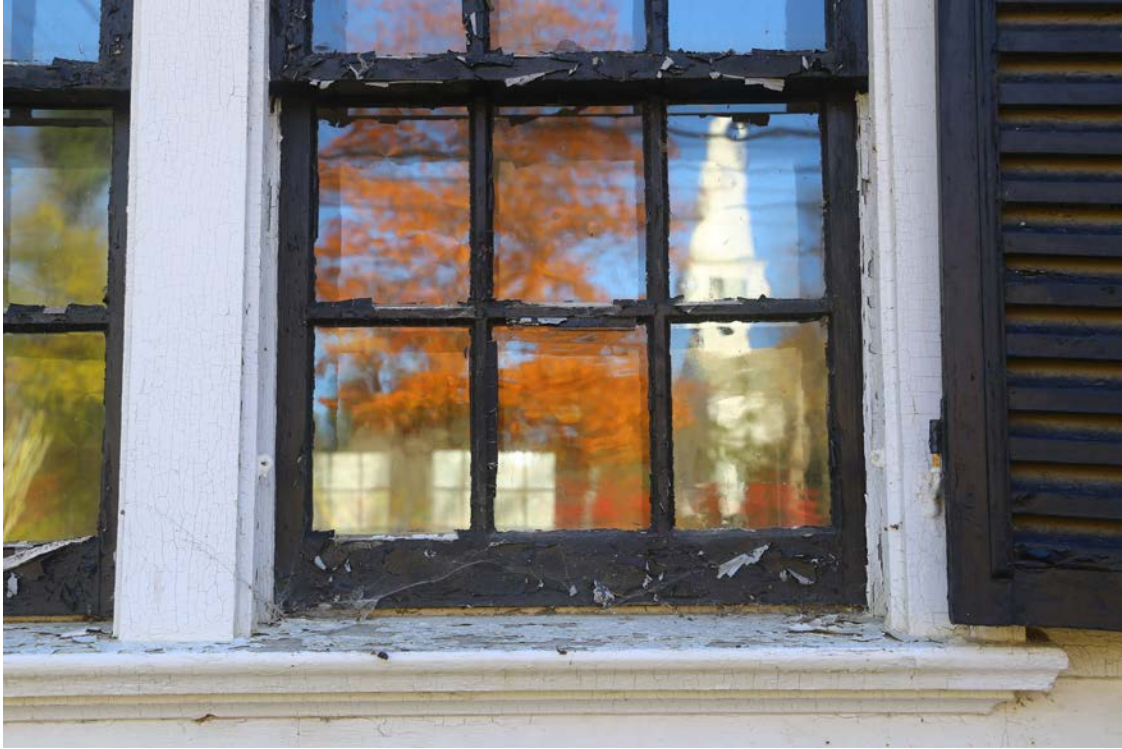
Fig. 15. Typical condition of the window sash paint and putty. The wood frames remain sound.

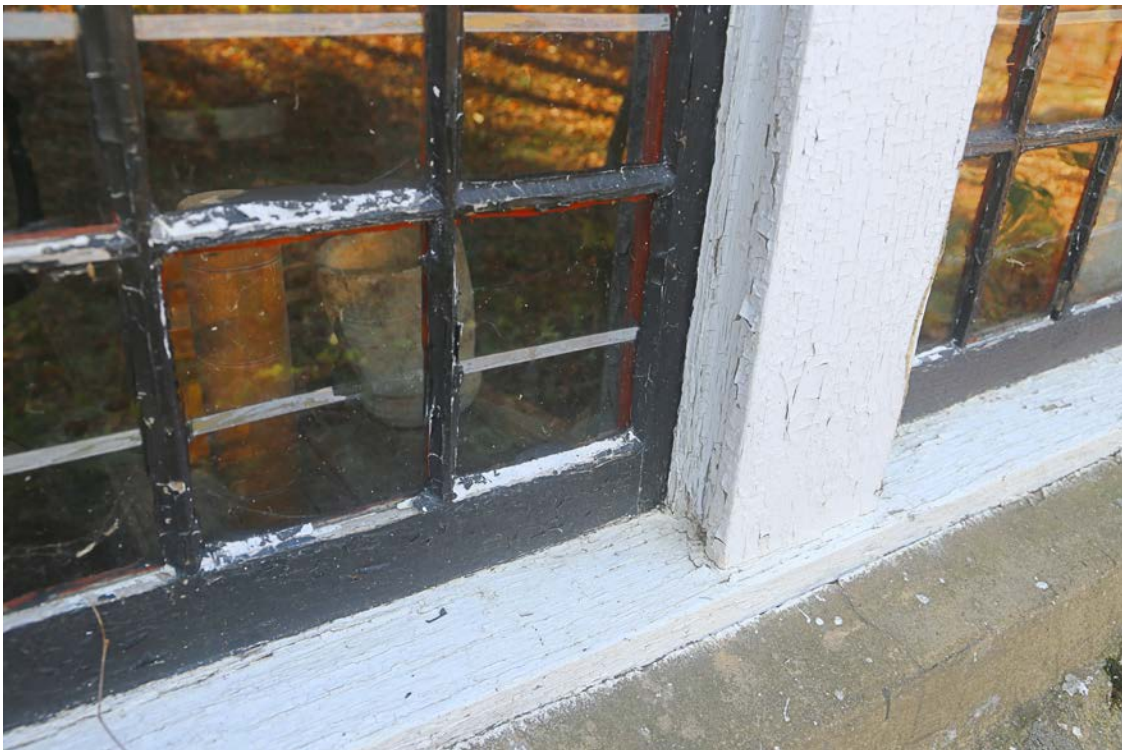
Fig. 16. South elevation, west cellar windows. Detail showing deteriorated glazing putty and failing paint. The interior surface of these sash have been damaged by rodents.

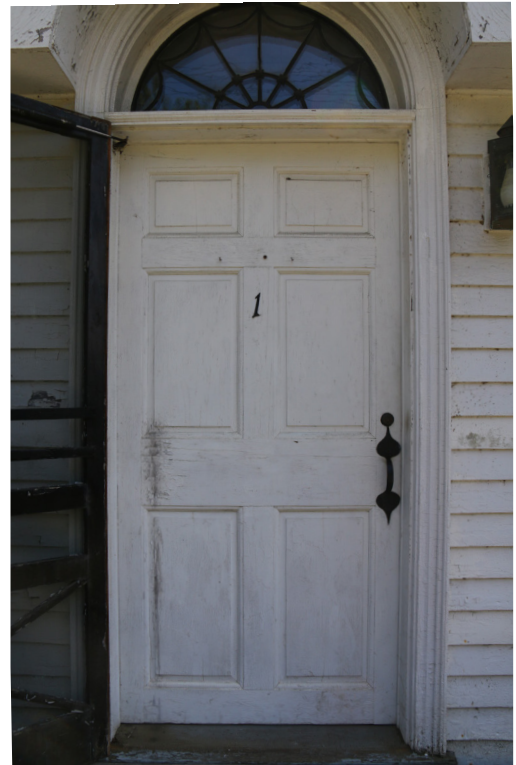
Fig. 17. Detail of the front door. The door handle imitates an 18th century Suffolk latch.

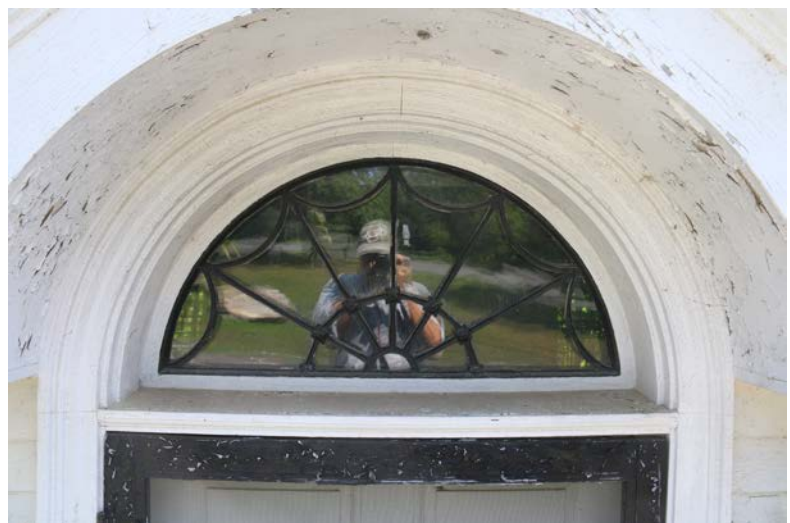
Fig. 18. Detail of the finely designed fanlight at the main entrance.

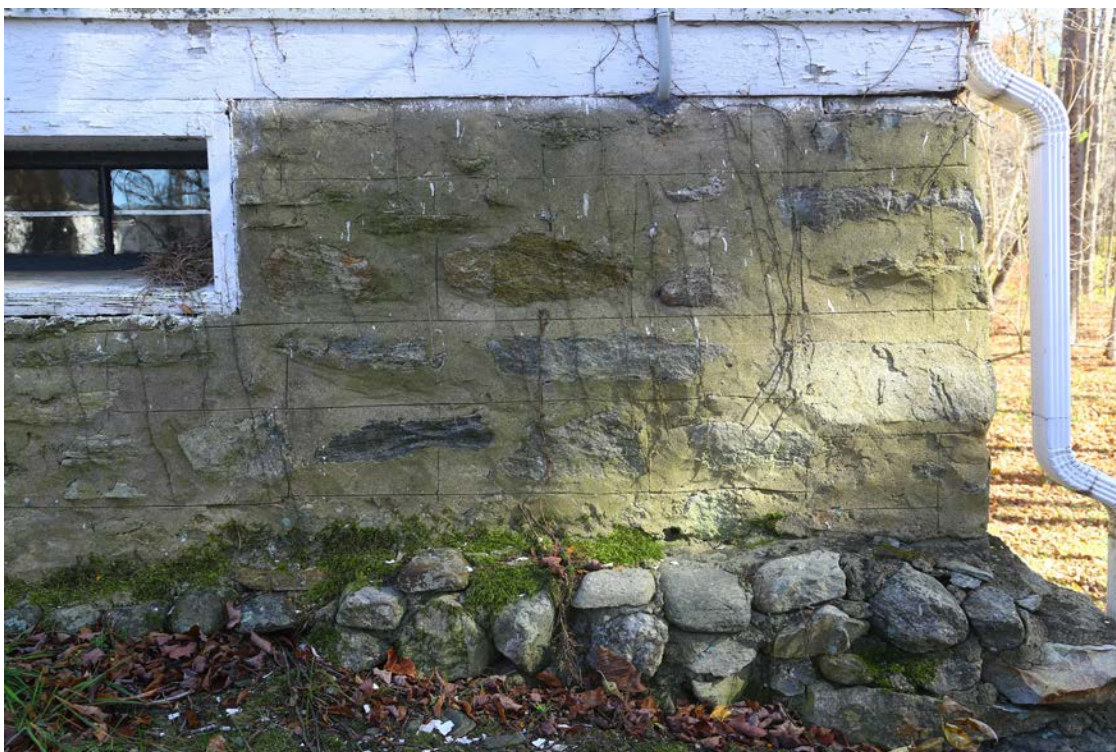
Fig. 19. Typical treatment of the foundation. The foundation shows areas of exposed rubble stone, with rendered masonry above in some locations. The render is struck to create the appearance of joints, giving the impression that the foundation is constructed of coursed stone.

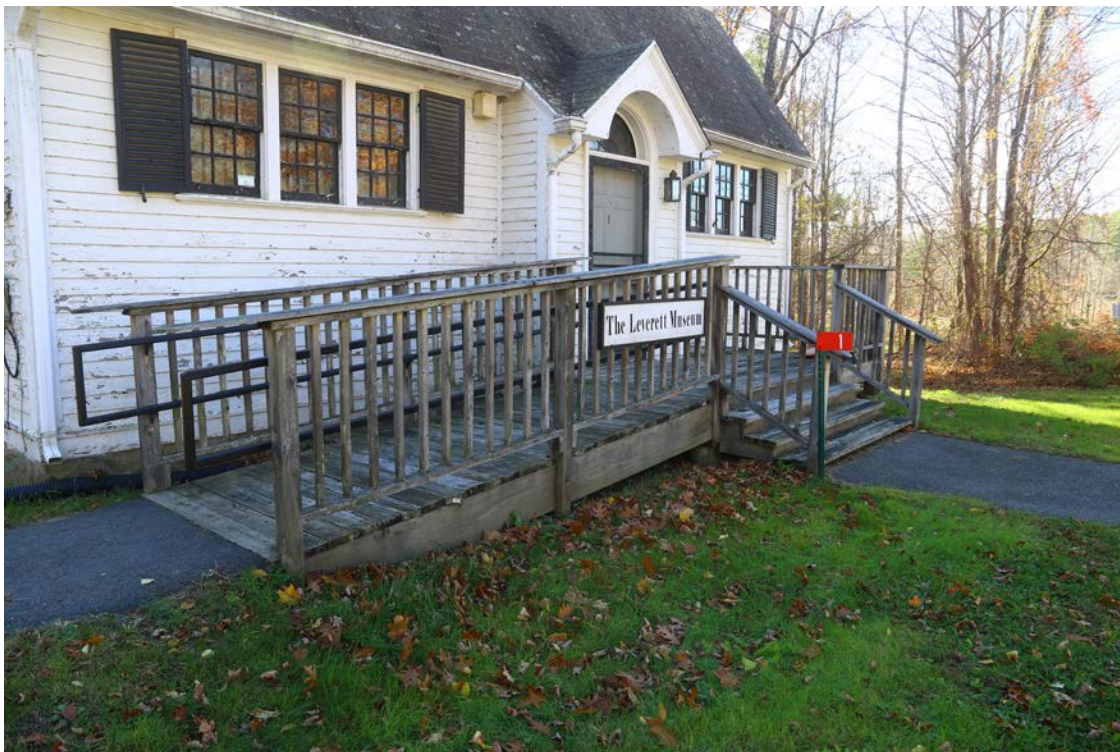
Fig. 20. North elevation showing the access ramp and steps.

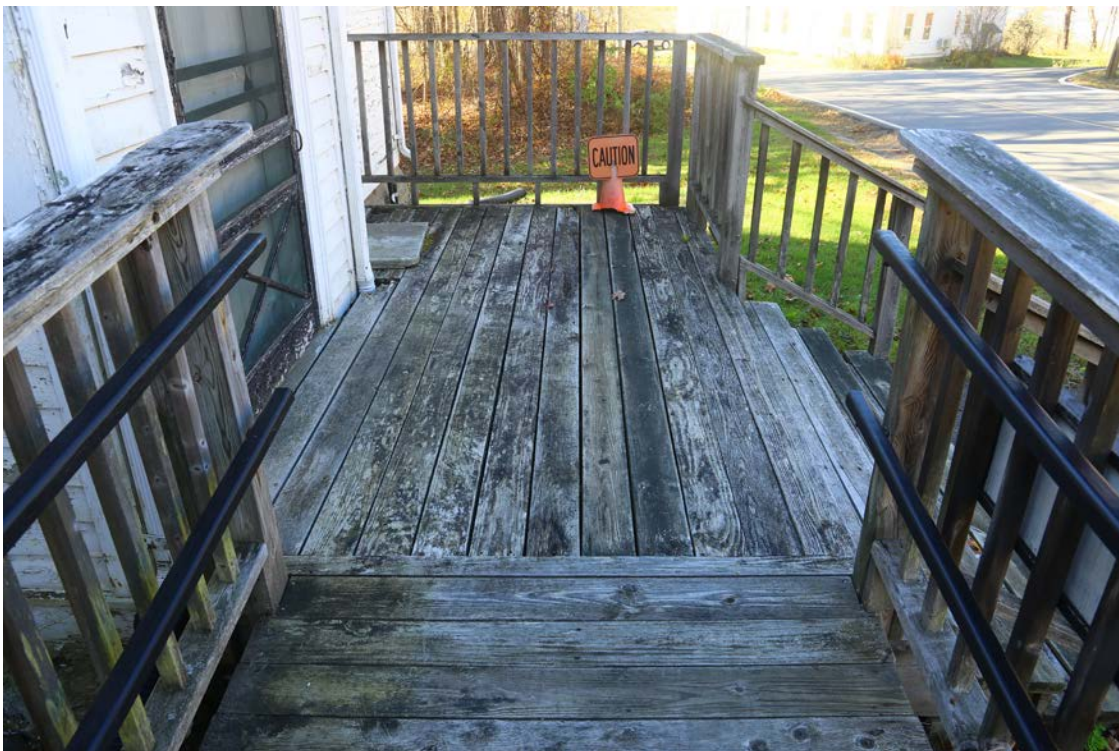
Fig. 22. Committee members have commented that the wood decking is extremely slippery when it becomes wet. Various parts of the decking and posts are rotted and in danger of failing if weight is put on them.

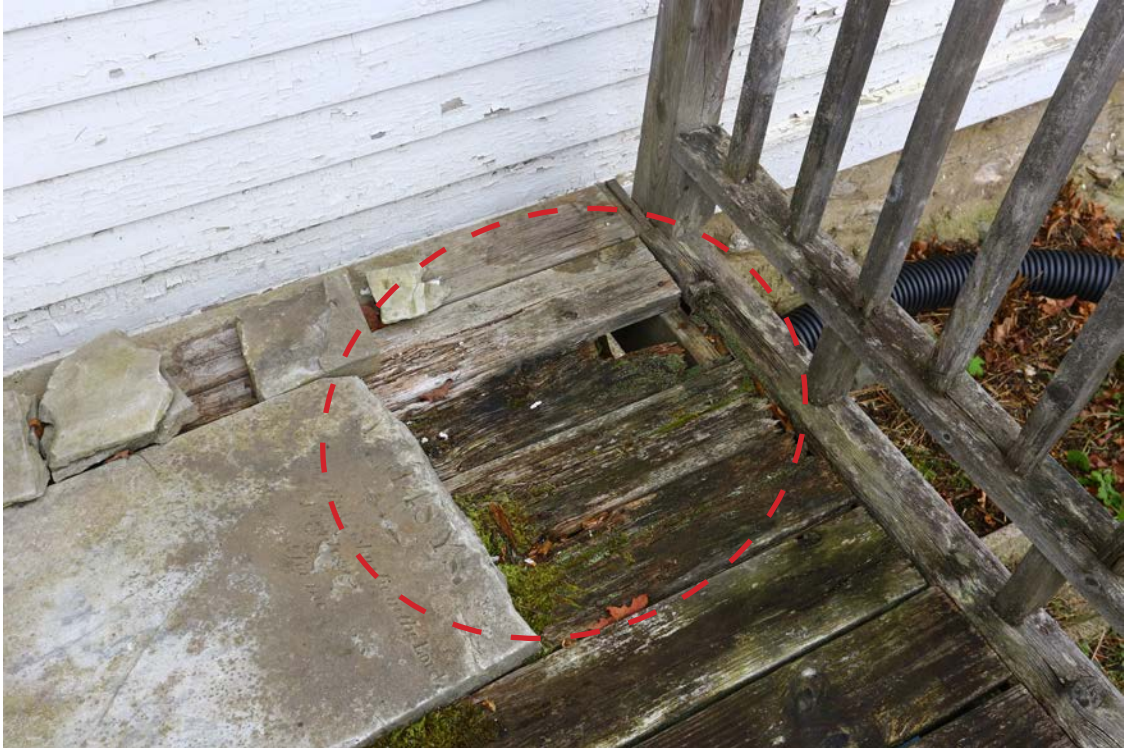
Fig. 23. West end of the deck showing area of severely rotted boards.

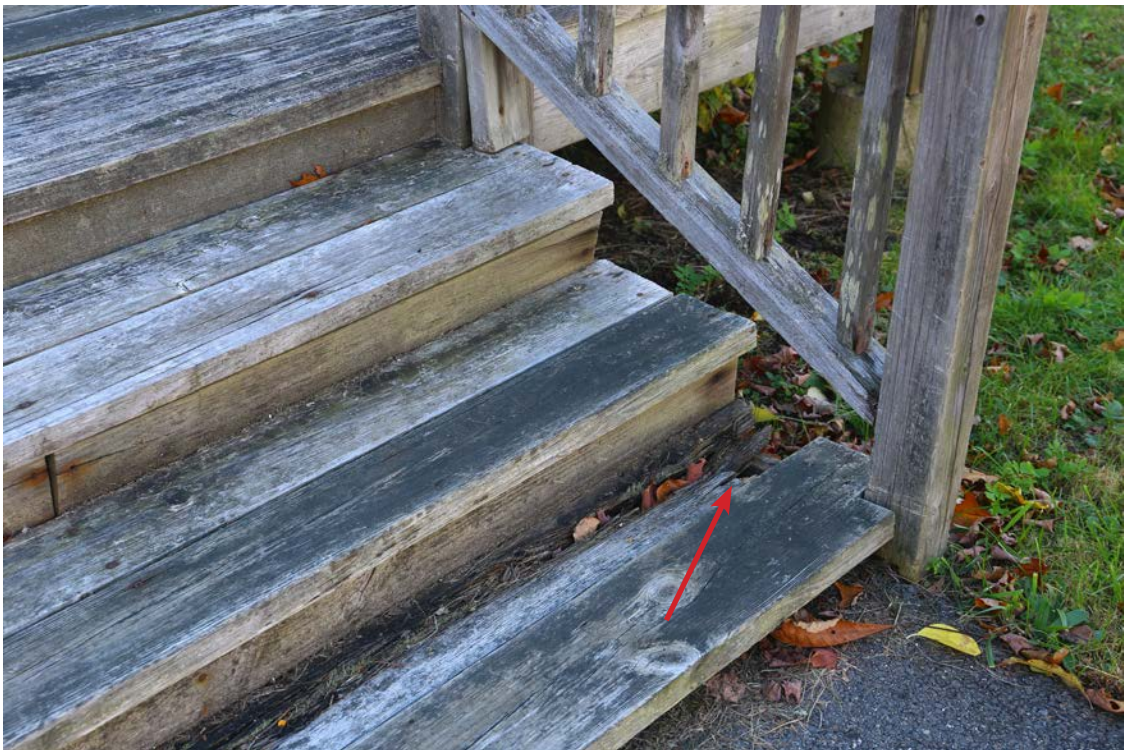
Fig. 24. Detail showing rotted stair tread. Many of the posts are deteriorated where they meet the ground and are in danger of failing if weight is put on them.

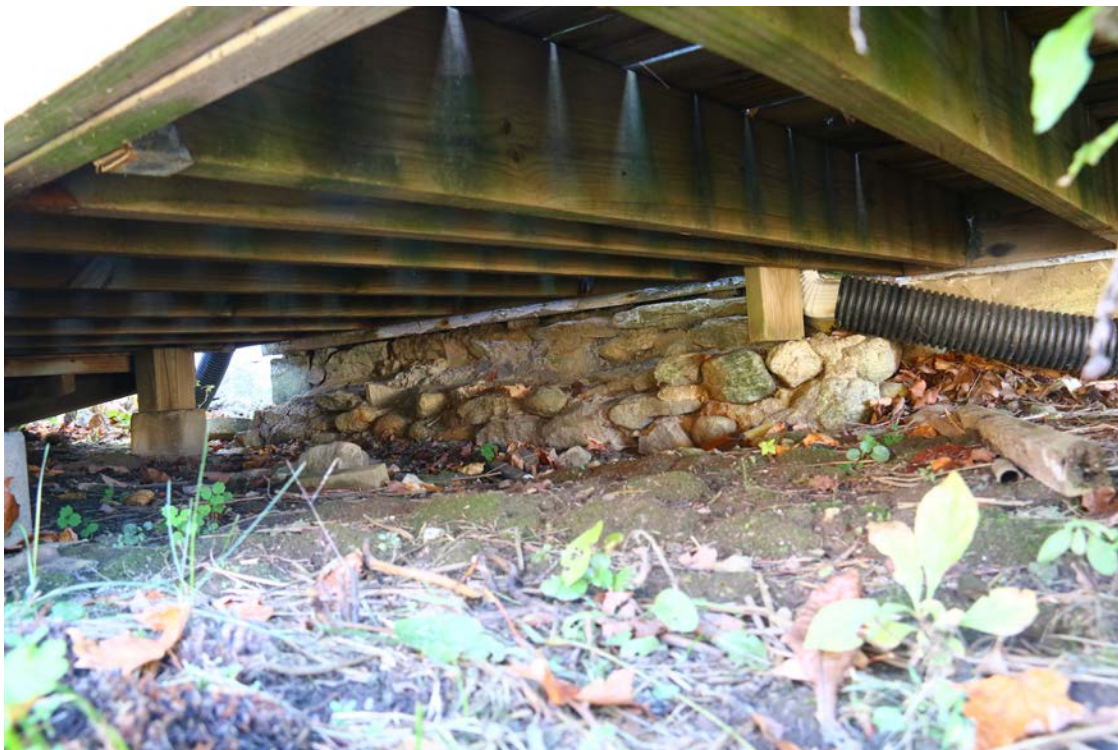
Fig. 25. View under the north deck showing the remains of the original steps into the building.

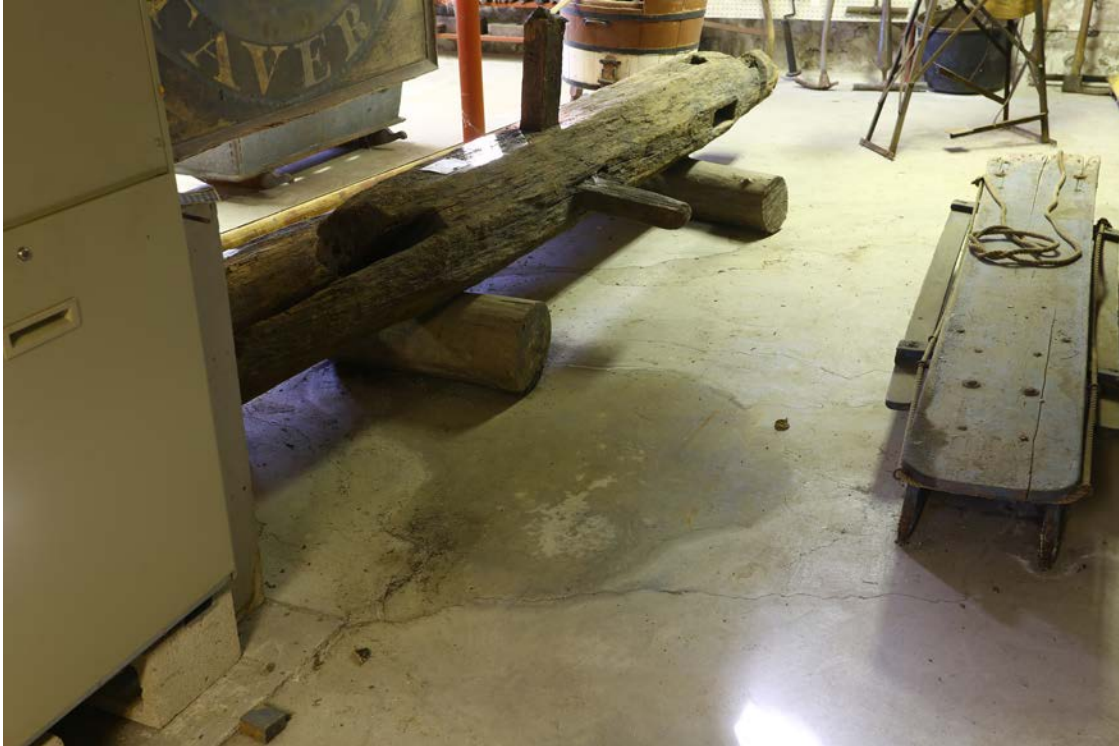
Fig. 26. The dark stain on the floor is evidence of past/recent water. The source and cause of this is not known. The cellar should be periodically monitored after snow melt and heavy rain to understand how it reacts when subject to large amounts of water. No water was observed at the time of the building survey.

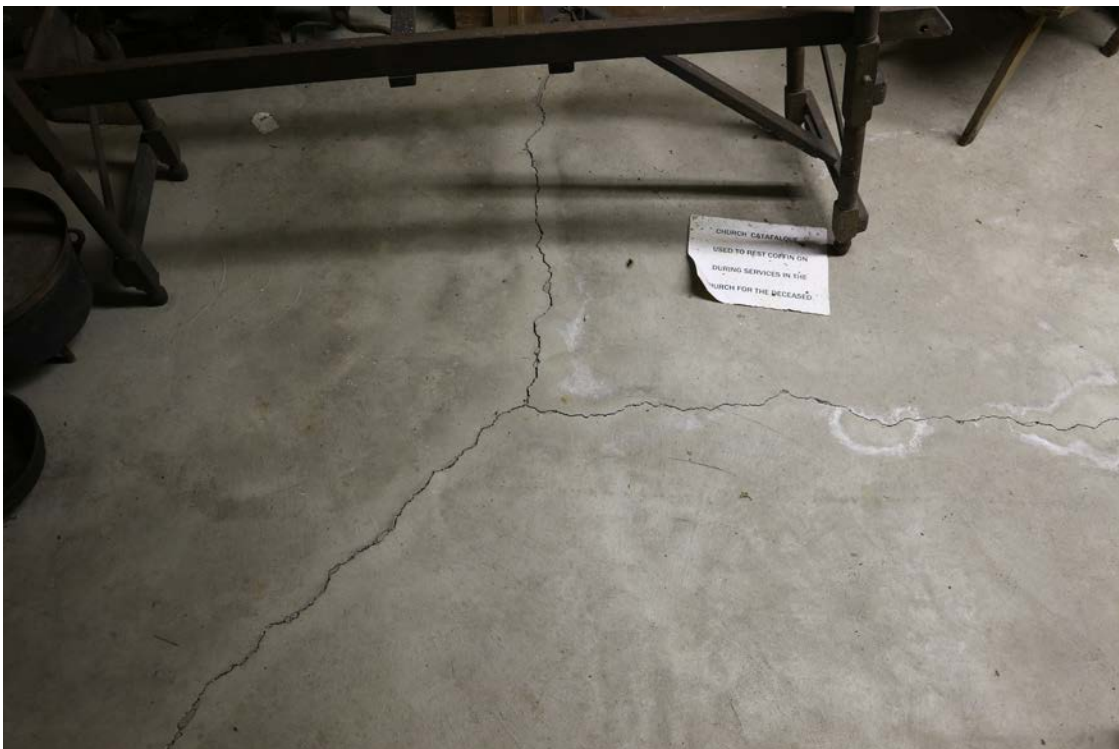
Fig. 27. Random cracks are present in the floor slab. Aside from allowing ground water into the building (note stains), they are not a matter of great concern.

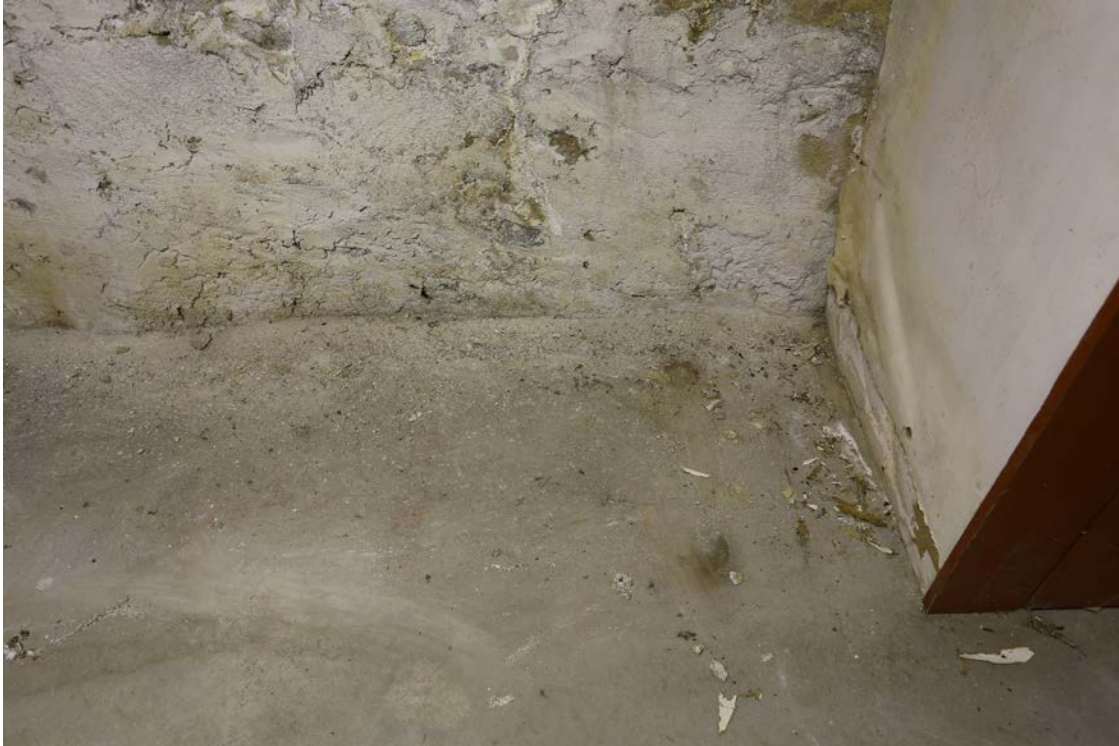
Fig. 28. Typical powdery debris collecting at the base of the cellar walls from deteriorating coatings and masonry. The walls remain sound and in good condition.

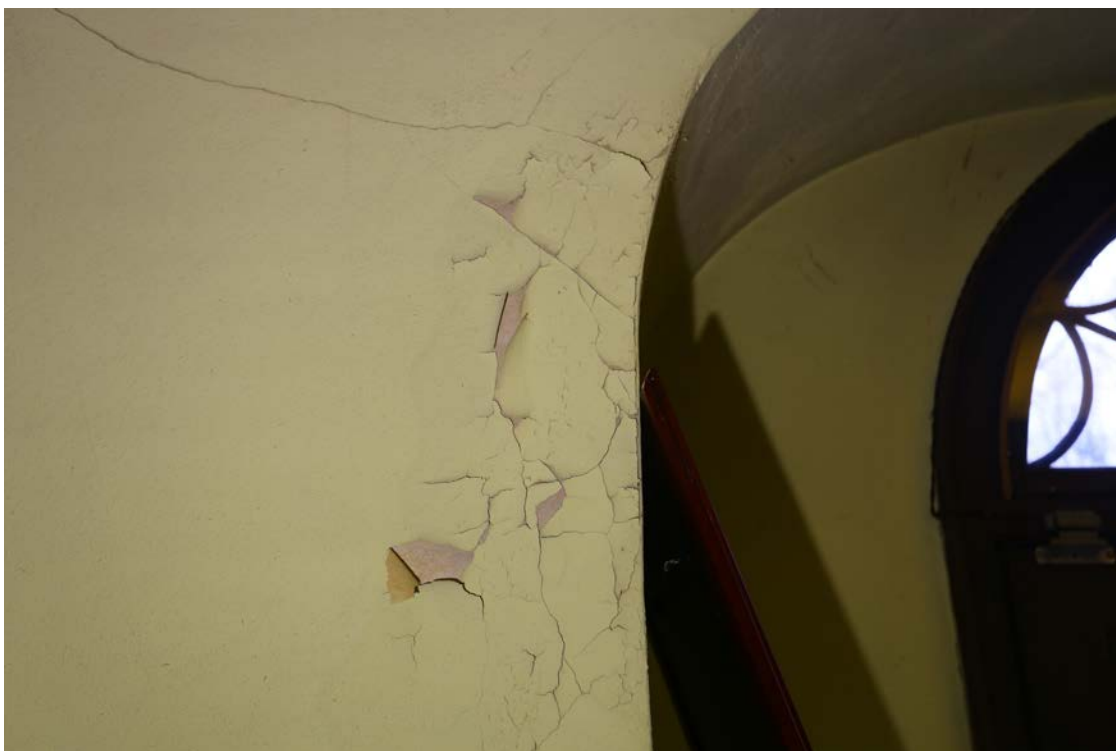
Fig. 29. Localized area of failing paint at the north entry.
