THE FIELD BUILDING LEVERETT, MASSACHUSETTS

BUILDING CONDITIONS ASSESSMENT MARCH 2026

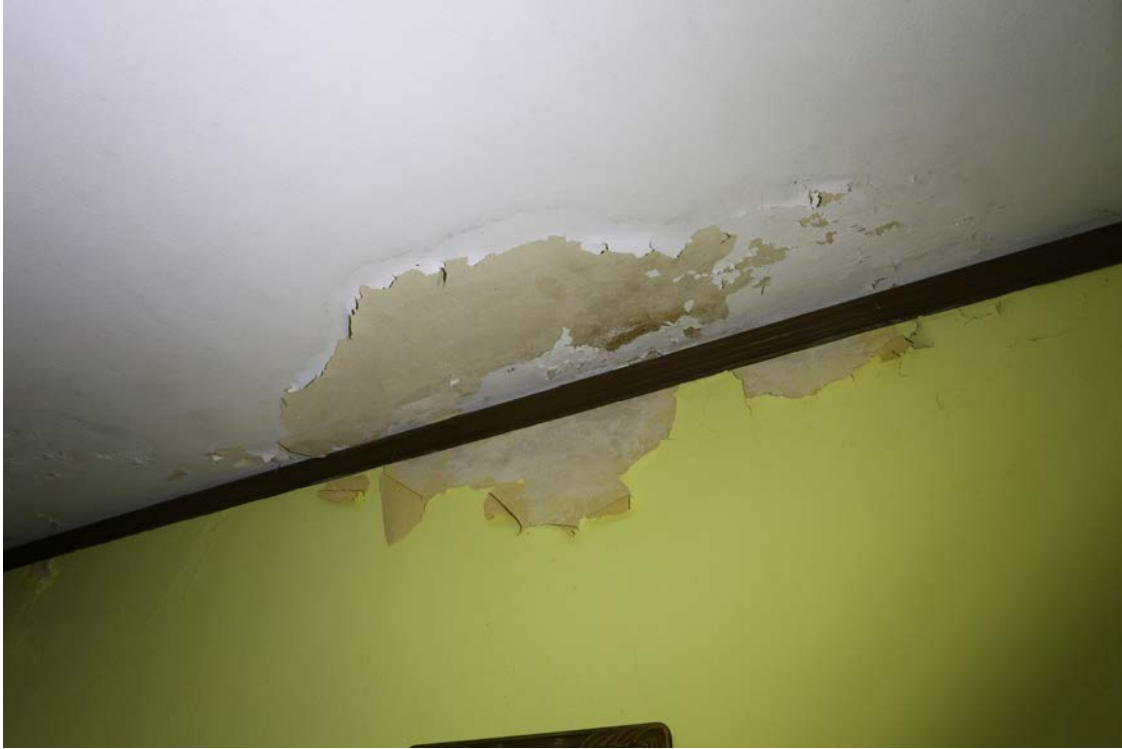
Fig. 30. Water damaged paint and plaster above the fireplace. This appears to be old damage and not from active leaks.

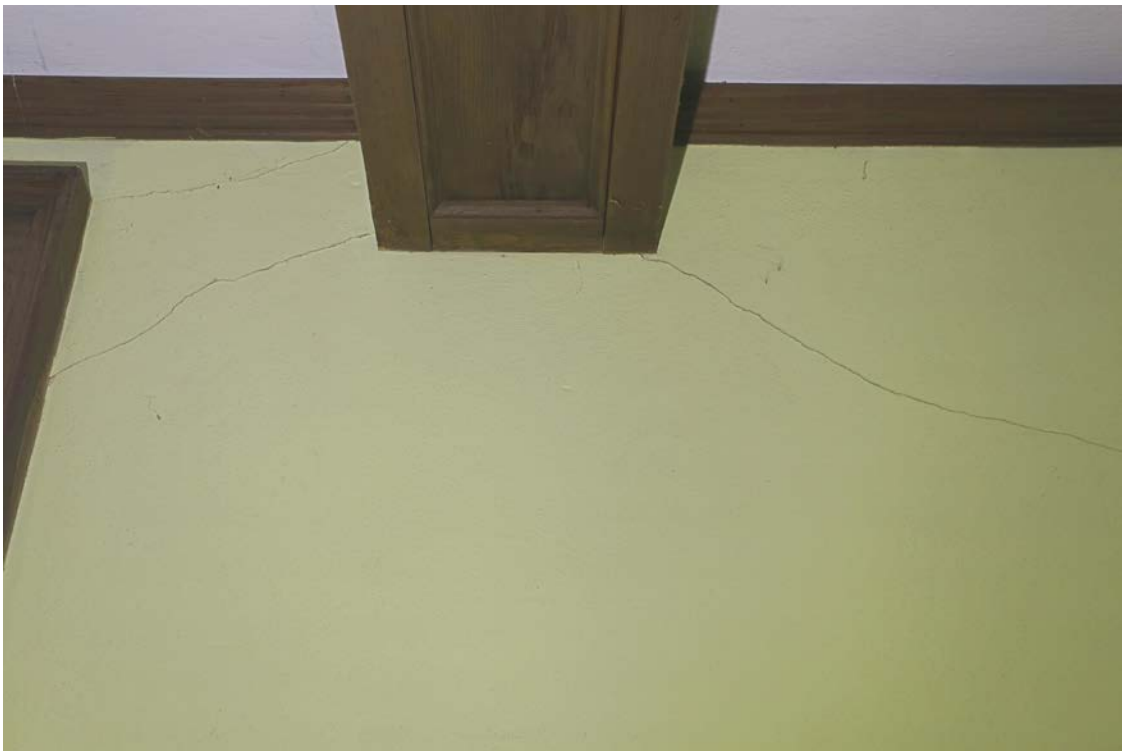
Fig. 31. Cracks radiating from the north end of the west ceiling timber on the first floor. No obvious movement/displacement is present and the surrounding materials appear to be in good condition.

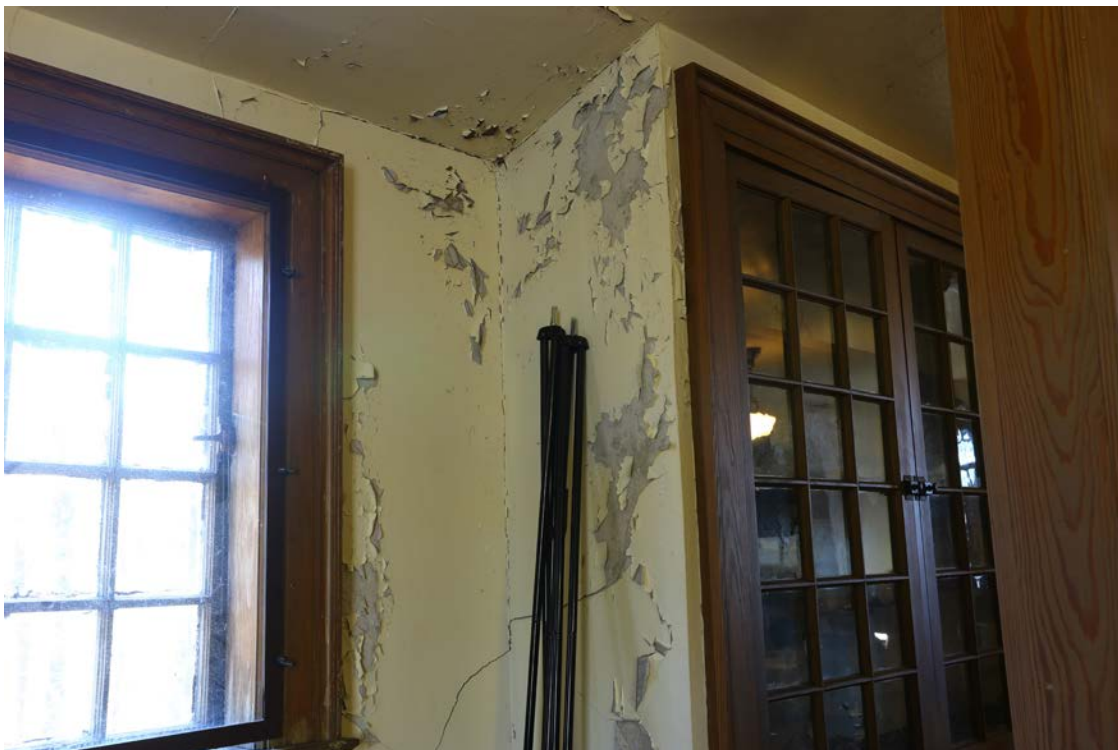
Fig. 32. Second floor, south elevation. Failing paint and plaster appear to be the result of water infiltration associated with past roofing and/or flashing failures in this area. These issues do not appear to be active.

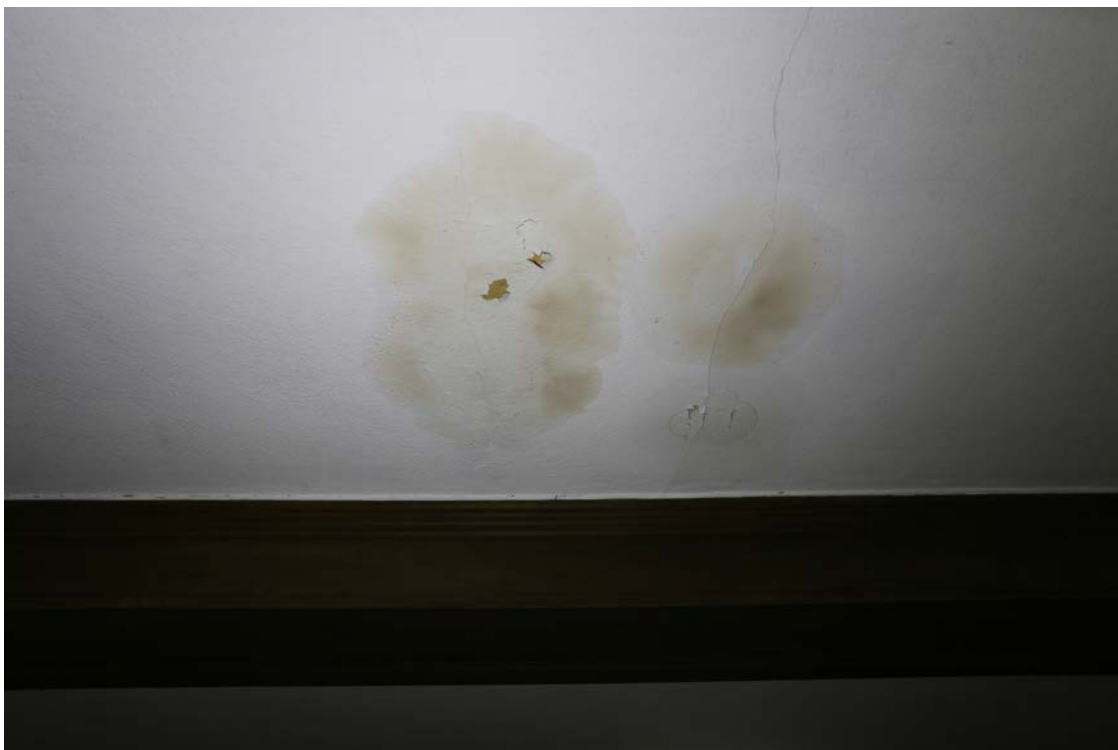
Fig. 33. Cracks, patches and stains on the first floor ceiling.

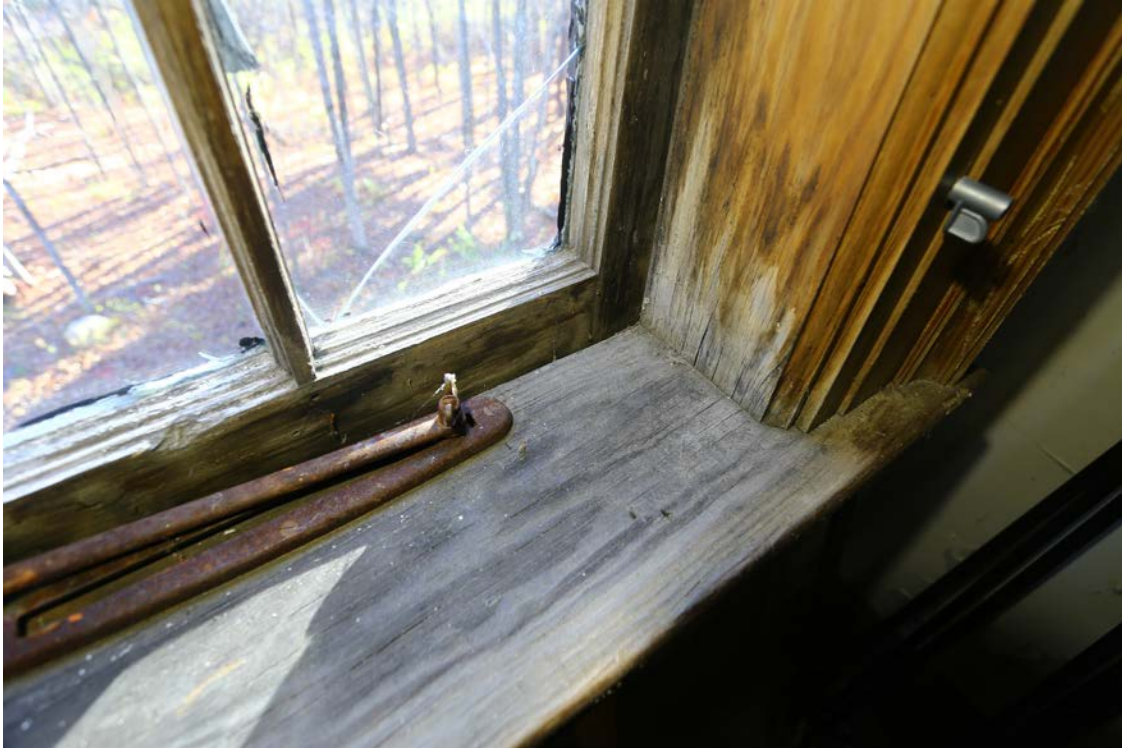
Fig. 34. The woodwork trimming and finishing many of the window openings suffers from UV damage and, in some cases water damage. The woodwork should be prepped and finished with a high quality clear coat or paint finish.

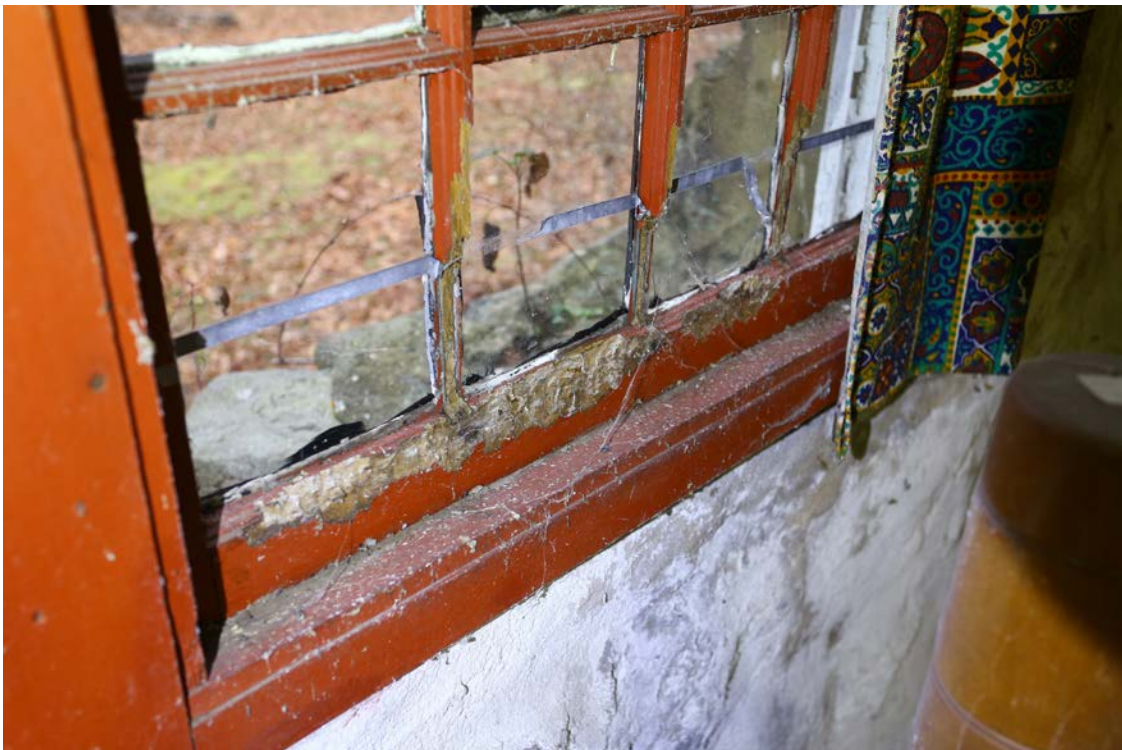
Fig. 35. Cellar, southwest corner. The window sash is damaged as a result of rodents gnawing on the woodwork.

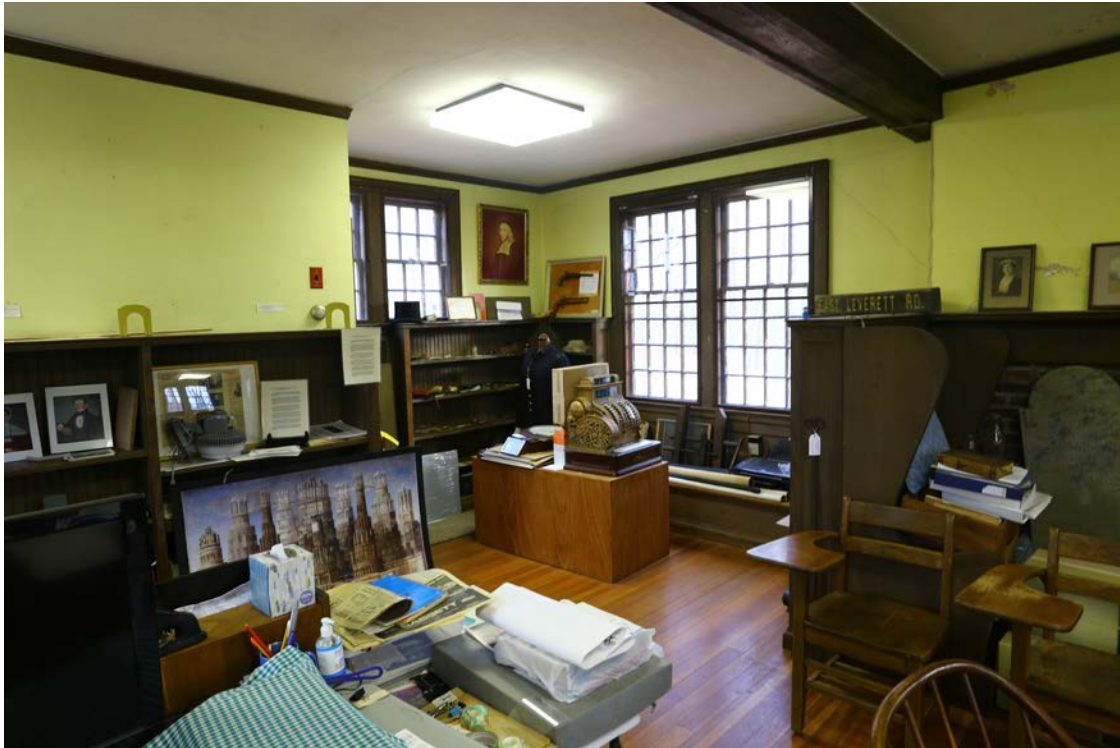
Fig. 36. Example of the first floor ceiling fixtures. The light fixtures are dated and should be replaced. Improved lighting should be installed throughout the building. Consideration should be given to fixtures that are both functional and appropriate to the building's aesthetic.

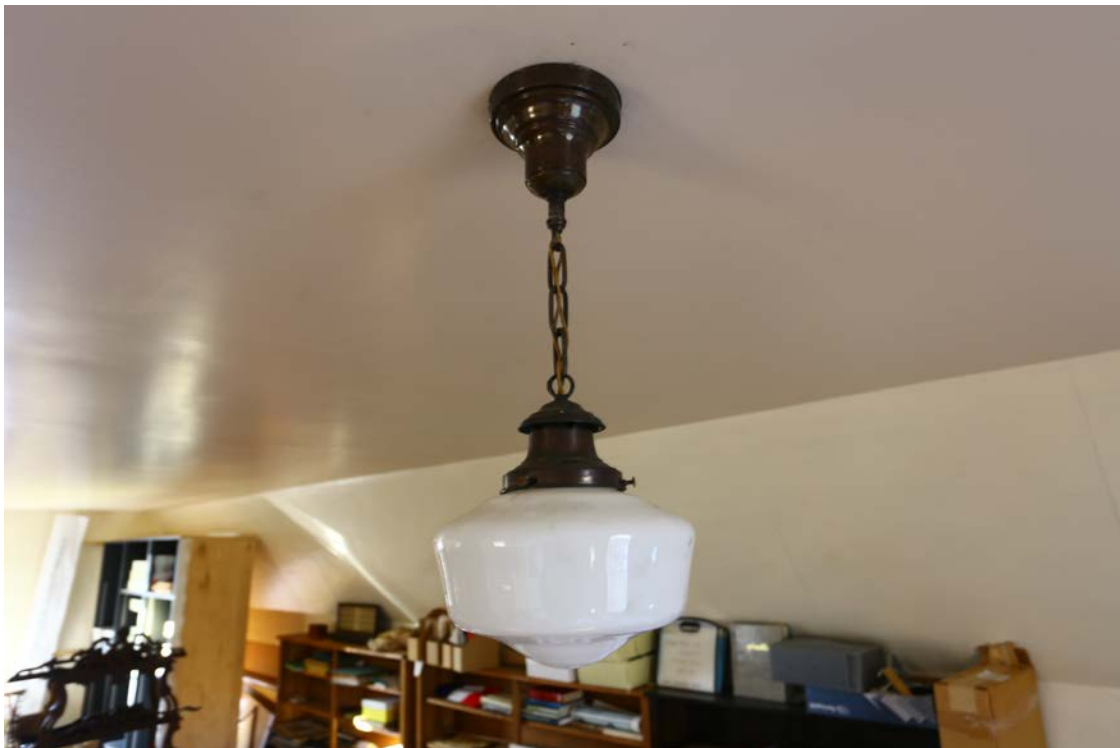
Fig. 37. Second floor ceiling fixture. These fixtures are likely original to the building and remain in service. They are served by cloth-covered wiring, suggesting the wiring may date to the construction of the building. The fixtures are fine examples of their period and should be rewired if they are to remain in use.
