DUDLEYVILLE ROAD RESTORATION EVALUATION

December 8, 2023

Dudleyville Road Restoration Evaluation

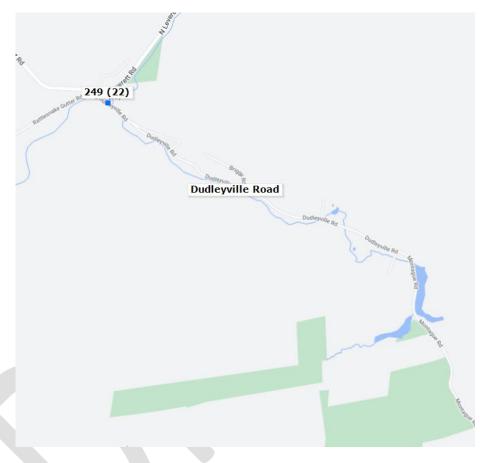
Image 2: TDMS ATR Counts³

On June 6 and 7 of 2023, Boston Traffic Data deployed an Automatic Traffic Recorder (ATR) about 400 feet south of North Leverett Road. The recorded AADTs were 215 (103 northbound and 112 southbound) and 238 (121 northbound and 117 southbound), respectively. These counts were slightly lower than the 261 count that was recorded in July of 2014. The mean speed on June 6, 2023 was 26.4 miles per hour in the northbound direction and 23.1 miles per hour in the southbound direction. The mean speed on June 7, 2023 was 24.4 miles per hour in the northbound direction and 22.5 miles per hour in

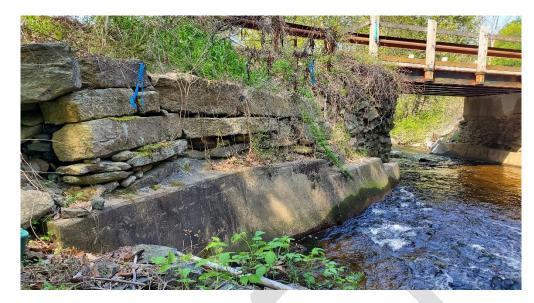
Image 3: Bridge 1

Bridge 1 is an existing structure with a hydraulic opening that is 20-feet-wide and 7.8-feettall. The existing crossing does not meet stream crossing standards because the width of the hydraulic opening is less than 1.2 times bankfull width, as described in Section 1.6.1.2 below. The existing crossing meets openness ratio requirements. Under existing conditions, Bridge 1 can convey the 10-year storm event with 2 feet of freeboard as required by MassDOT.

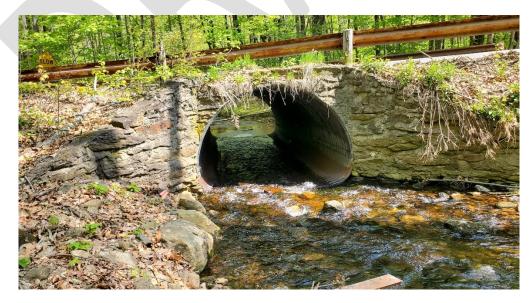
Image 4: Culvert 1

Culvert 1 is an existing round pipe with a diameter of 7 feet. The existing crossing does not meet stream crossing standards because the width of the hydraulic opening is less than 1.2 times bankfull width, as described in Section 1.6.1.2 below. The existing crossing meets openness ratio requirements. Under existing conditions, Culvert 1 can convey the 10-year storm event without overtopping the culvert. This crossing is less than 10-feet in width, so it is not classified as a bridge per MassDOT; however, replacing this crossing may lead to a span greater than 10 feet due to bankfull width requirements. If the crossing span was increased to greater than 10 feet, this crossing would be considered a bridge and subject to Chapter 85 review by MassDOT. As such, 2 feet of freeboard above the hydraulic design storm is required. This crossing currently has 2 feet of freeboard in the design storm, though it is not required with the existing geometry.

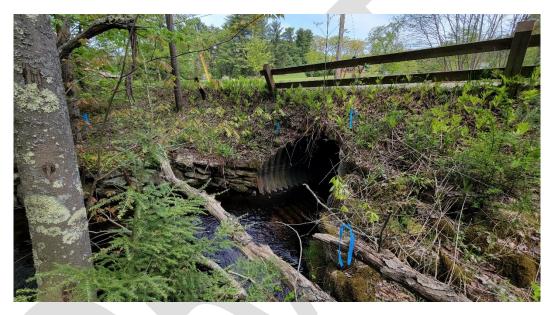
Image 5: Culvert 22

Culvert 22 is an existing round pipe with a diameter of 5.5 feet. The existing crossing does not meet stream crossing standards because the width of the hydraulic opening is less than 1.2 times bankfull width, as described in Section 1.6.1.2 below. The existing crossing meets openness ratio requirements. Under existing conditions, Culvert 22 can convey the 10-year storm event without overtopping the culvert. This crossing is less than 10-feet in width, so it is not classified as a bridge per MassDOT; however, replacing this crossing may lead to a crossing with a span greater than 10 feet due to bankfull width requirements. If the crossing span was increased to greater than 10 feet, this crossing would be considered a bridge and subject to Chapter 85 review by MassDOT. As such, 2 feet of freeboard above the hydraulic design storm is required. This crossing currently has more than 2 feet of freeboard in the design storm, though it is not required with the existing geometry.

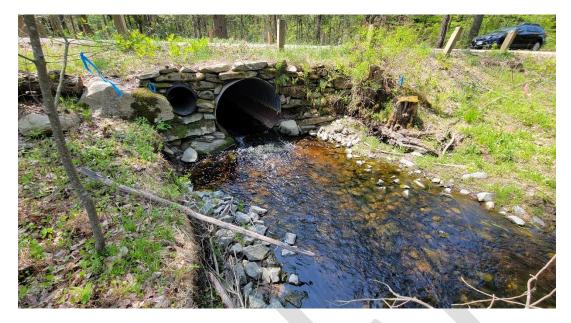
Image 6: Culverts 24 and 25

Culverts 24 and 25 are existing round pipes with 3-foot and 2-foot diameters. The existing crossing does not meet stream crossing standards because the width of the hydraulic opening is less than 1.2 times bankfull width, as described in Section 1.6.1.2 below, and because it does not meet openness ratio requirements. Under existing conditions, Culverts 24 and 25 cannot convey the 10-year storm event without overtopping the culvert. Additionally, replacing this crossing may lead to a crossing with a span greater than 10 feet due to bankfull width requirements. If the crossing span was increased to greater than 10 feet, this crossing would be considered a bridge and subject to Chapter 85 review by MassDOT. As such, 2 feet of freeboard above the hydraulic design storm is required. This crossing does not currently meet freeboard requirements.

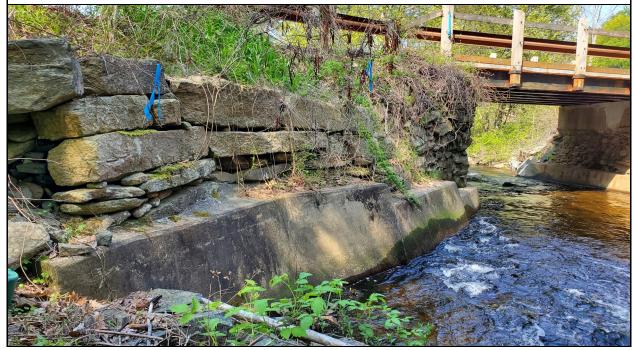
Photograph No.: 2	Date: 5/11/2023	Direction Taken: Northeast
-------------------	-----------------	----------------------------

Description: Flag Series B1B-3 TT BVW1D-1 marking MAHW of Sawmill River at 2 Dudleyville Road, Leverett, MA, 01054

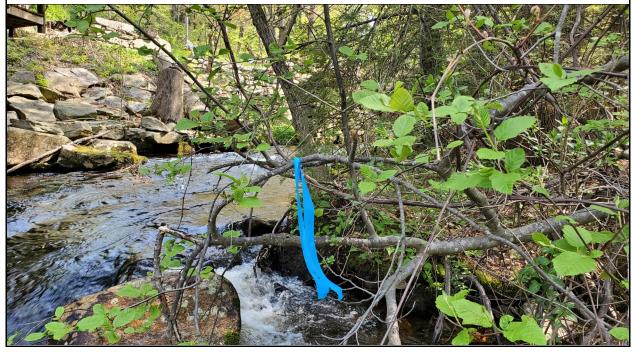
Photograph No.: 3	Date: 5/11/2023	Direction Taken: East	
-------------------	-----------------	-----------------------	--

Description: View of the Sawmill River Bypass Channel delineated as Flag Series BVW1C-1/3, and BVW1D-1/3.

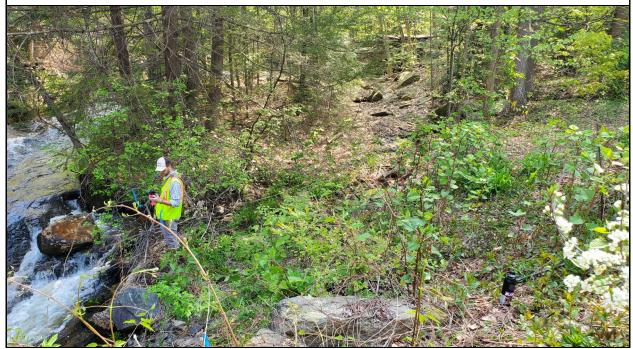
Photograph No.: 4	Date: 5/11/2023	Direction Taken: Southeast

Description: View of the Sawmill River Bypass Channel. Shown : Flag Series BVW1C-3

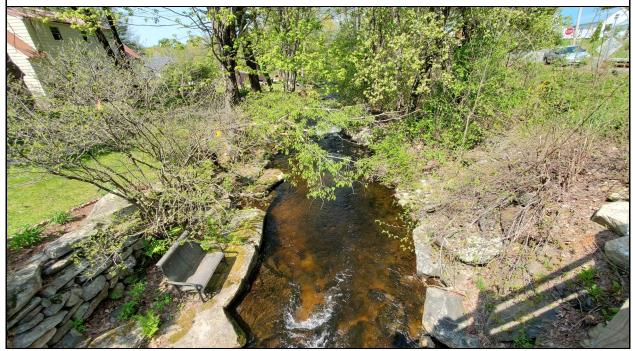
Photograph No.: 8	Date: 5/11/2023	Direction Taken: North	
Description: View of the Flag Series B1F-1/4 and current conditions of Bridge 1 at 1 Dudleyville

Description: View of the Flag Series B1F-1/4 and current conditions of Bridge 1 at 1 Dudle Road, Leverett, MA, 01054

To comply with the Stream Crossing Standards, the structure spans would exceed 10 feet and therefore the resulting structures would be classified as "bridges." Each of the modeled hydraulic openings can pass the hydraulic design storm (the 10-year storm event) with 2 feet of freeboard per MassDOT requirements. Note this analysis was limited in nature and does not consider tailwater conditions. A more in-depth analysis would be required to verify the hydraulic capacities of each crossing. The analysis determined required sizing of stream crossings given current regulations and did not take into account the conditions of the existing crossings or the presence of existing flooding issues. Existing crossings do not need to be replaced if they are in good/fair condition. Future condition review and structural analysis efforts should be performed on the structures, as necessary.

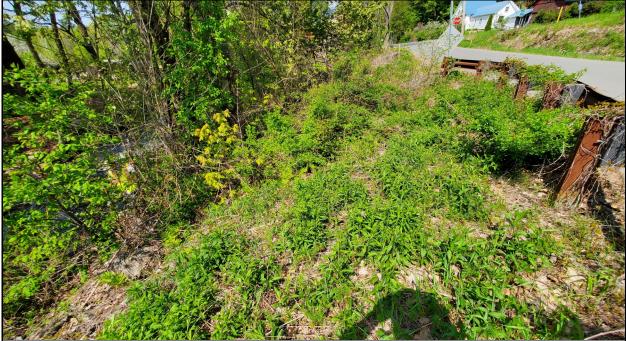
Photograph No.: 10 Date: 5/11/2023 Direction Taken: West				
Description: View of Flag Series B1F-1/3 from 1 Dudleyville Road, Leverett, MA.

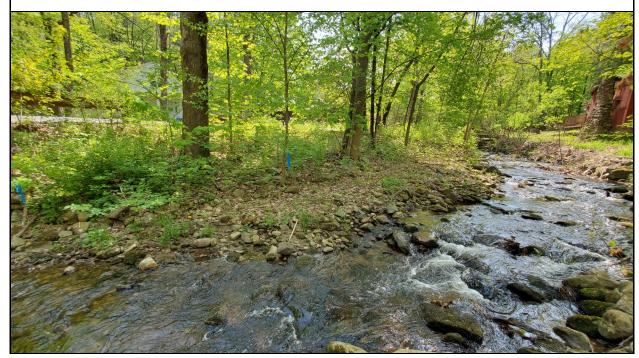
Photograph No.: 13	Date: 5/11/2023	Direction Taken: East

Description: View of Flag Series B2A-2/4 at 7 Dudleyville Road, Leverett, MA.

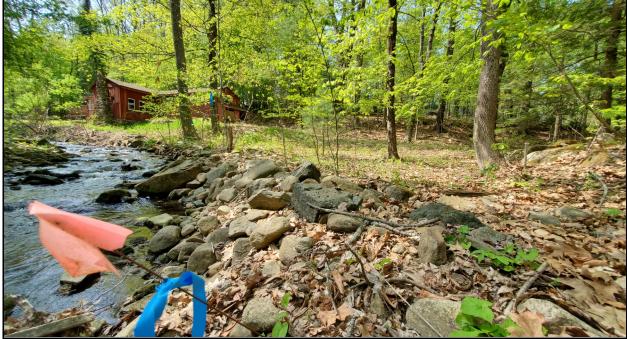
Photograph No.: 14	Date: 5/11/2023	Direction Taken: South		
Description: View of Flag Series B2B-1/4 from B2B-3 at 7 Dudleyville Road, Leverett, MA.

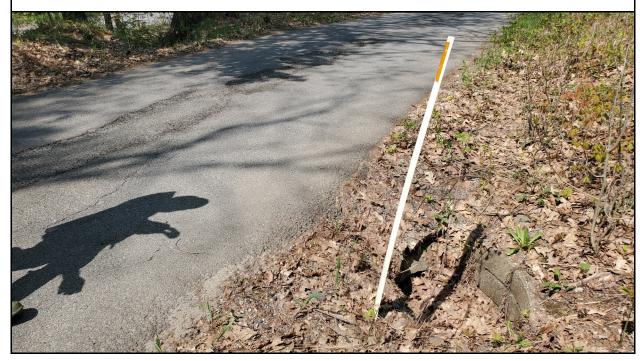
Photograph No.: 16 Date: 5/11/2023 Direction Taken: Northwest	
---	--

Description: View of uppermost Inlet of Culvert 1 at 12 Briggs Road, Leverett, MA.

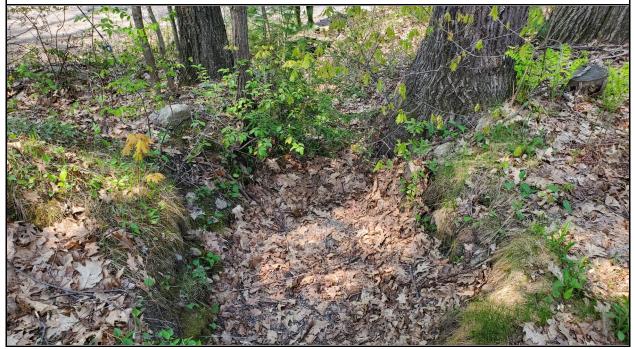
Photograph No.: 17	Date: 5/11/2023	Direction Taken: Southwest
--------------------	-----------------	----------------------------

Description: Downslope view of Outlet Channel from 12 Briggs Road, conveying to Dudleyville Road, Leverett, MA.

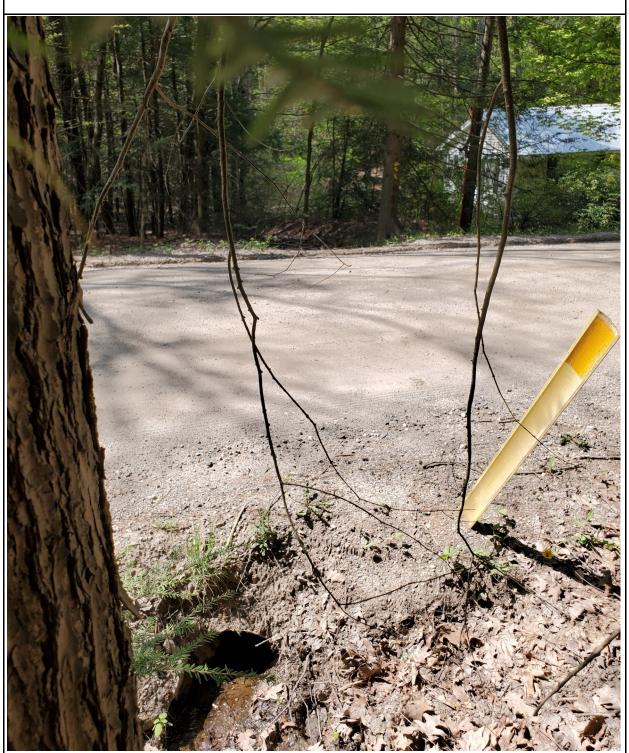
Photograph No.21: Date: 5/11/2023 Direction Taken: Southwest
--

Description: Inlet view of Culvert 2 at 23 Dudleyville Road Leverett, MA, draining to Dudleyville Brook.

Culvert Name	Existing Size (inches)	Culvert Station	Recommended Action	Recommended Size (inches)
Culvert 2	24	11+93	Replace	30
New Culvert 2A	-	13+25	Install New Culvert	18
Culvert 3	12	15+47	Replace	24
Culvert 4	15	17+41	Replace	18
Culvert 5	15	19+03	Replace	24

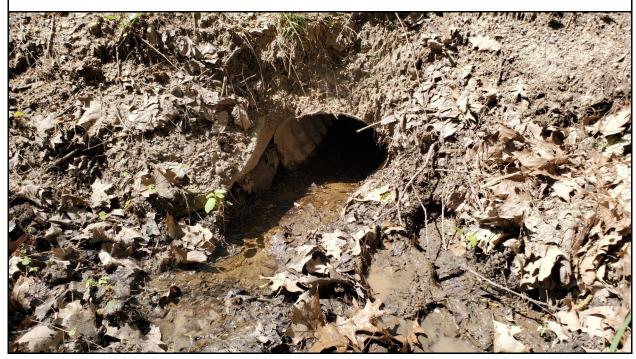
Photograph No.: 23	Date: 5/11/2023	Direction Taken: Northwest

Description: Culvert 2 Inlet, Roadside Ditch, Dudleyville Road, Leverett, MA.

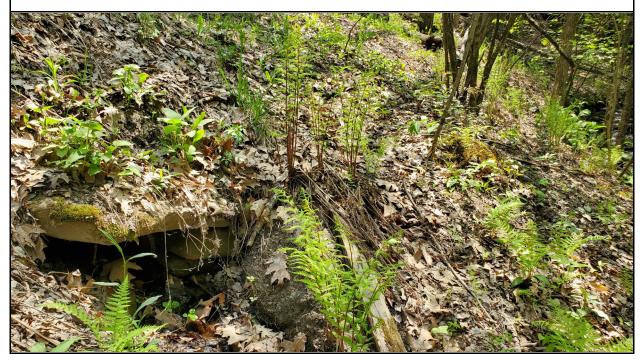
Photograph No.: 24	Date: 5/11/2023	Direction Taken: East

Description: Culvert 3 outlet, conveying to Dudleyville Road, Leverett, MA.

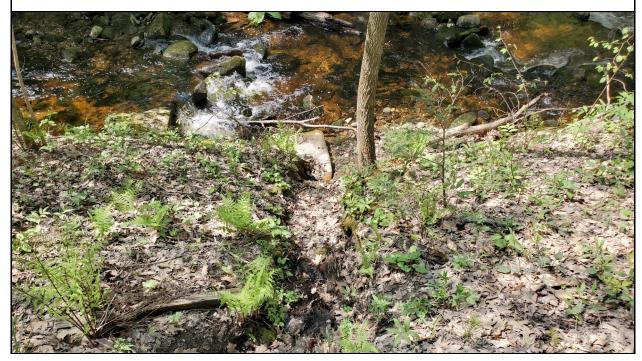
Photograph No.: 25	Date: 5/11/2023	Direction Taken: Southwest
--------------------	-----------------	----------------------------

Description: Culvert 3 Outlet Channel at Dudleyville Brook, Dudleyville Road, Leverett, MA.

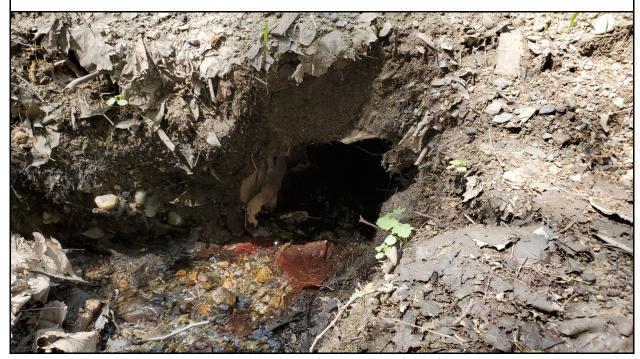
Photograph No.: 31	Date: 5/11/2023	Direction Taken: East
--------------------	-----------------	-----------------------

Description: Culvert 5 Inlet at roadside Stormwater Channel, Dudleyville Road, Leverett, MA.

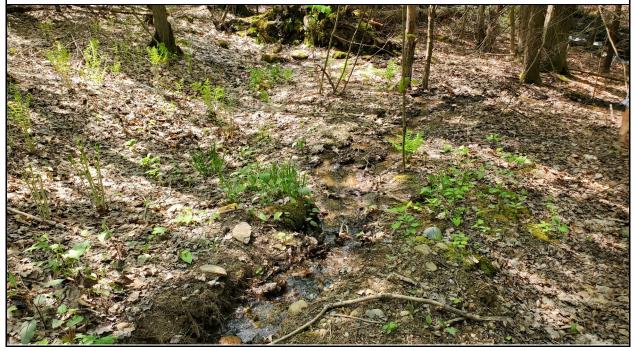
Photograph No.: 32 Date	: 5/11/2023	Direction Taken: Southwest
-------------------------	-------------	----------------------------

Description: View of the drainage channel conveying Dudleyville Road Stormwater from Culvert 5 to Dudleyville Brook, Dudleyville Road, Leverett, MA..

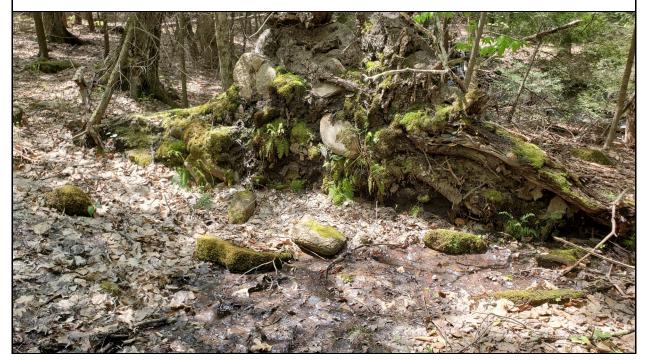
Photograph No.: 33 Date: 5/11/2023	Direction Taken: Southeast
---	----------------------------

Description: Culvert 5 drainage channel and overturned tree roots. Dudleyville Road, Leverett, MA.

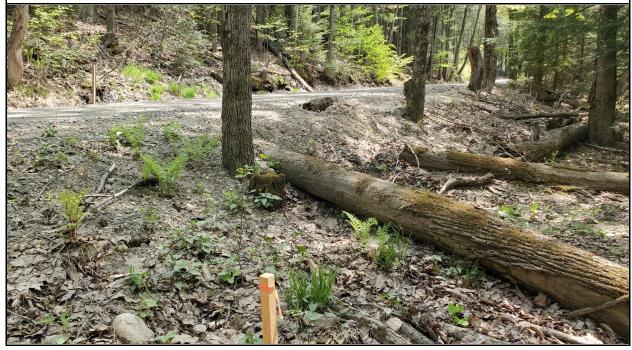
Photograph No.: 34	Date: 5/11/2023	Direction Taken: Northeast

Description: View of Dudleyville Road and Culvert 6 outlet area. Property in background is 24 Briggs Road. Dudleyville Road, Leverett, MA.

Culvert 6	15	20+53	Replace	18
Culvert 7	12	22+11	Remove	-
Culvert 7A	-	23+25	Install New Culvert	24
Culvert 7B	-	25+90	Install New Culvert	24
Culvert 8	12	27+18	Replace	18
Culvert 9	12	29+26	Replace	24
Culvert 10	12	31+67	Replace	36
Culvert 11	12	32+25	Remove	-
Culvert 12	15	34+65	Replace	18
Culvert 13	12	37+36	Replace	18
Culvert 14	18	38+25	Replace	18
Culvert 15	15	39+45	Replace	24
Culvert 16	12	41+90	Replace	30
New Culvert 16A	-	42+60	Install New Culvert	24
Culvert 17	15	45+61	Replace	24
Culvert 18	12	47+00	Replace	24
Culvert 19	12	47+71	Remove	-
Culvert 20	12	50+70	Replace	18
Culvert 21	15	52+18	Replace	18
Culvert 23	15	57+79	Replace	18
New Culvert 25A	-	62+05	Install New Culvert	18
Culvert 26	47	64+32	Retain Existing	47
Culvert 27	12	67+93	Replace	18
Culvert 28	12	69+95	Replace	18

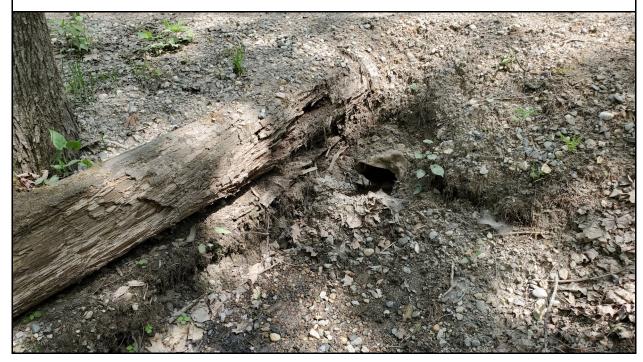
Description: Culvert 6 Outlet, Dudleyville Road, Leverett, MA..

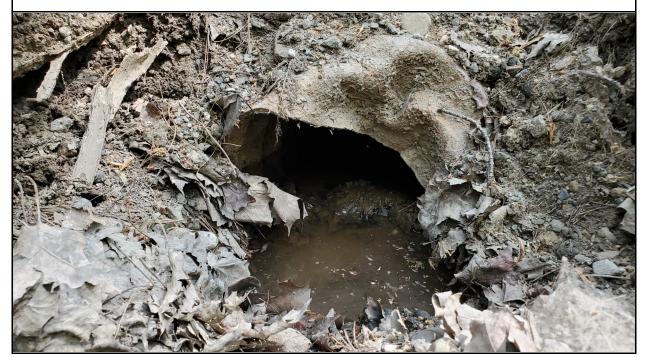
Photograph No.: 36	Date: 5/11/2023	Direction Taken: North

Description: View of Culvert 6 Outlet damage, Dudleyville Road, Leverett, MA.

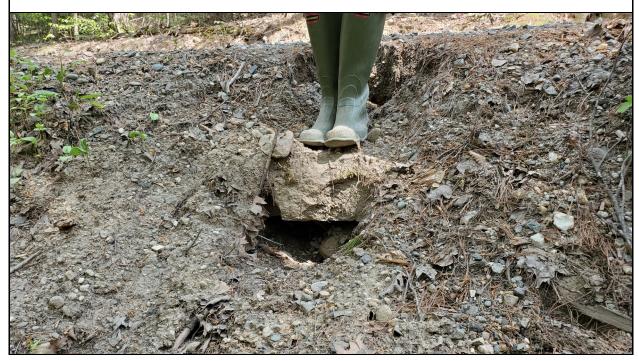
Photograph No.: 38	Date: 5/11/2023	Direction Taken: Northwest

Description: Culvert 7 Outlet, Dudleyville Road, Leverett, MA.

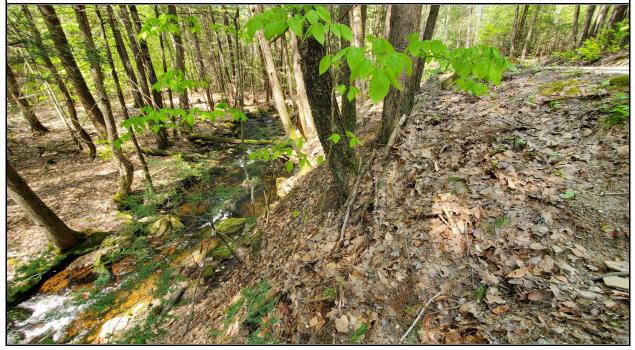
Photograph No.: 39	Date: 5/11/2023	Direction Taken: West

Description: Culvert 7 Outlet drainage area looking downstream with Dudleyville Brook and Dudleyville Road, Leverett, MA..

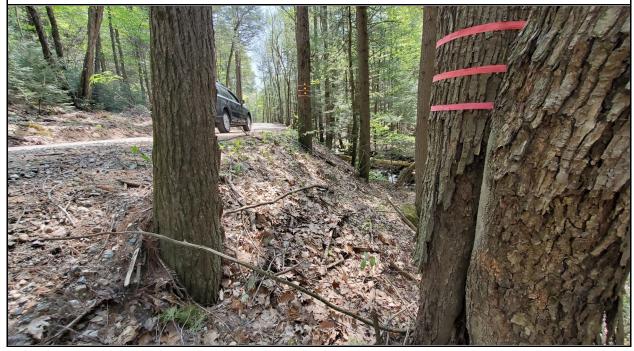
Photograph No.: 41	Date: 5/11/2023	Direction Taken: East

Description: Culvert 7 Outlet drainage area looking upstream Dudleyville Brook, Dudleyville Road, Leverett, MA.

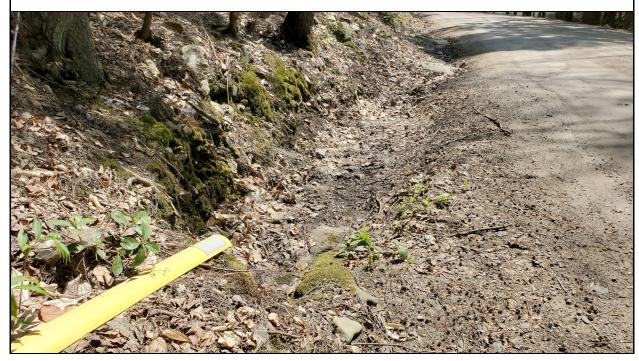
Photograph No.: 43	Date: 5/11/2023	Direction Taken: East

Description: Culvert 8 roadside ditch, Dudleyville Road.

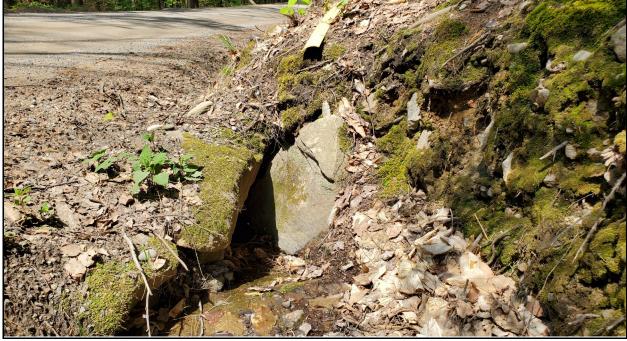
Photograph No.: 44	Date: 5/11/2023	Direction Taken: West
Description: Culvert 8 I	nlet at roadside storm	water ditch.

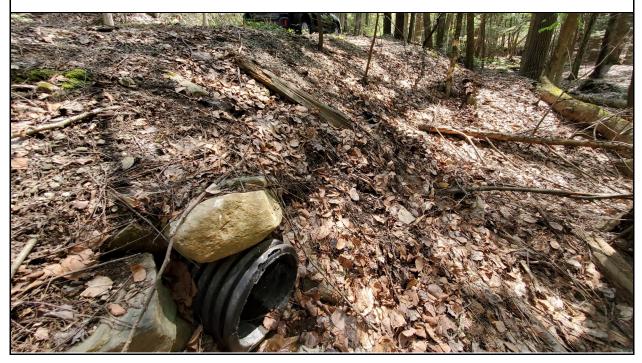
Photograph No.: 47	Date: 5/11/2023	Direction Taken: East

Description: Culvert 8 Outlet, Dudleyville Brook – Dudleyville Road, Leverett, MA.

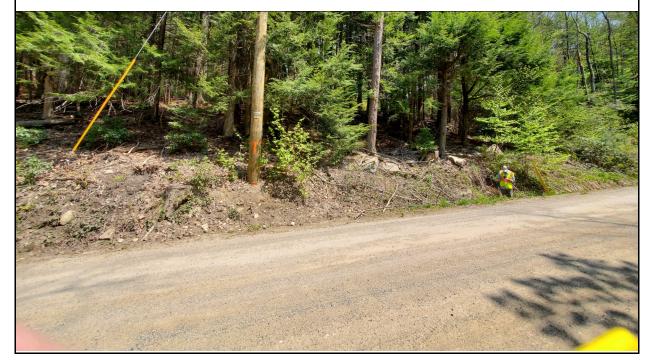
Photograph No.: 48	Date: 5/11/2023	Direction Taken: Northeast

Description: Area of Culvert 9 Inlet at roadside stormwater ditch — Dudleyville Road, Leverett, MA.

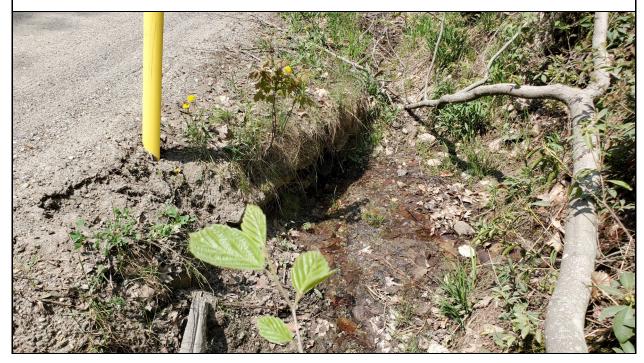
Photograph No.: 50	Date: 5/11/2023	Direction Taken: West
--	--------------------	-----------------	-----------------------

Description: Culvert 10 inlet, at roadside stormwater ditch — Dudleyville Road, Leverett, MA.

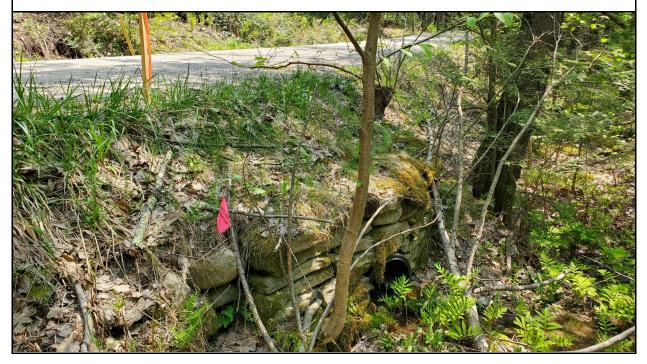
Photograph No.: 51	Date: 5/11/2023	Direction Taken: Northeast

Description: Culvert 10 Outlet discharges to BVW-3 - Dudleyville Road, Leverett, MA.

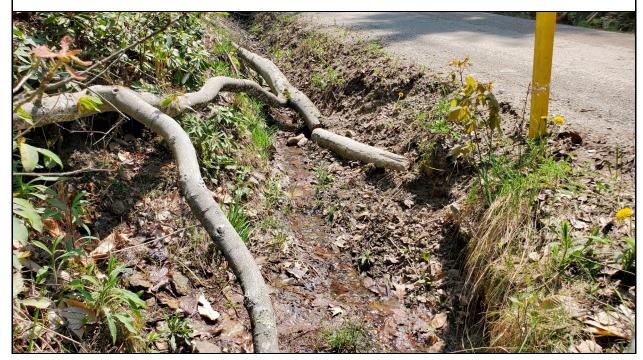
Photograph No.: 52 Date: 5/11/2023	Direction Taken: East
------------------------------------	-----------------------

Description: Culvert 11 inlet, at roadside stormwater ditch — Dudleyville Road, Leverett, MA.

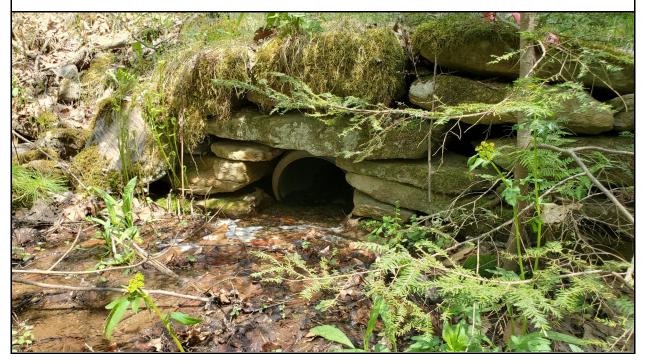
Photograph No.: 53	Date: 5/11/2023	Direction Taken: Northwest

Description: Culvert 11 Outlet discharges to BVW-3 - Dudleyville Road, Leverett, MA.

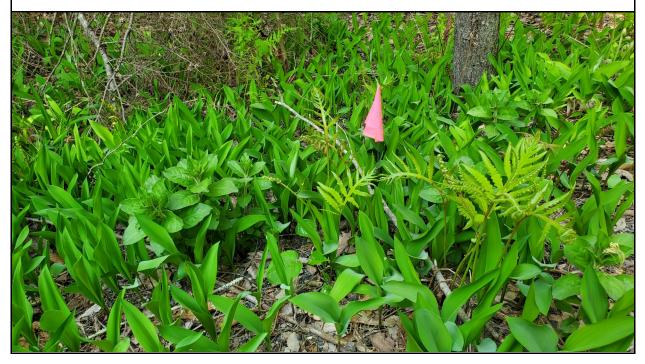
Photograph No.: 57	Date: 5/11/2023	Direction Taken: South	
Press intiger DVAV 2. Deven and direct De diese ille Des die Levenster MA

Description: BVW-3, Down-gradient — Dudleyville Road, Leverett, MA.

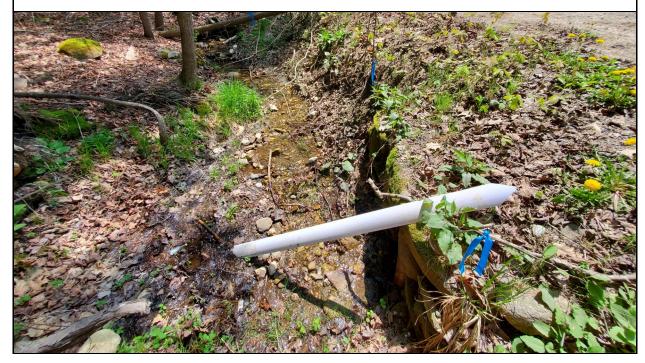
Photograph No.: 58	Date: 5/11/2023	Direction Taken: East
--------------------	-----------------	-----------------------

Description: Culvert 12 inlet, at roadside stormwater ditch — Dudleyville Road, Leverett, MA.

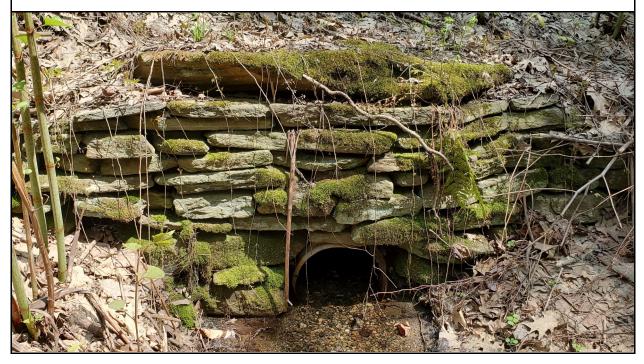
Photograph No.: 59	Date: 5/11/2023	Direction Taken: North

Description: Culvert 12 Outlet discharges to BVW-4 — Dudleyville Road, Leverett, MA.

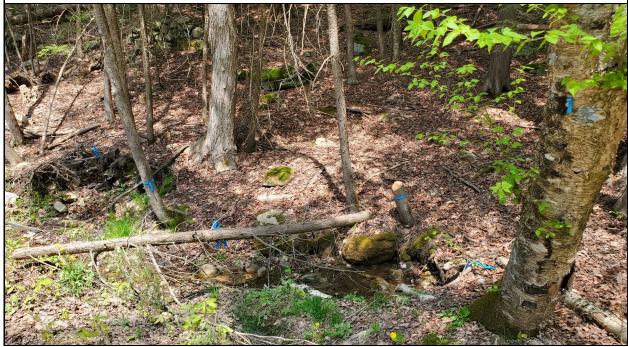
Photograph No.: 60	Date: 5/11/2023	Direction Taken: Northwest
--------------------	-----------------	----------------------------

Description: BVW 4, Up-gradient — Dudleyville Road, Leverett, MA.

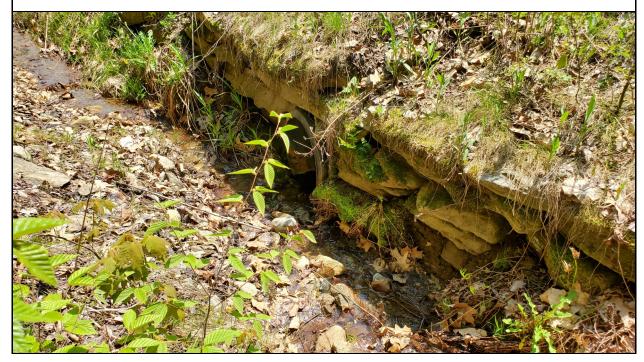
Photograph No.: 62	Date: 5/11/2023	Direction Taken: Southeast
--------------------	-----------------	----------------------------

Description: Culvert 13 inlet, at roadside stormwater ditch — Dudleyville Road, Leverett, MA.

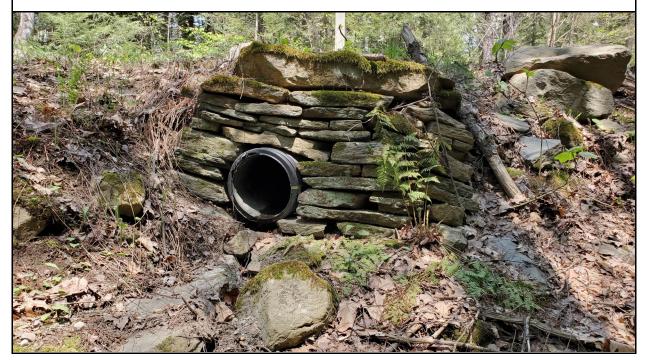
Photograph No.: 63	Date: 5/11/2023	Direction Taken: North
--	--------------------	-----------------	------------------------

Description: Culvert 13 Outlet discharges to Dudleyville Brook — Dudleyville Road, Leverett, MA.

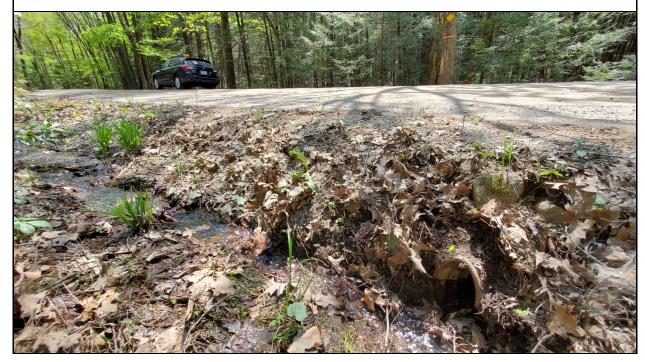
Description: Culvert 14 inlet, at roadside stormwater ditch — Dudleyville Road, Leverett, MA.

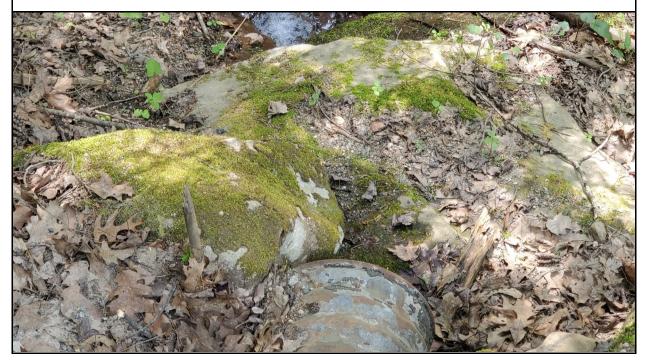
Photograph No.: 65	Date: 5/11/2023	Direction Taken: South	
--	--------------------	-----------------	------------------------	--

Description: Culvert 14 Outlet discharges to Dudleyville Brook — Dudleyville Road, Leverett, MA.

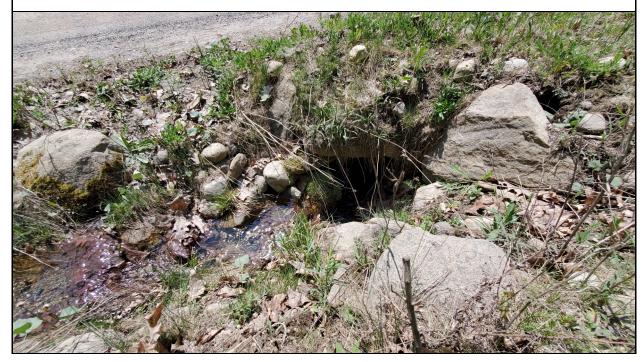
Photograph No.: 66 Date: 5/11/2	023 Direction Taken: Southeast
---------------------------------	--------------------------------

Description: Culvert 15 Inlet, at roadside stormwater ditch — Dudleyville Road, Leverett, MA.

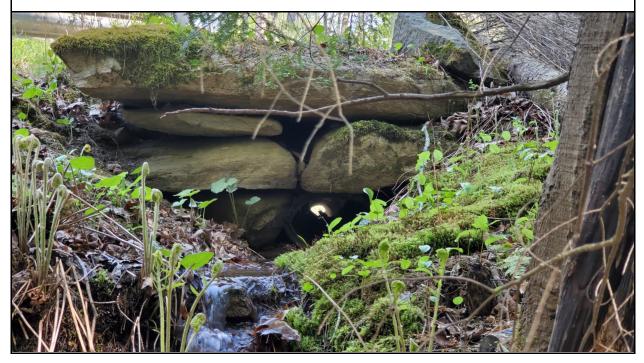
Photograph No.: 67	Date: 5/11/2023	Direction Taken: North

Description: Culvert 15 Outlet discharges to Dudleyville Brook — Dudleyville Road, Leverett, MA.

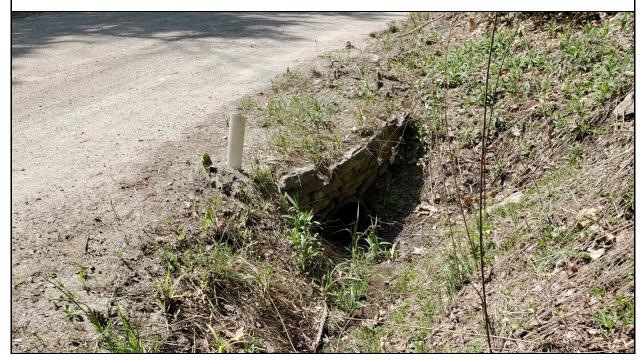
1		
Photograph No.: 68	Date: 5/11/2023	Direction Taken: Southeast

Description: Culvert 16 Inlet, at roadside stormwater ditch — Dudleyville Road, Leverett, MA.

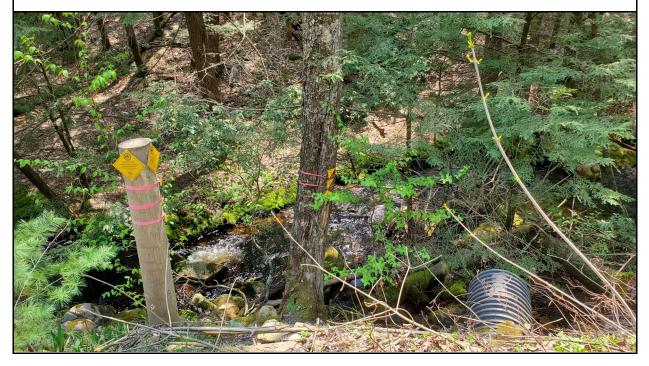
Photograph No.: 69	Date: 5/11/2023	Direction Taken: South

Description: Culvert 16 Outlet discharges to Dudleyville Brook — Dudleyville Road, Leverett, MA.

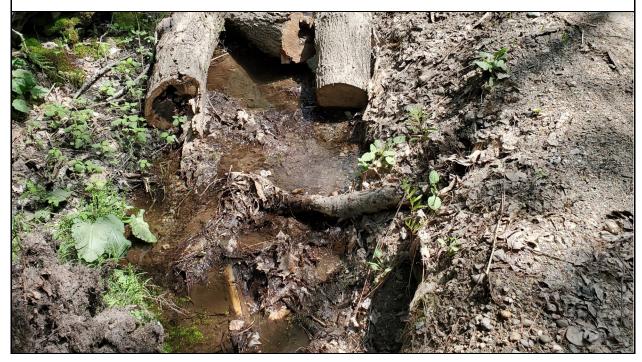
Photograph No.: 70 Date: 5/11/2023	Direction Taken: East
------------------------------------	-----------------------

Description: Culvert 17 Inlet, at roadside stormwater ditch — Dudleyville Road, Leverett, MA.

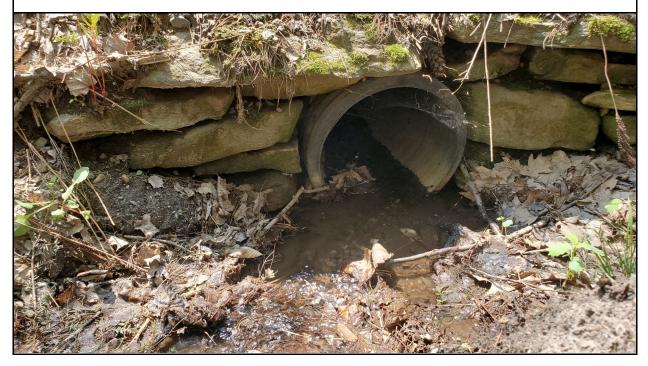
Photograph No.: 71	Date: 5/11/2023	Direction Taken: North

Description: Culvert 17 Outlet discharges to Bank-5 — Dudleyville Road, Leverett, MA.

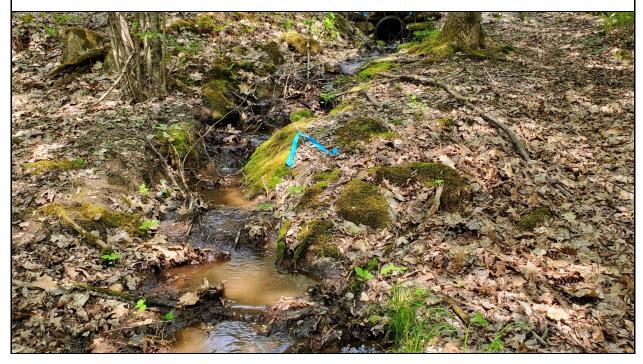
Photograph No.: 72 Date: 5/11/2023	Direction Taken: North
------------------------------------	------------------------

Description: Culvert-17 Outlet & Bank-5 — Dudleyville Road, Leverett, MA.

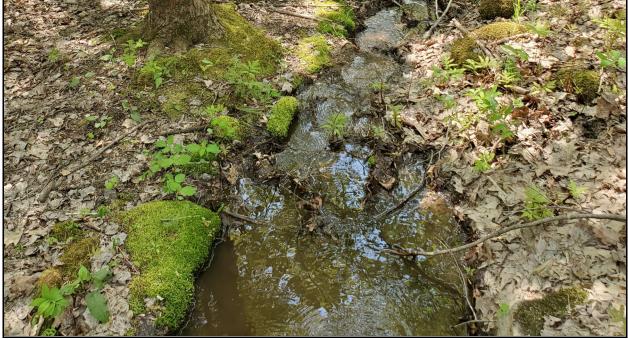
Photograph No.: 73 Date: 5/11/2023 Direction Taken: South		
Description: Bank-5 — Dudleyville Road, Leverett, MA.

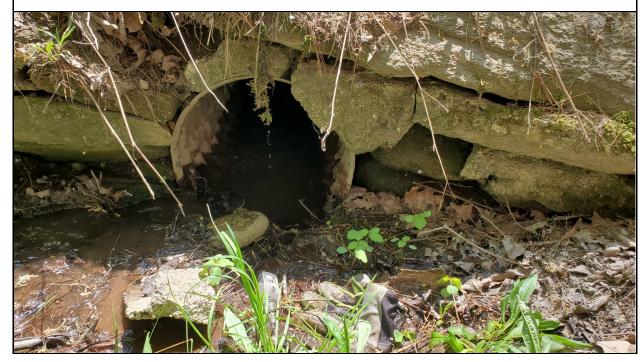
Photograph No.: 74	Date: 5/11/2023	Direction Taken: East

Description: Culvert 18 Outlet, at roadside stormwater ditch — 92 Dudleyville Road, Leverett, MA.

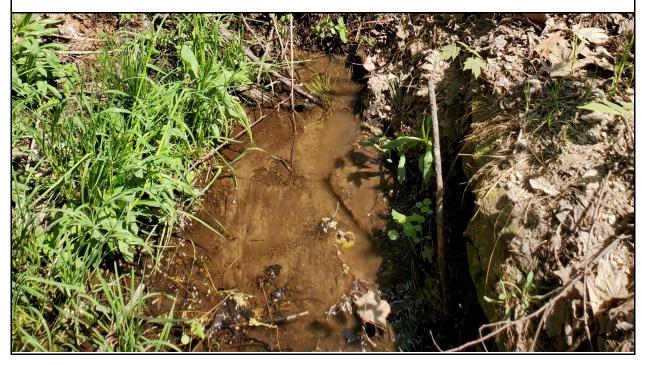
Photograph No.: 75	Date: 5/11/2023	Direction Taken: East
--------------------	-----------------	-----------------------

Description: Culvert 18 Outlet discharges to Bank-6 — Dudleyville Road, Leverett, MA.

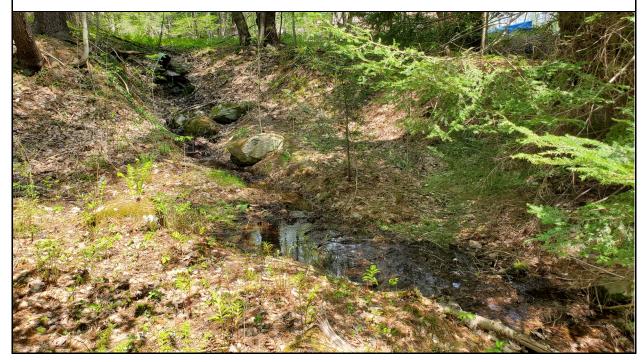
Photograph No.: 76	Date: 5/11/2023	Direction Taken: North
--------------------	-----------------	------------------------

Description: Bank-6, Upstream — Dudleyville Road, Leverett, MA.

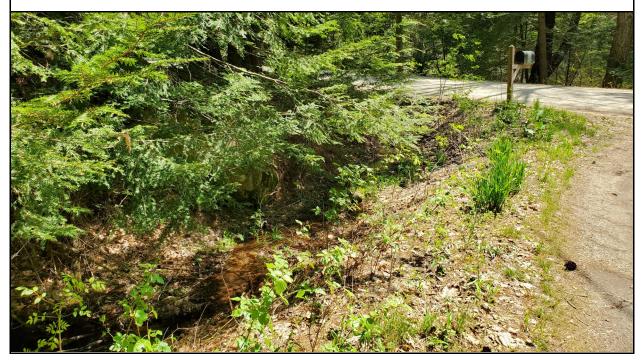
Photograph No.: 77	Date: 5/11/2023	Direction Taken: East

Description: Bank-6 to Culvert 19 – Dudleyville Road, Leverett, MA.

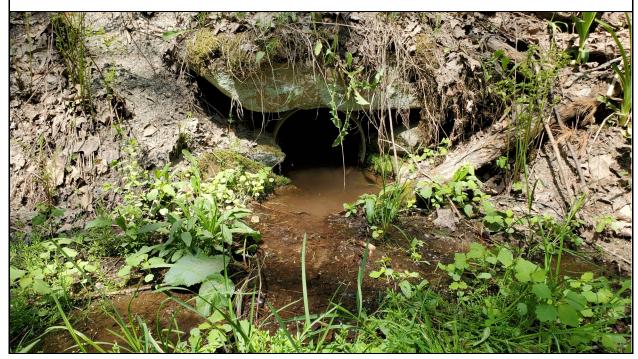
Photograph No.: 78	Date: 5/11/2023	Direction Taken: North

Description: Culvert 19 Outlet at BVW 7 — Dudleyville Road, Leverett, MA.

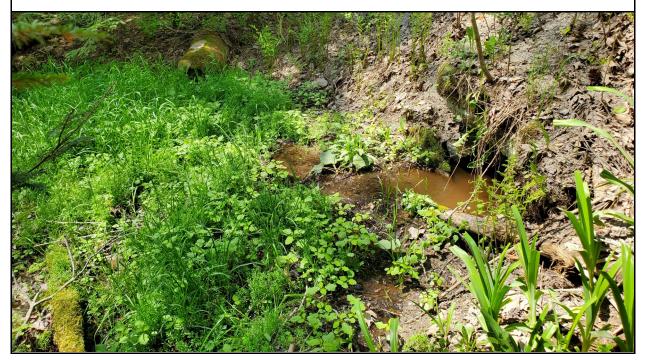
Photograph No.: 79	Date: 5/11/2023	Direction Taken: West

Description: Culvert 19 Outlet at BVW 7 — Dudleyville Road, Leverett, MA.

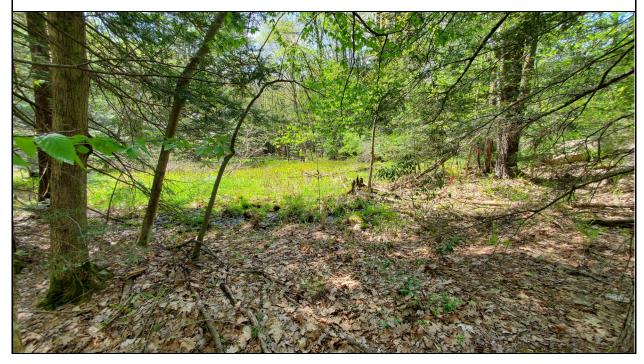
Description: BVW 7 — Dudleyville Road, Leverett, MA.

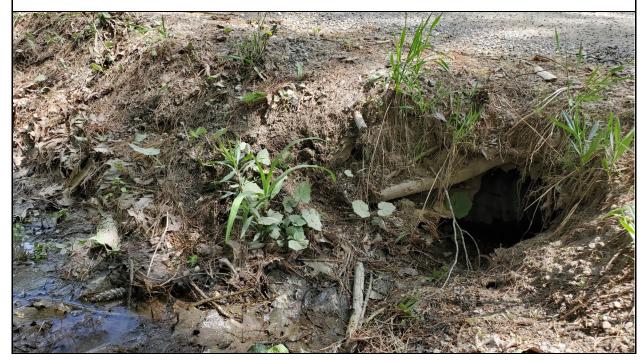
Photograph No.: 82	Date: 5/11/2023	Direction Taken: South

Description: Culvert 20 Inlet, at roadside stormwater ditch - 102 Dudleyville Road, Leverett, MA.

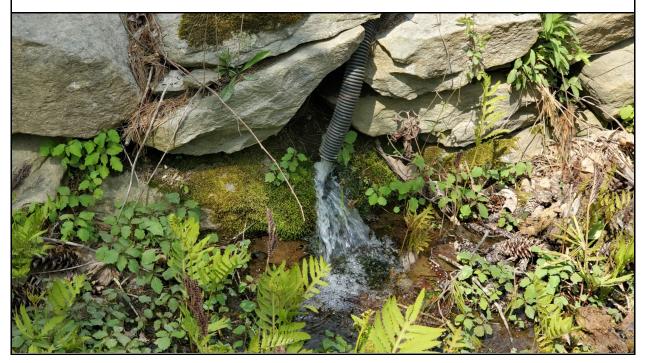
Description: Household Discharge to Culvert-20 at - 102 Dudleyville Road, Leverett, MA

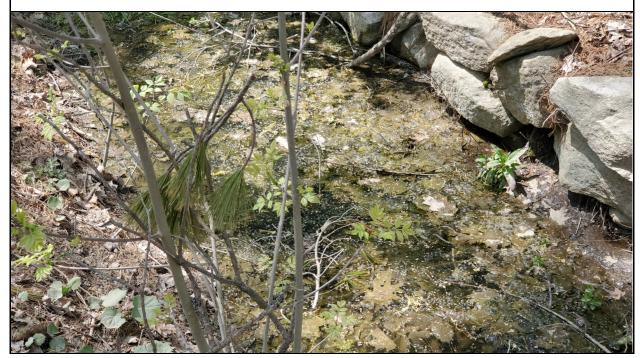
Photograph No.: 84	Date: 5/11/2023	Direction Taken: Northwest
--------------------	-----------------	----------------------------

Description: Household Discharge to Culvert-20 at - 102 Dudleyville Road, Leverett, MA.

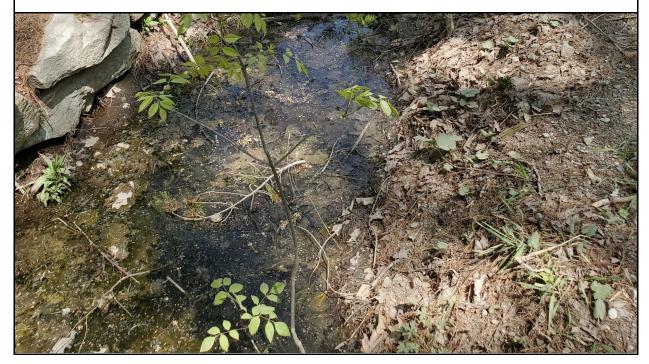
Photograph No.: 85Date: 5/11/2023Direction Taken: East
--

Description: Household Discharge to Culvert-20 at - 102 Dudleyville Road, Leverett, MA.

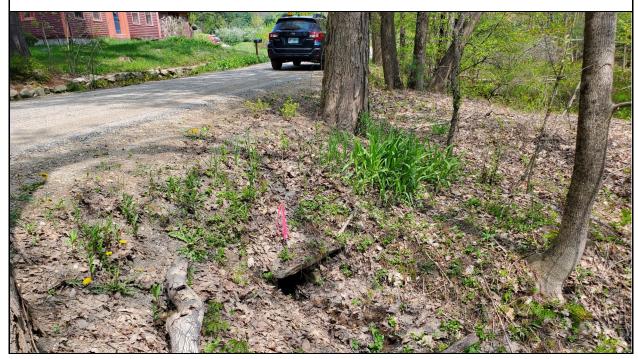
Photograph No.: 86	Date: 5/11/2023	Direction Taken: East
--	--------------------	-----------------	-----------------------

Description: Culvert-20 Outlet to BVW-8 — Dudleyville Road, Leverett, MA.

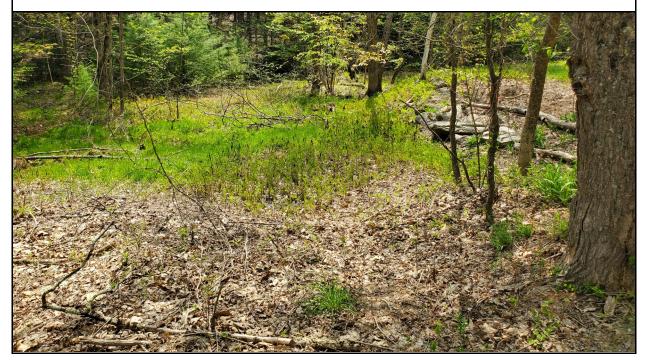
Photograph No.: 87	Date: 5/11/2023	Direction Taken: Southwest

Description: BVW-8 at - 121 Dudleyville Road, Leverett, MA.

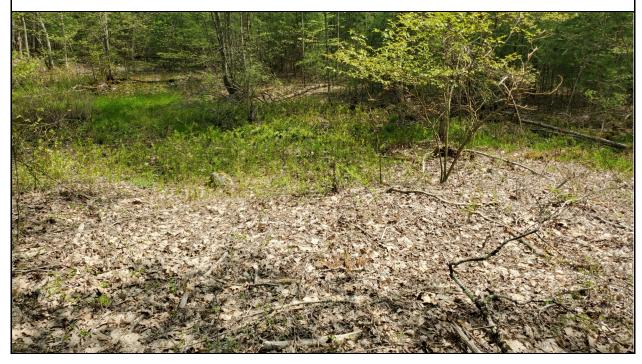
Photograph No.: 88	Date: 5/11/2023	Direction Taken: Southeast
--	--------------------	-----------------	----------------------------

Description: BVW-8 at - 121 Dudleyville Road, Leverett, MA.

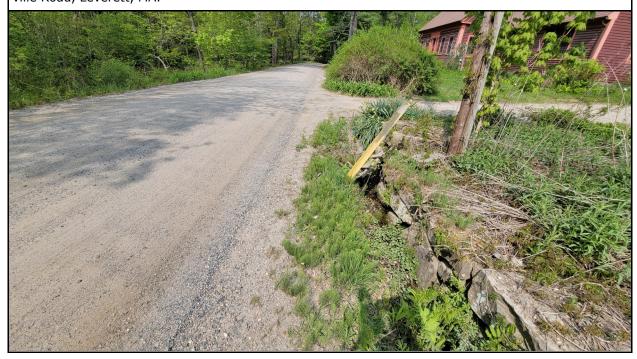
Photograph No.: 89	Date: 5/11/2023	Direction Taken: West	
Description: Culvert-21 Inlet, at roadside stormwater ditch Culvert-21 Outlet to BVW-9 — Dudley-ville Road, Leverett, MA.

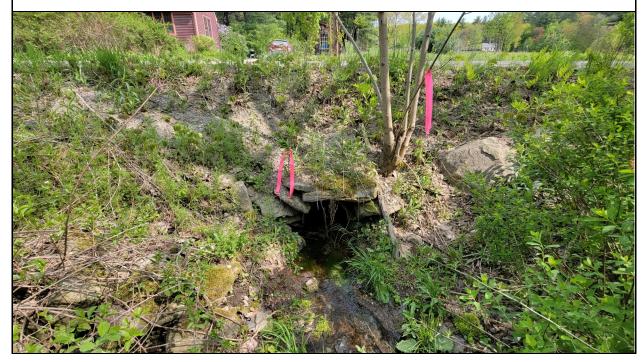
Photograph No.: 90	Date: 5/11/2023	Direction Taken: North

Description: Culvert-21 Outlet to BVW-9 at - 102 Dudleyville Road, Leverett, MA.

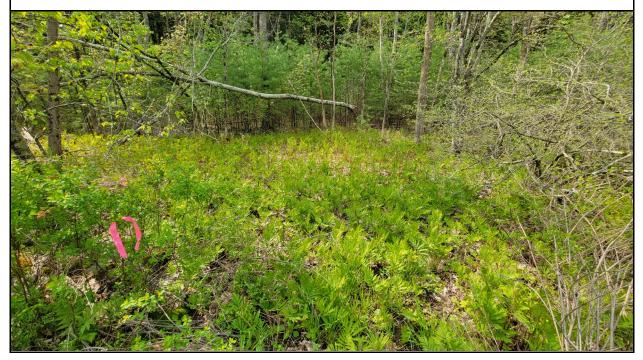
Photograph No.: 91	Date: 5/11/2023	Direction Taken: Southeast

Description: BVW-9 at - 102 Dudleyville Road, Leverett, MA.

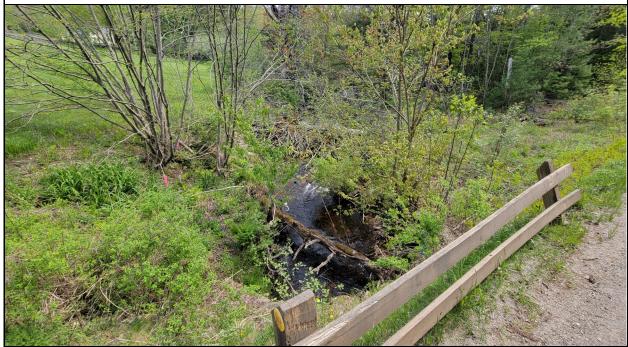
Photograph No.: 94 Date: 5/11/2023	Direction Taken: Northeast
------------------------------------	----------------------------

Description: BVW-10 at - 114 Dudleyville Road, Leverett, MA.

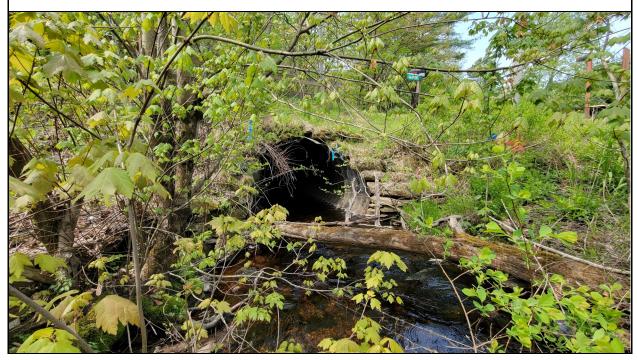
Photograph No.: 96	Date: 5/11/2023	Direction Taken: Southeast
--------------------	-----------------	----------------------------

Description: Culvert-22 Inlet at - 114 Dudleyville Road, Leverett, MA.

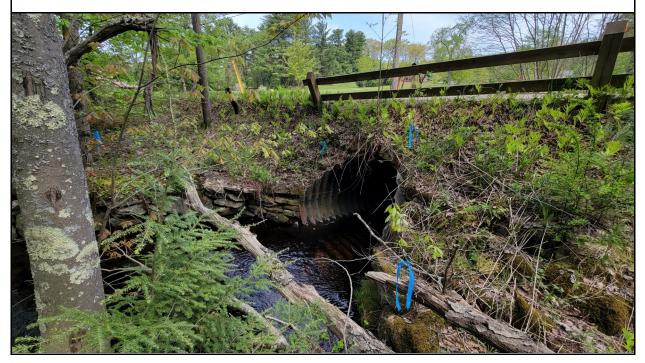
Photograph No.: 97	Date: 5/11/2023	Direction Taken: Northwest
--	--------------------	-----------------	----------------------------

Description: Culvert-22 Outlet, at roadside stormwater ditch -102 Dudleyville Road.

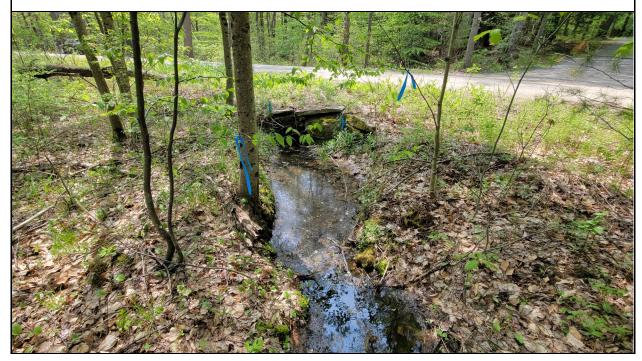
Description: Culvert-23 Inlet at Bank-11 B / C - 114 Dudleyville Road, Leverett, MA.

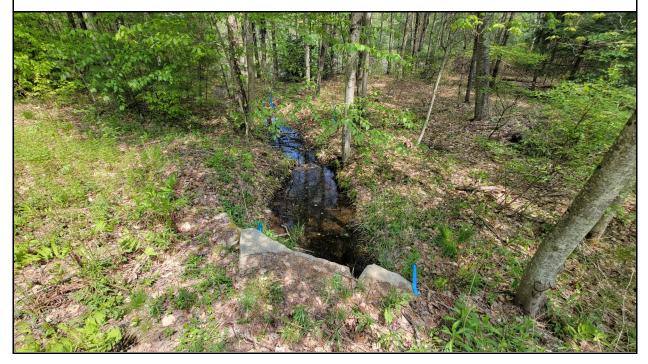
Photograph No.: 99	Date: 5/11/2023	Direction Taken: South

Description: Culvert-23 Downstream at Bank-11 B / C - 114 Dudleyville Road, Leverett, MA.

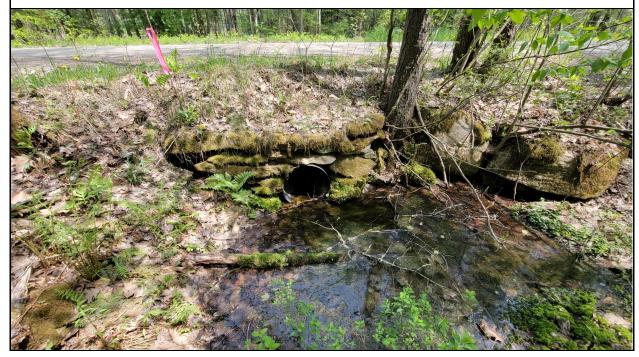
Photograph No.: 100 Date: 5/11/2023	Direction Taken: North
-------------------------------------	------------------------

Description: Culvert-23 Outlet at BVW-11-A - 114 Dudleyville Road, Leverett, MA.

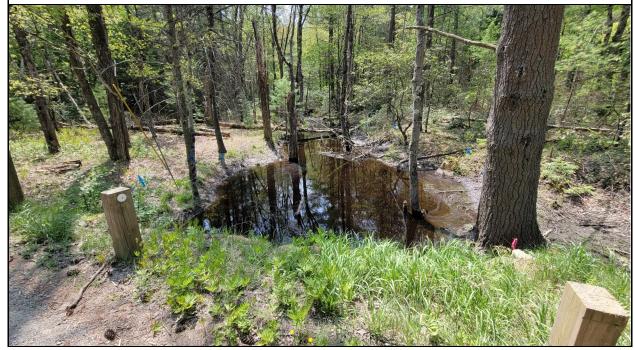
Photograph No.: 102 Date: 5/11/2023 Direction Taken: South	Photograph No.: 102	Date: 5/11/2023	Direction Taken: South
--	---------------------	-----------------	------------------------

Description: Bank-12 D/E Upstream & BVW-12 at Culvert-24 / 25 - 0 Dudleyville Road, Leverett, MA.

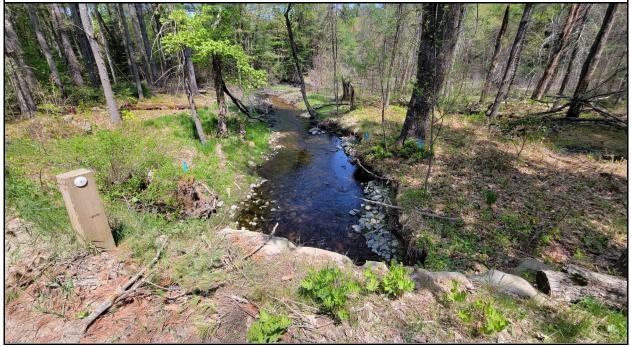
Photograph No.: 103	Date: 5/11/2023	Direction Taken: North
Description: Back-12 A/C Downstroom & BVW-12 at Culvert-24 / 25 - 114 / 140 Dudlowillo Boad

Description: Bank-12 A/C Downstream & BVW-12 at Culvert-24 / 25 — 114 / 140 Dudleyville Road, Leverett, MA.

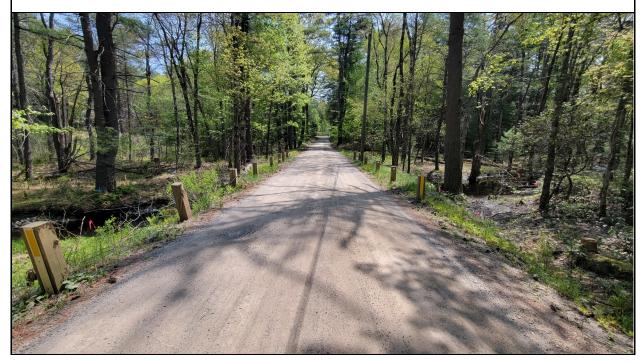
Photograph No.: 104 Date: 5/11/2023 Direction Taken: East

Description: Culvert-24 / 25 at - 114 / 140 Dudleyville Road, Leverett, MA.
