DUDLEYVILLE ROAD RESTORATION EVALUATION

December 8, 2023

Dudleyville Road Restoration Evaluation

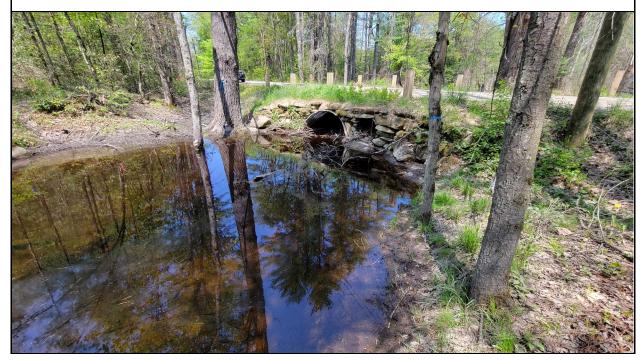
Description: Culvert-24 / 25 Inlet & Bank—BVW-12 at — 114 / 140 Dudleyville Road, Leverett, MA.

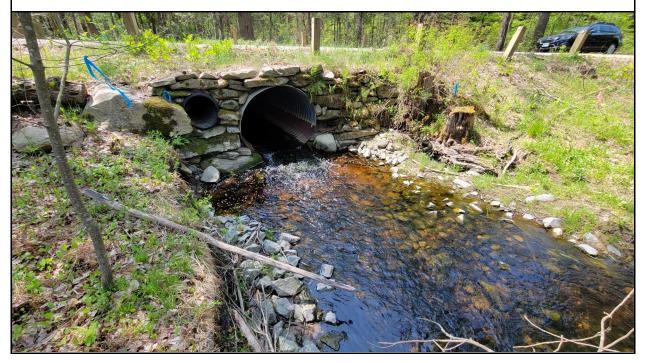
Photograph No.: 107	Date: 5/11/2023	Direction Taken: South

Description: Culvert-24 / 25 Outlet & Bank / BVW-12 at - 0 / 140 Dudleyville Road, Leverett, MA.

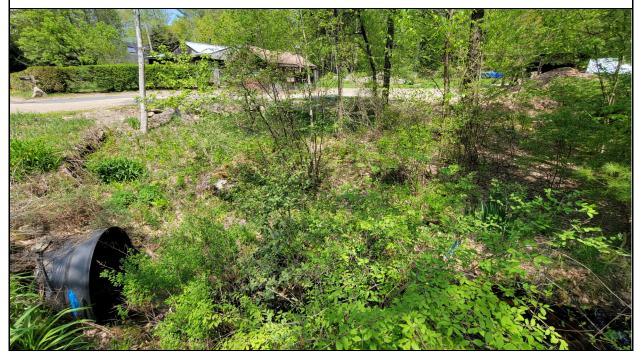
Photograph No.: 108 Date: 5/11/2023	3 Direction Taken: Northwest
-------------------------------------	------------------------------

Description: Culvert-26 Inlet at Bank-13 A/C & BVW-13B — 150 Dudleyville Road, Leverett, MA.

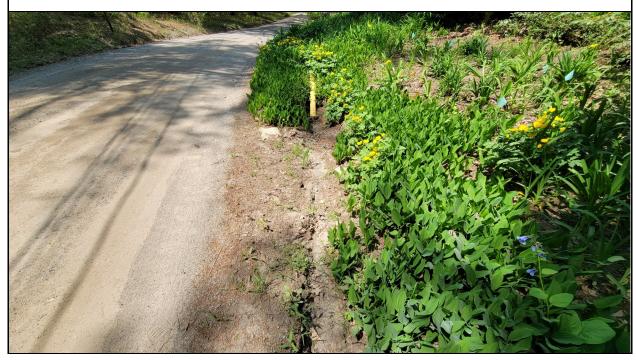
Photograph No.: 110 Date: 5/11/2023	Direction Taken: West
-------------------------------------	-----------------------

Description: Culvert-27 Inlet at - 160 Dudleyville Road, Leverett, MA.

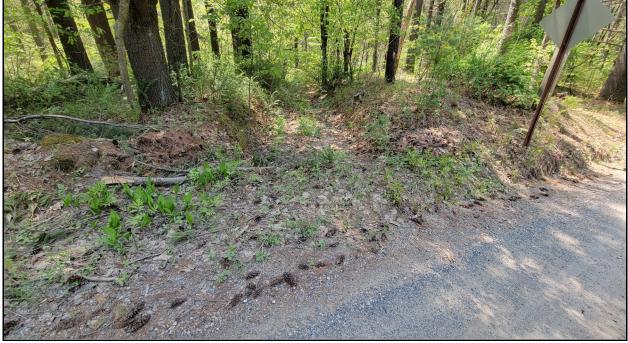
Photograph No.: 111	Date: 5/11/2023	Direction Taken: Southwest		
Description: Culvert-27 Outlet (Buried) at — 0 Dudleyville Road, Leverett, MA.

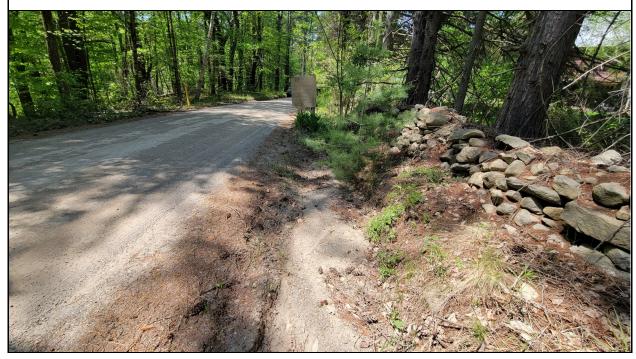
Photograph No.: 112 Date: 5/11/2023	Direction Taken: West
-------------------------------------	-----------------------

Description: Culvert-28 Inlet at — 163 Dudleyville Road, Leverett, MA.

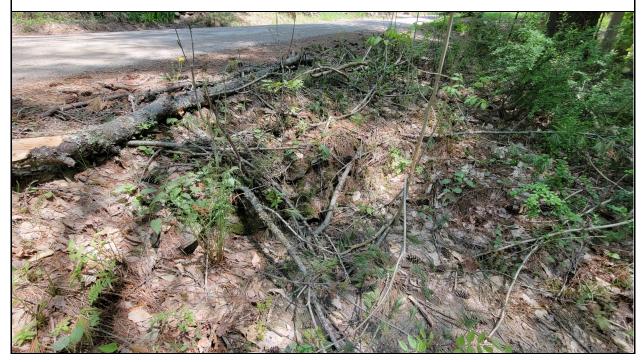
Photograph No.: 114 Date: 5/11/2023	Direction Taken: Northeast
-------------------------------------	----------------------------

Description: Culvert-28 Outlet at - 163 Dudleyville Road, Leverett, MA.

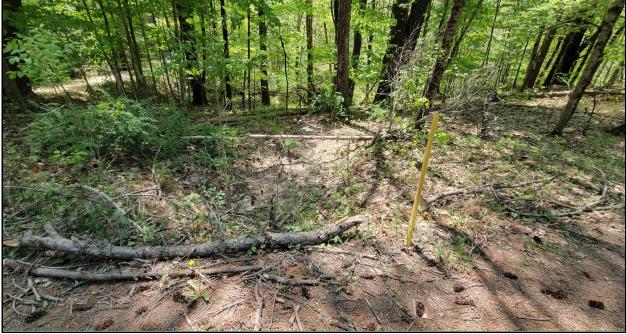
Photograph No.: 115 Date: 5/11/2023 Direction Taken: South							
Description: Culvert-28 Outlet (Buried) at $-$ 163 Dudleyville Road, Leverett, MA.
