**Application for Community
Preservation Funding
For Projects Requesting \$25,000 or more**

A Project Name: **Structural stabilization of the N. Leverett Sawmill**

Structural stabilization of the N. Leverett sawmill through reinforcement/replacement of masonry, piers, posts, framing, sub-floor joists, metal support members and beams on the stone foundations, lower and upper floors

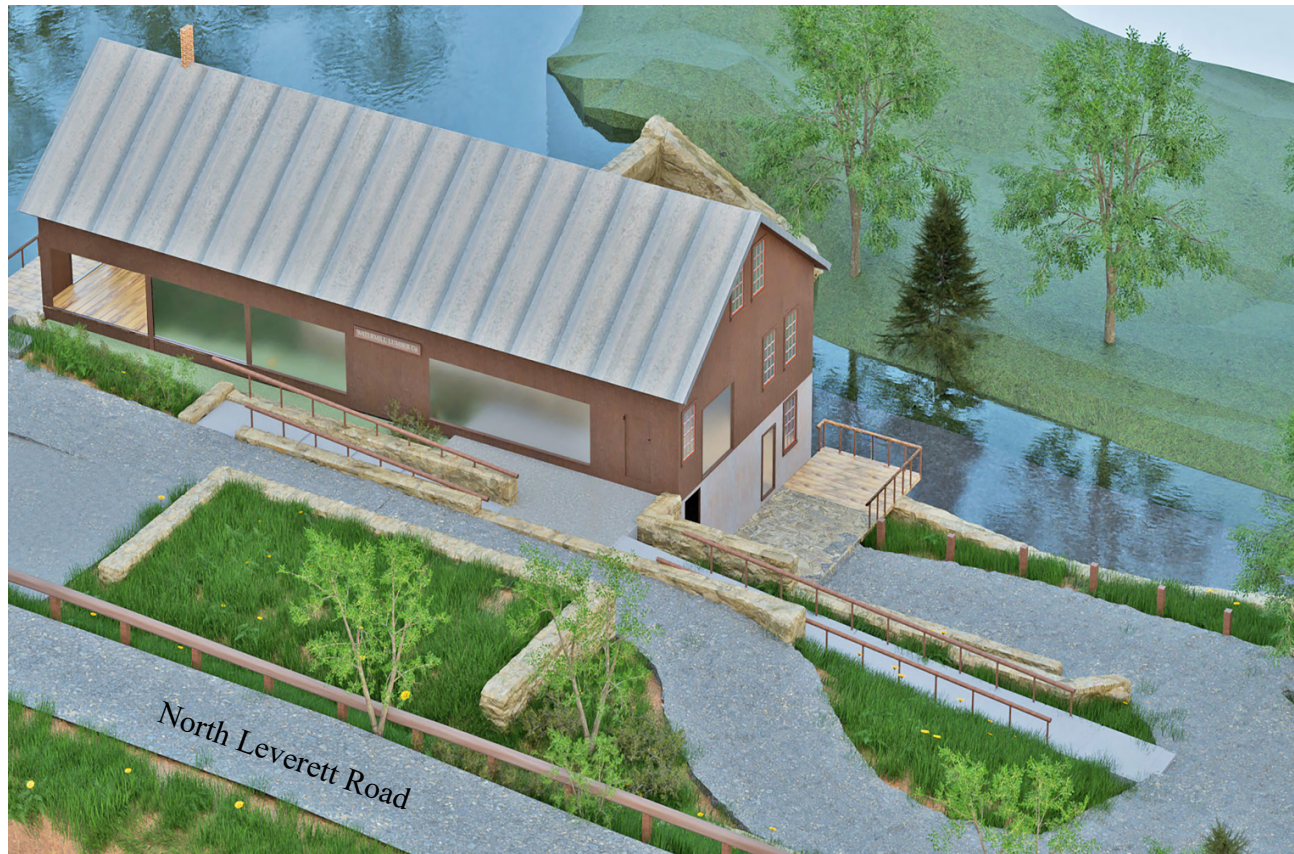
Fig 2 – artists rendition of mill and landscape rehabilitation

Platforms at the E end of the mill will be excluded because the Leverett Historical Commission has ruled that it conflicts with the Historical Restriction held on the building envelope

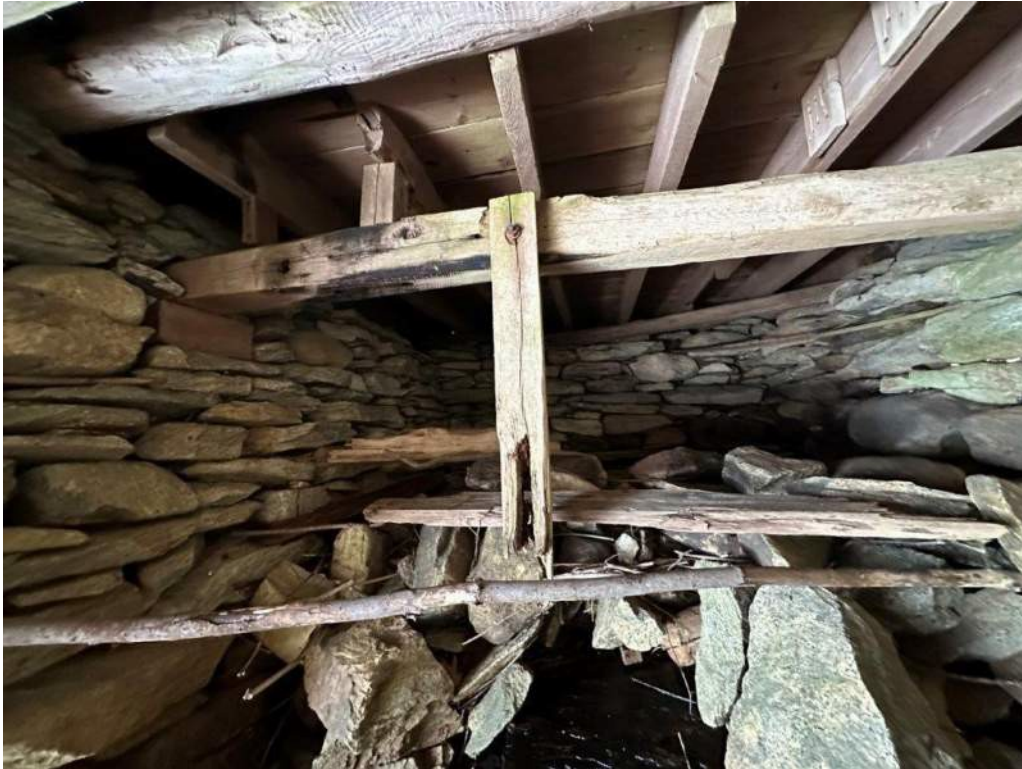
Photo 1
Poorly supported and rotted joist ends

- The main wood floor girt that spans north-south is notched at its end to bypass the rough stone edges of the foundation wall. With that said, the east-west spanning joists are only toe-nailed into the girt at their ends. One of the joists is rotted and no longer reaches the girt, leaving part of the floor unsupported (See Photo 1 of Appendix 1). *The cut on the beam and poor joist end connections result in a vulnerable floor in need of reinforcement, especially if it will soon be opened to the public. The joist ends should be re-supported with face mounting hangers, while the rotted joist is then sistered and extended to reach to the existing girt.*

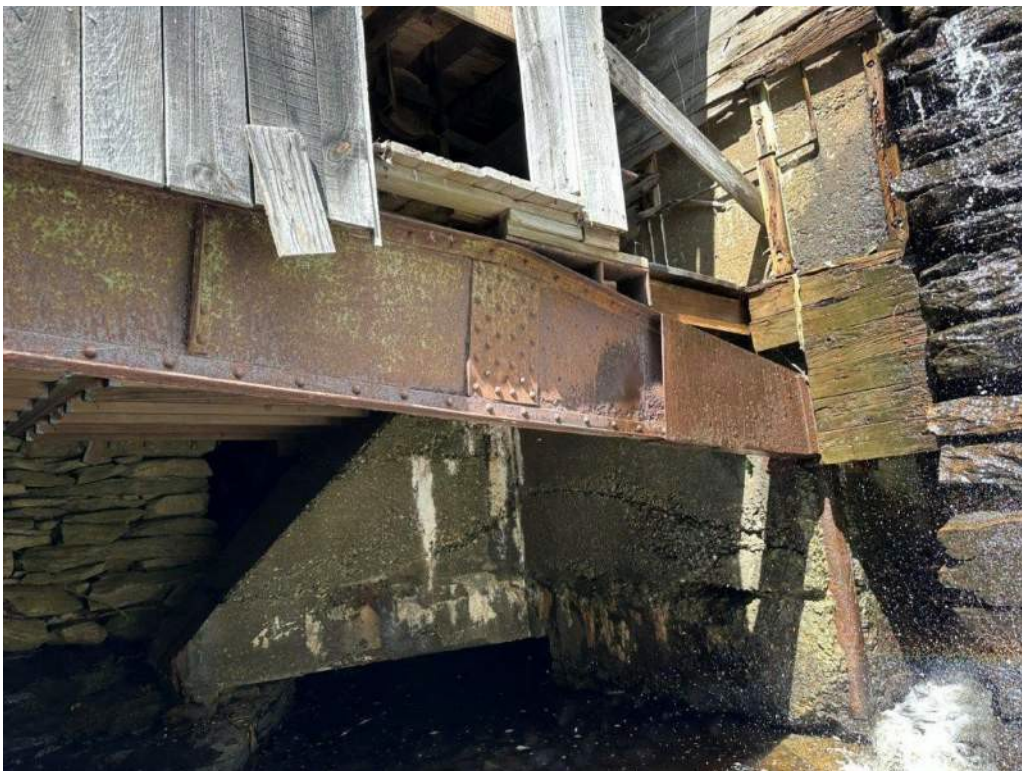
Photo 2
Rusting beam at south elevation with poor continuous floor support

The metal beam support that runs along part of the south elevation is badly deteriorated at its end where it sits on a concrete pier (Photo 2). It also slopes down at the east end, not fully supporting the floor sheathing. At the beam's other end, there is a gap between the beam's bottom face and the top of the stone foundation wall. This means that the load the beam is carrying is not being safely nor properly transferred to the foundation. Finally, the dry laid stone pier that the metal beam sits on is partially undermined, missing a group of stones at its base. *Though further investigation and analysis is necessary to understand the extent of load that the beam is carrying, the beam will either need to be replaced or cleaned, with possibly new end supports welded or bolted on, and then coated to withstand the elements. Re-support of the floor at the sloped location is also recommended. The dry laid pier will also need to be resupported at its base and infilled with matching and compatible stones.*

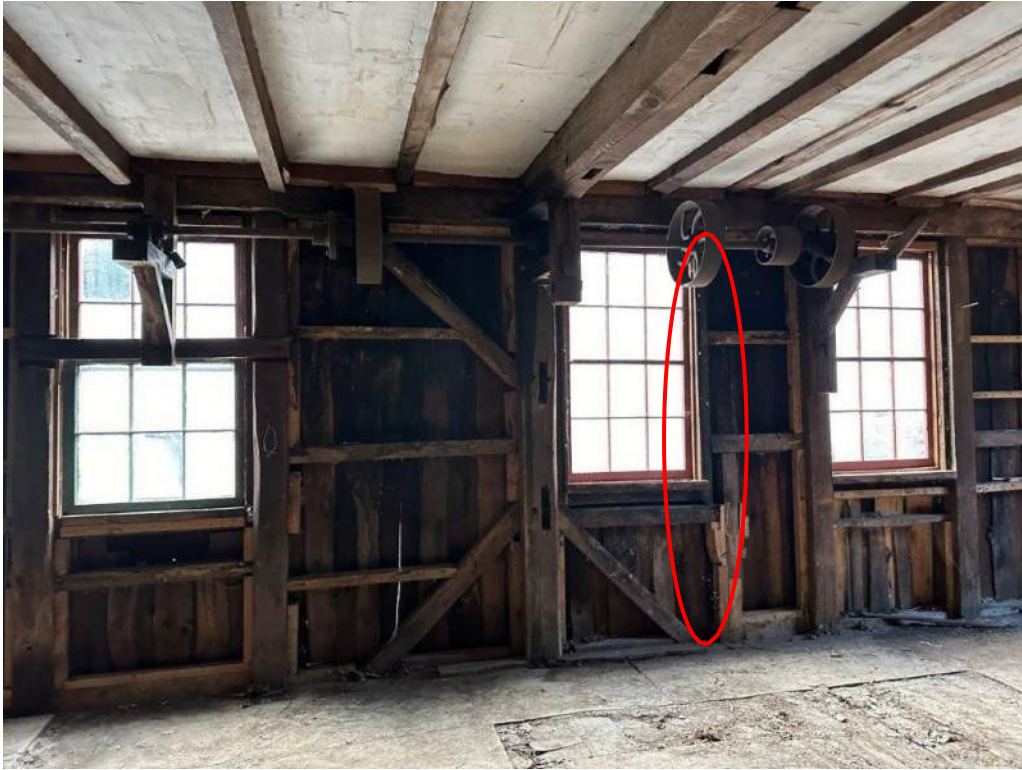
Photo 3
Missing window stud

In the finished room, one of the windows was missing a jack stud (Photo 3), meaning that the adjacent window's stud is enduring more load than it's likely designed for. *To avoid overstressing the other members, the stud should be replaced, keeping up with the redundancy intended for in the wall framing.*

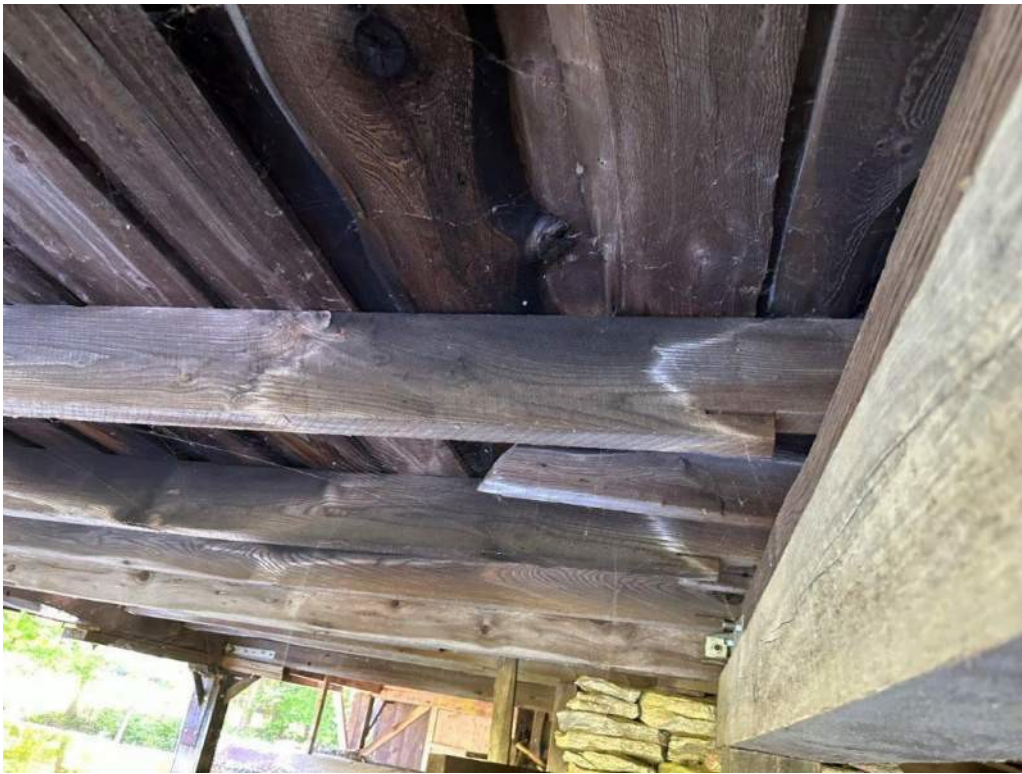
Photo 4
Notched floor joist

- We found that some of the beams and joists at this level are notched at a right angle on their tension face at their end connections as this was a very common joinery technique (Photo 4). However, most often, these notched ends start to split at the right angle due to release of stress built up at the notch. This condition reduces the shear capacity of the member meaning that the member is in an overstressed state. We saw on a few occasions where the members have already begun to split.

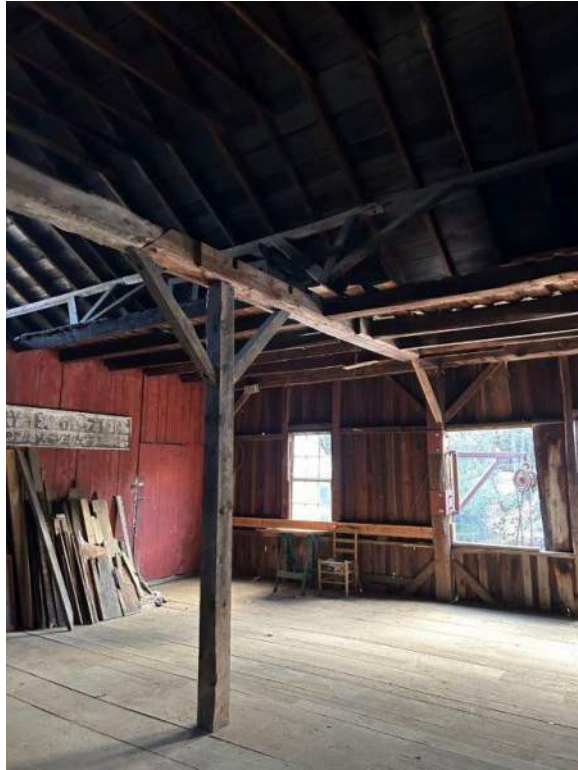
Photo 5
Spliced timber beam

- Some of the horizontal, north-south spanning beams are spliced along their span and meagerly supported (Photo 5). *This condition should be reinforced, potentially with a direct support below or steel reinforcement plate.*

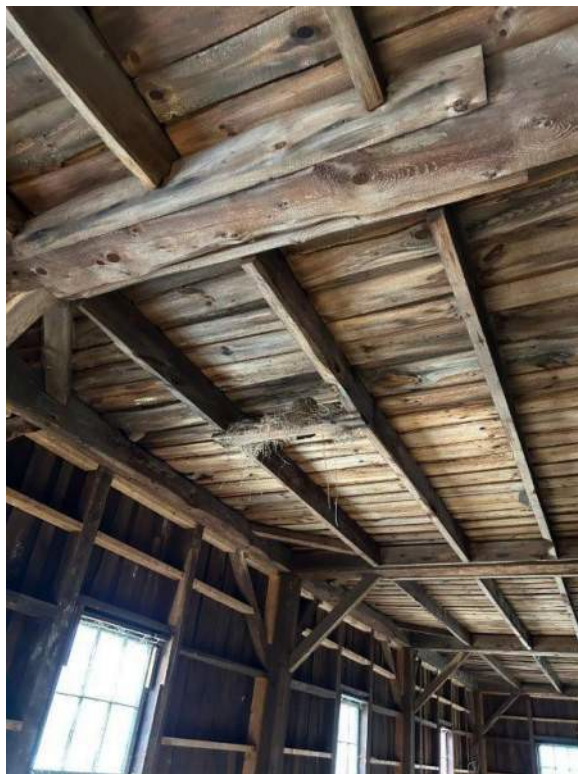
Photo 6
Scant framing at loft level

- The framing of the loft level is also insufficient if the space is to be used, especially for storage or equipment. The joist ends are either toe nailed or deeply notched over scantily connected ledgers, in addition to the joist spans appearing long (Photo 6). *The end connections of the joists will need to be reinforced with metal face mount hangers before access is permitted, and sistering may be needed.*

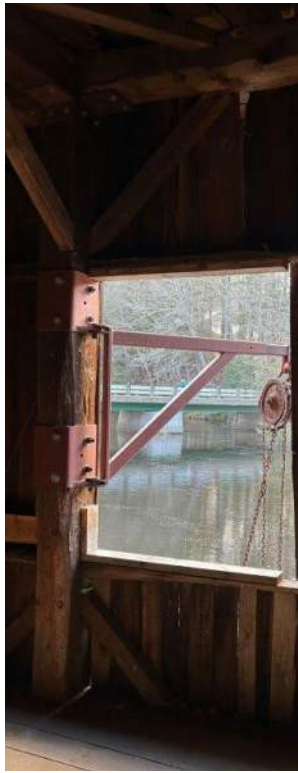
Photo 7

Window opening at south elevation

- One of the windows is missing along the south elevation to allow for the pulley system to extend outwards over the waterway (Photo 7). This opening can permit water to enter and weaken the internal building systems. *The window opening should be boarded up or shutters added to allow for protection from water ingress during storms.*

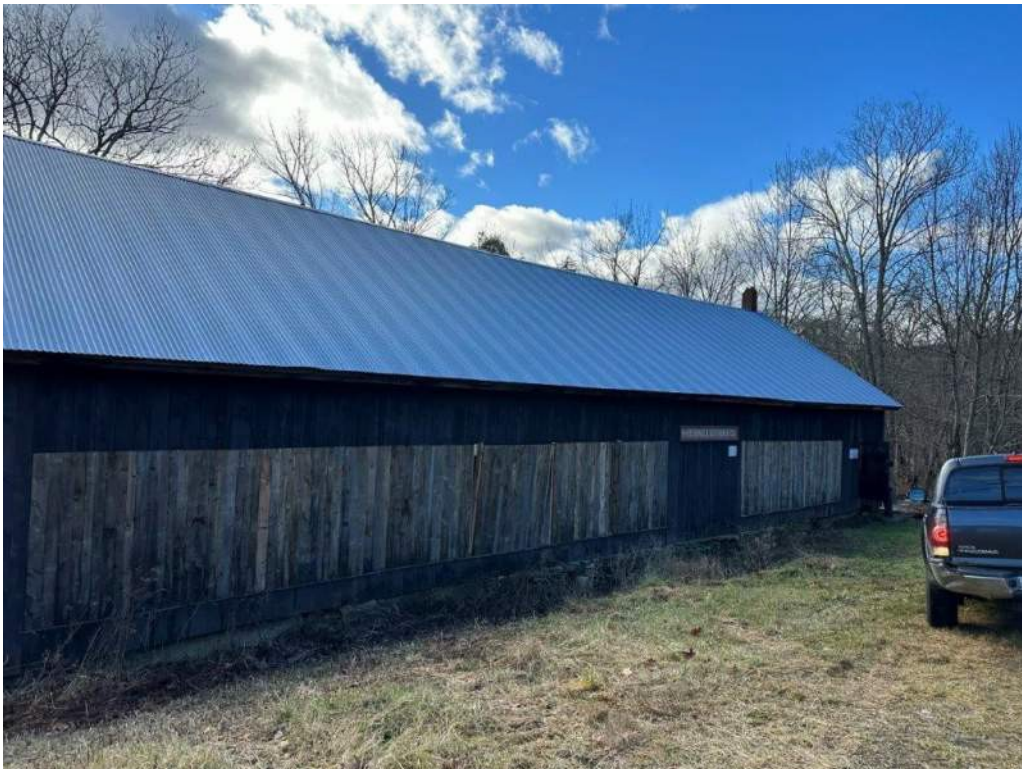
Photo 8

North elevation

The exterior of the building appears to be in mostly sound condition aside from some weathering/potential rot along the roof's rake board and some fallen bricks missing from the chimney (Photo 8). *The rake should be inspected further for any worn areas. The top of the chimney should be dismantled, rebuilt and protected with a cap placed over the top to limit water entry.*

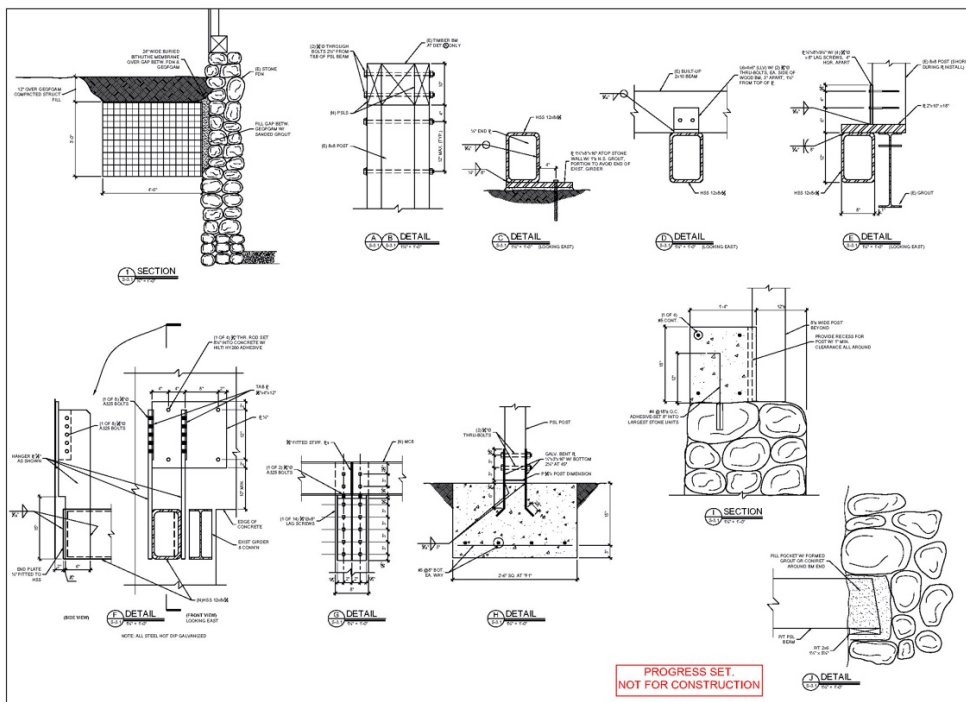
SECTIONAL NOTATION	
50 Westinghouse Dr., Suite #1 North Leverett, MA 01930-1001 Phone: 408/338-1100 Fax: 408/338-1101 www.sectionalnotation.com Email: sales@sectionalnotation.com	
NORTH LEVERETT SAWMILL RESTORATION 70 NORTH LEVERETT RD. NORTH LEVERETT, MA 01930	
CLIENT NAME:	
SCALE AS SHOWN	
DRAWN BY	
CHECKED BY	
DATE	
PROJECT NO.	
SECTION AND DETAILS	
Drawing No. S-3.1
